G-051-099 Final Report: Remote Measurement of Reclamation Success

Development of Operational Aerial Analytics  
for Remotely Measuring Reclamation Success in North Dakota

**Final Report**

June 30, 2021

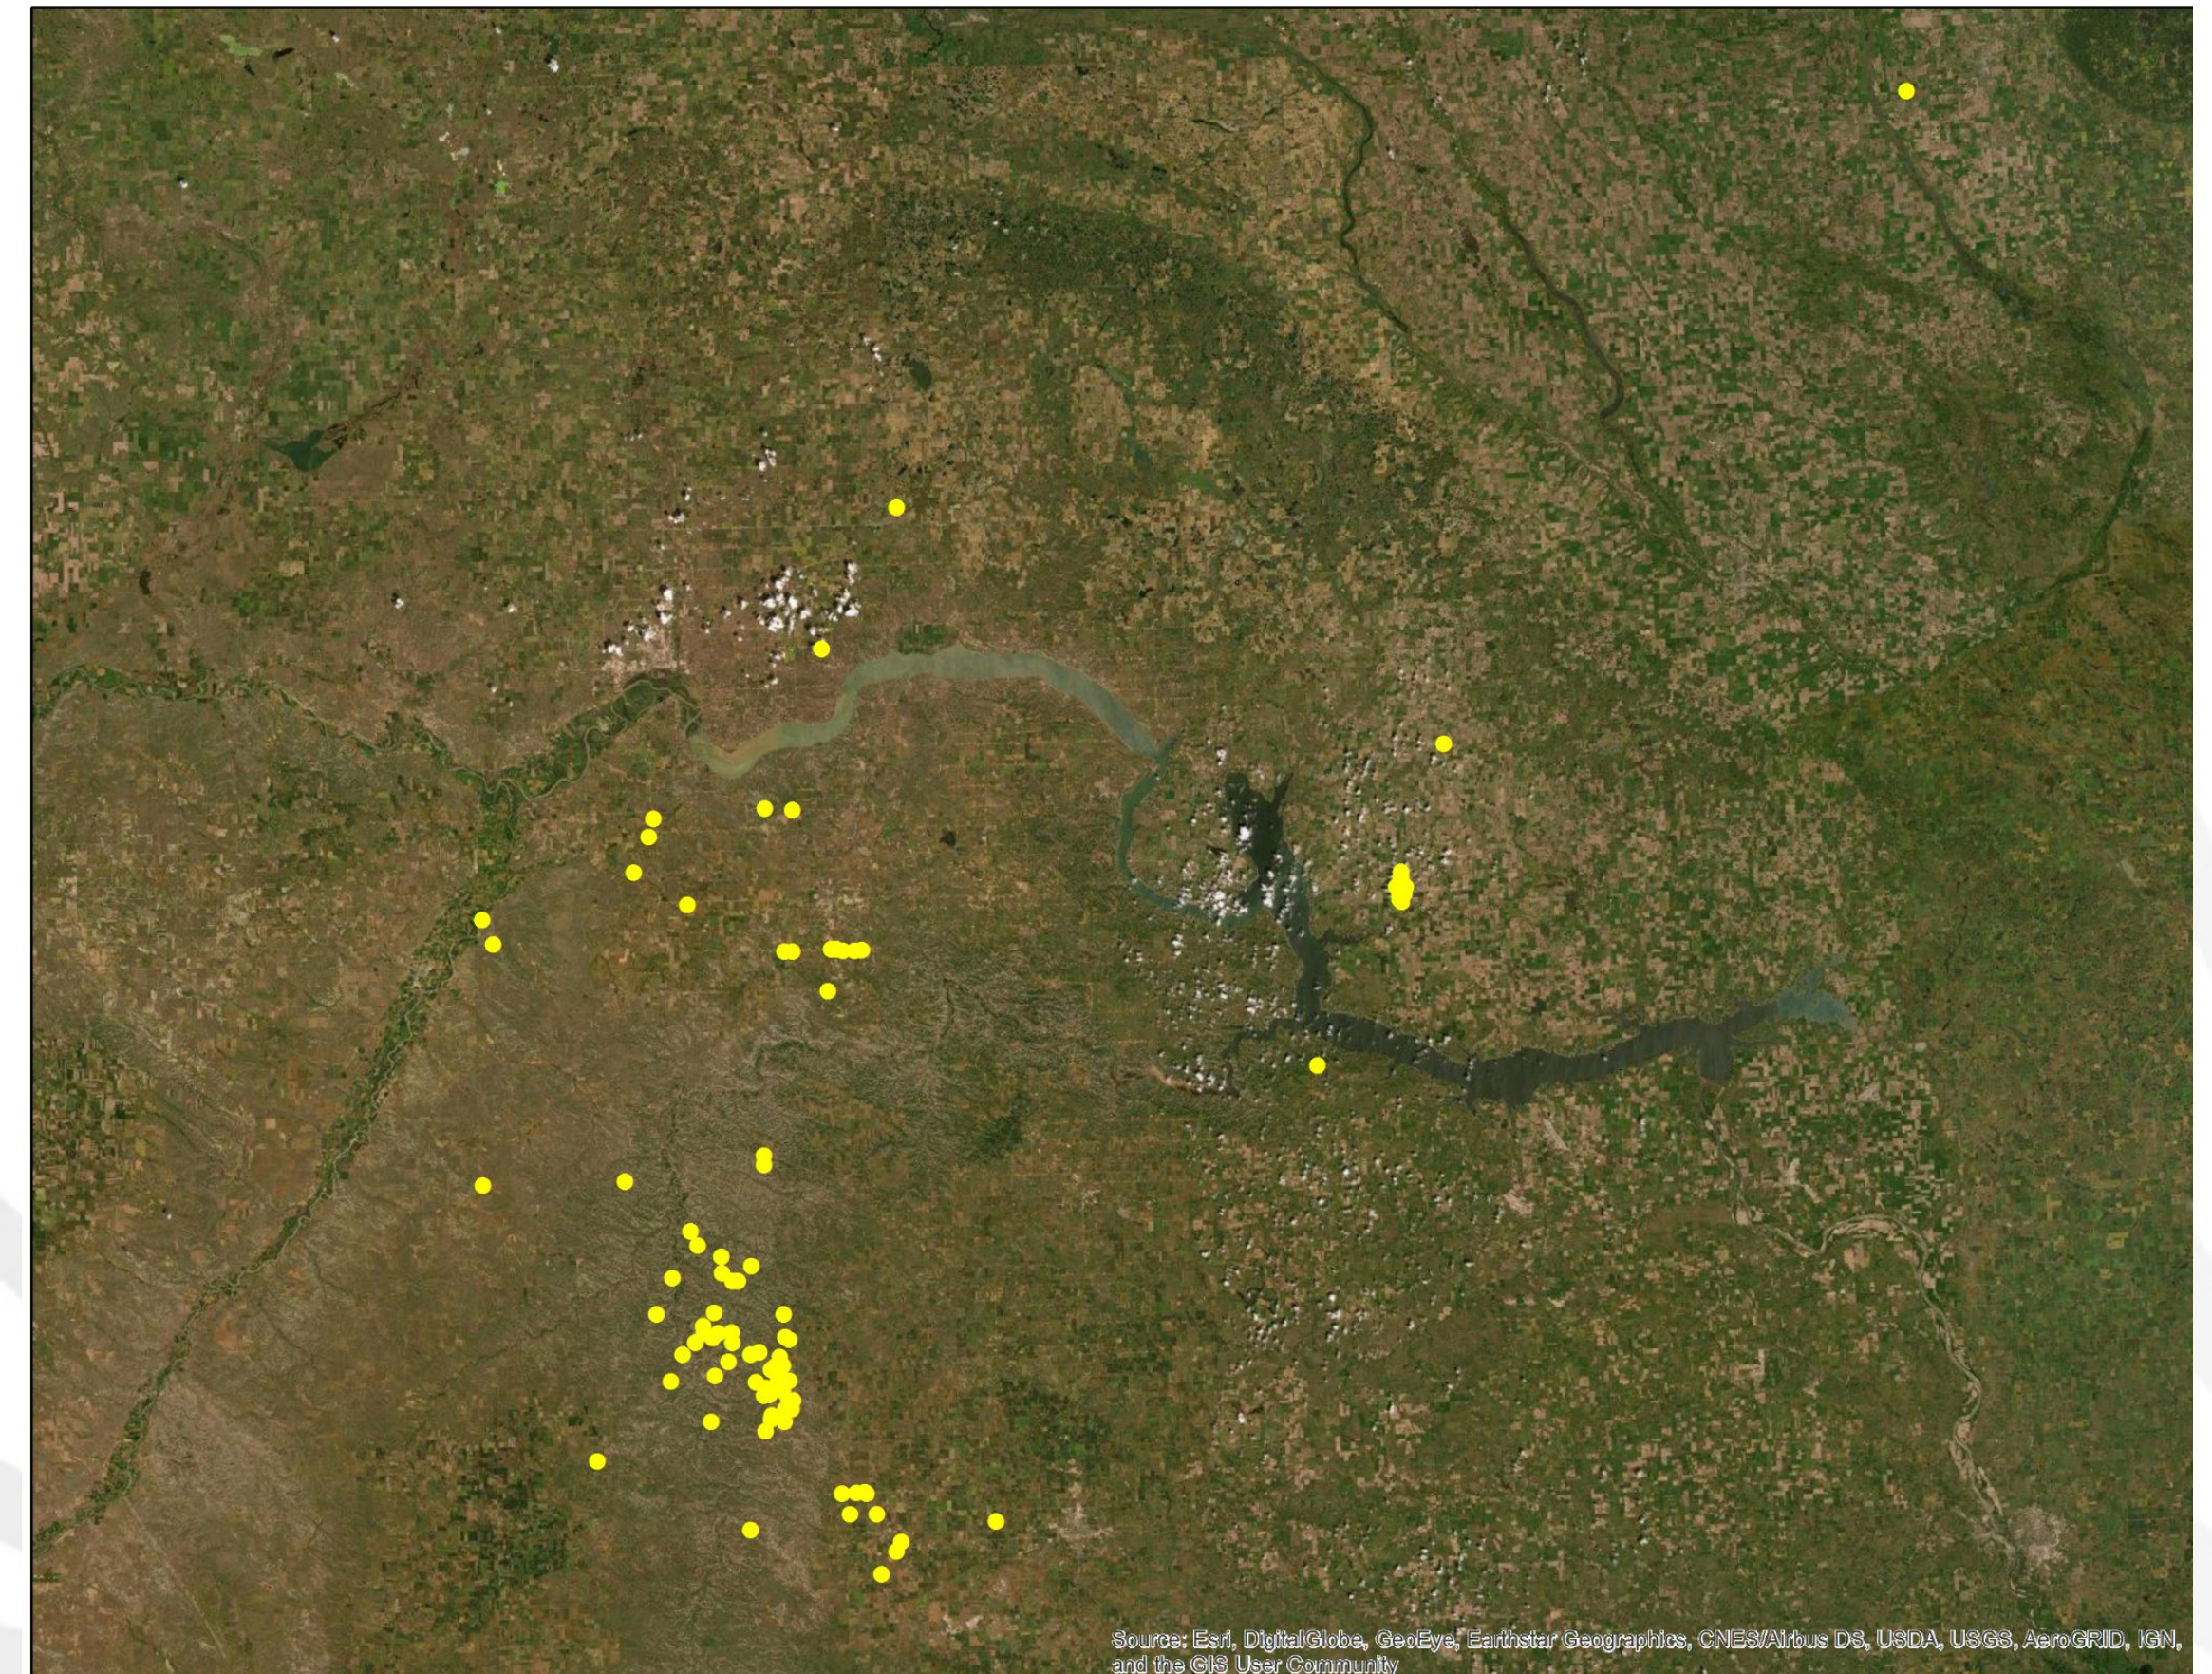
Whiting Pads selected for detailed analysis (n = 101)

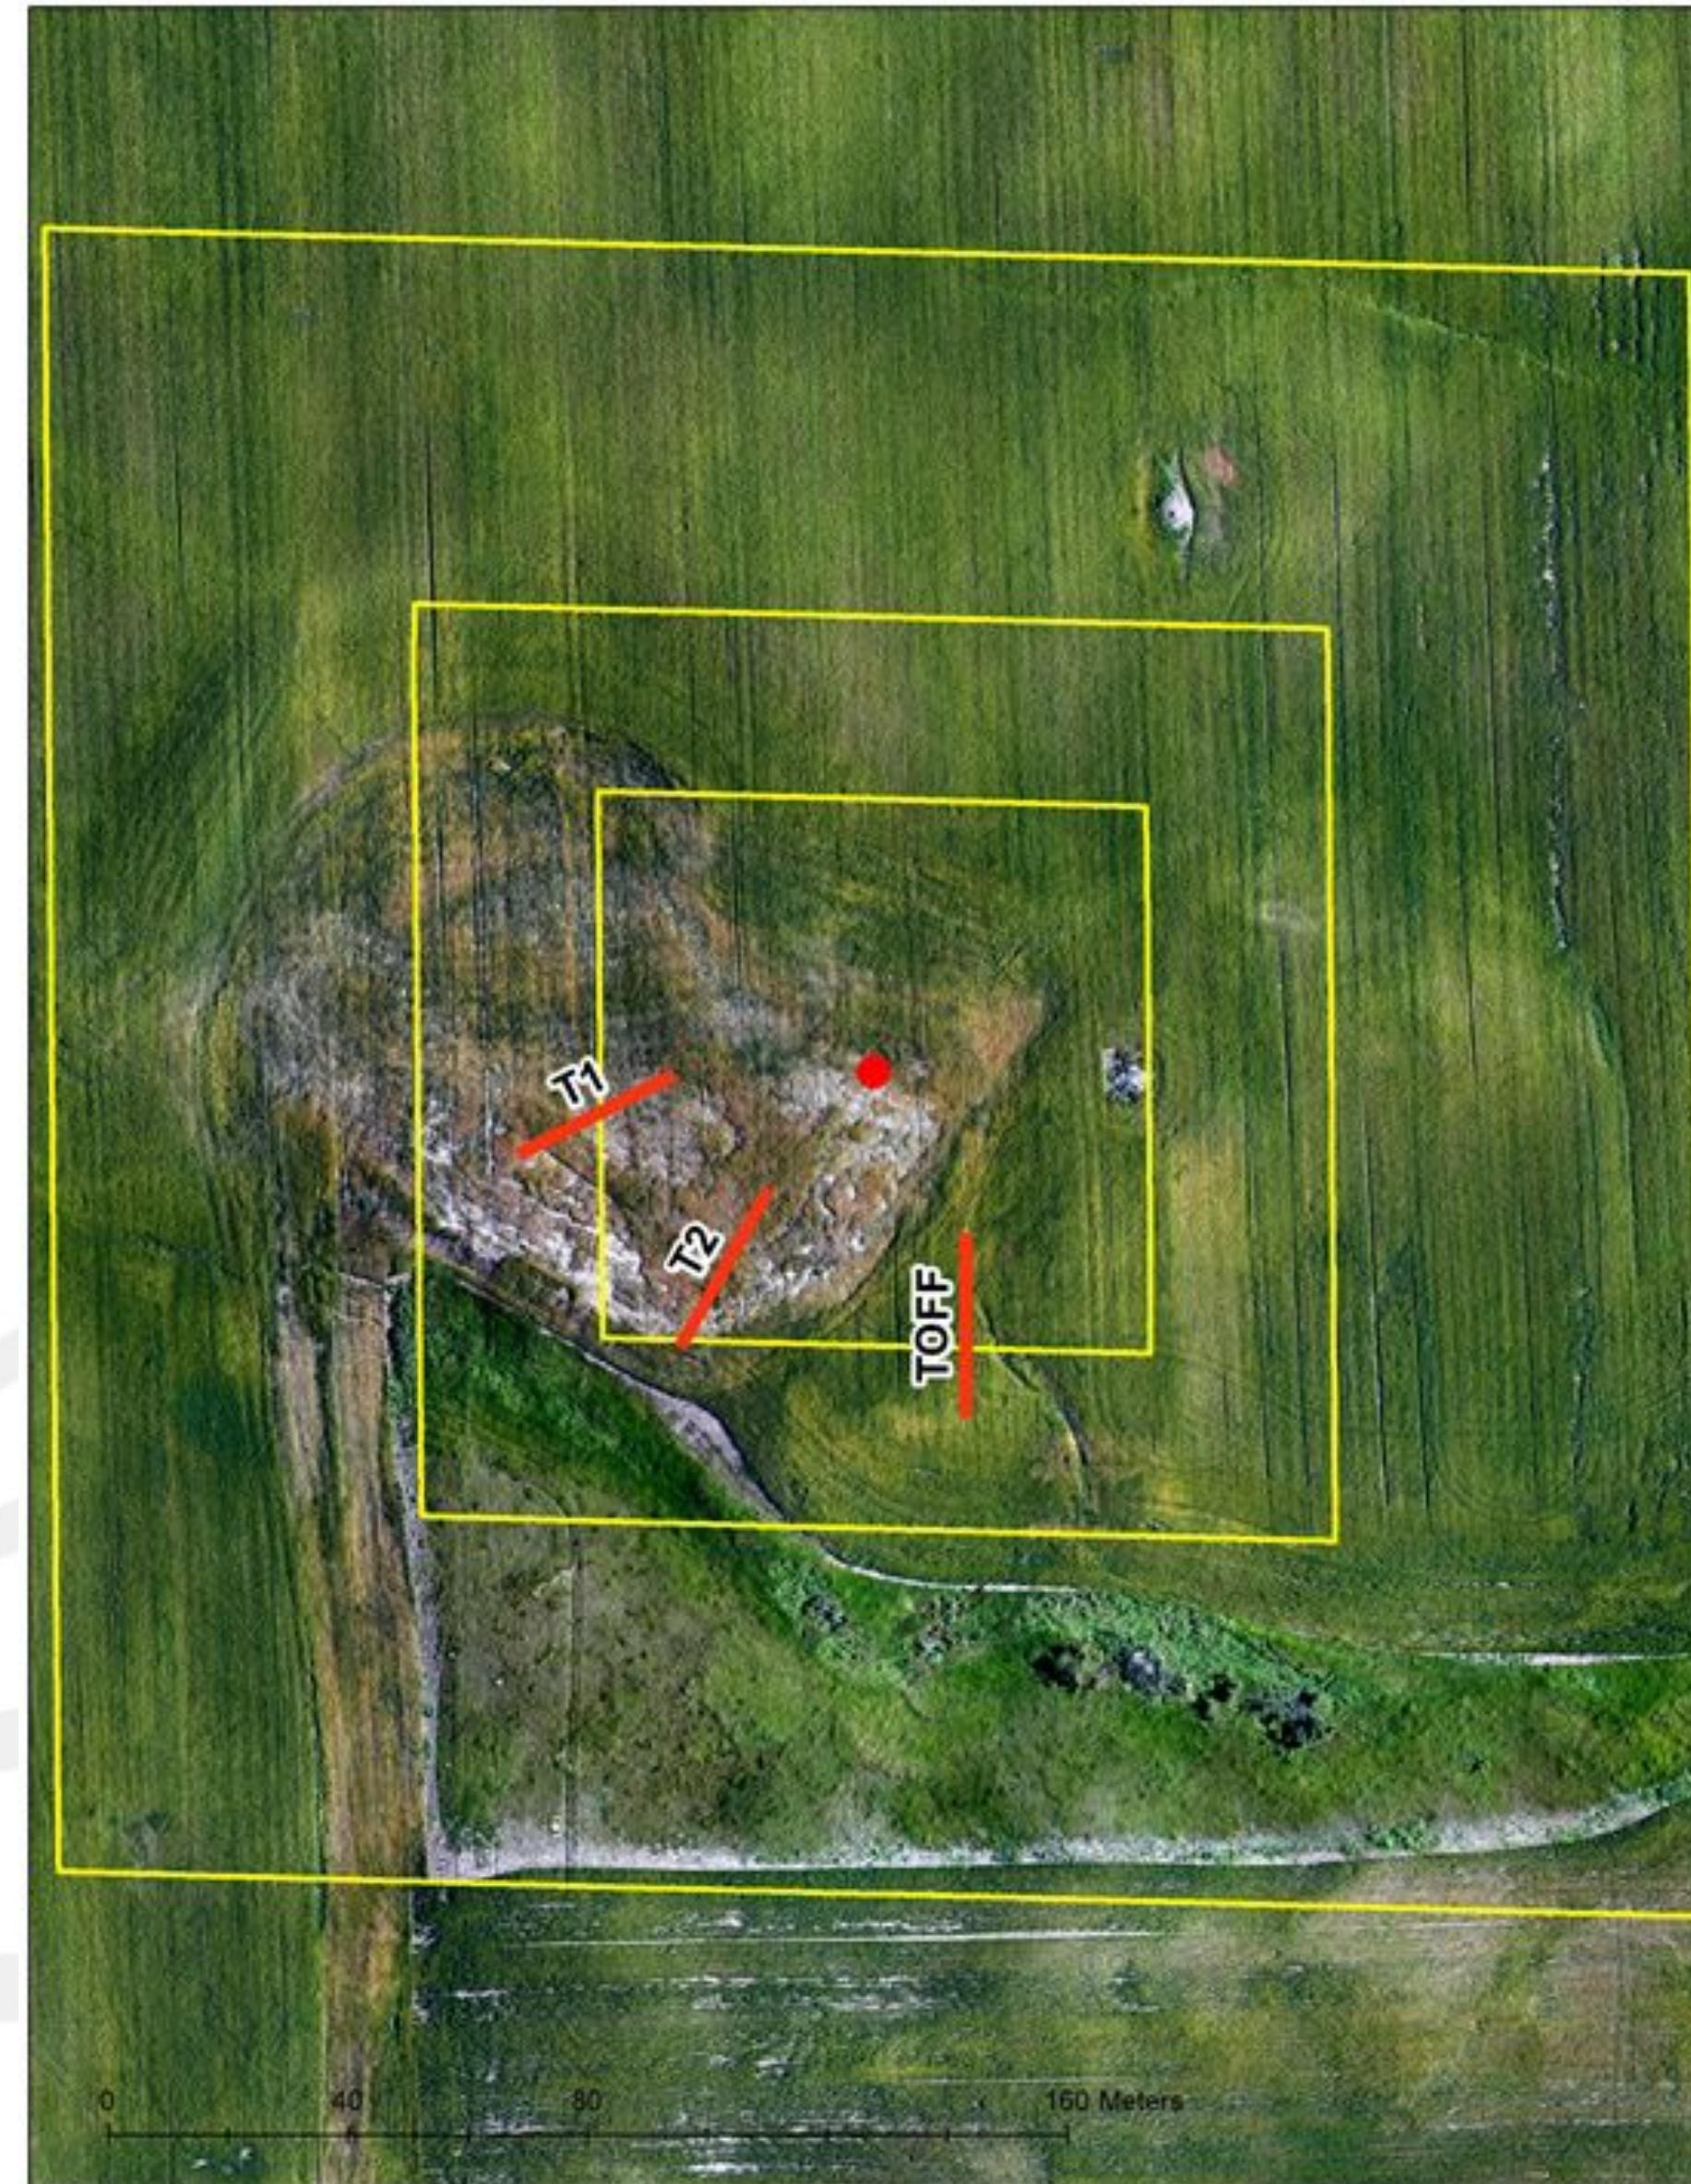
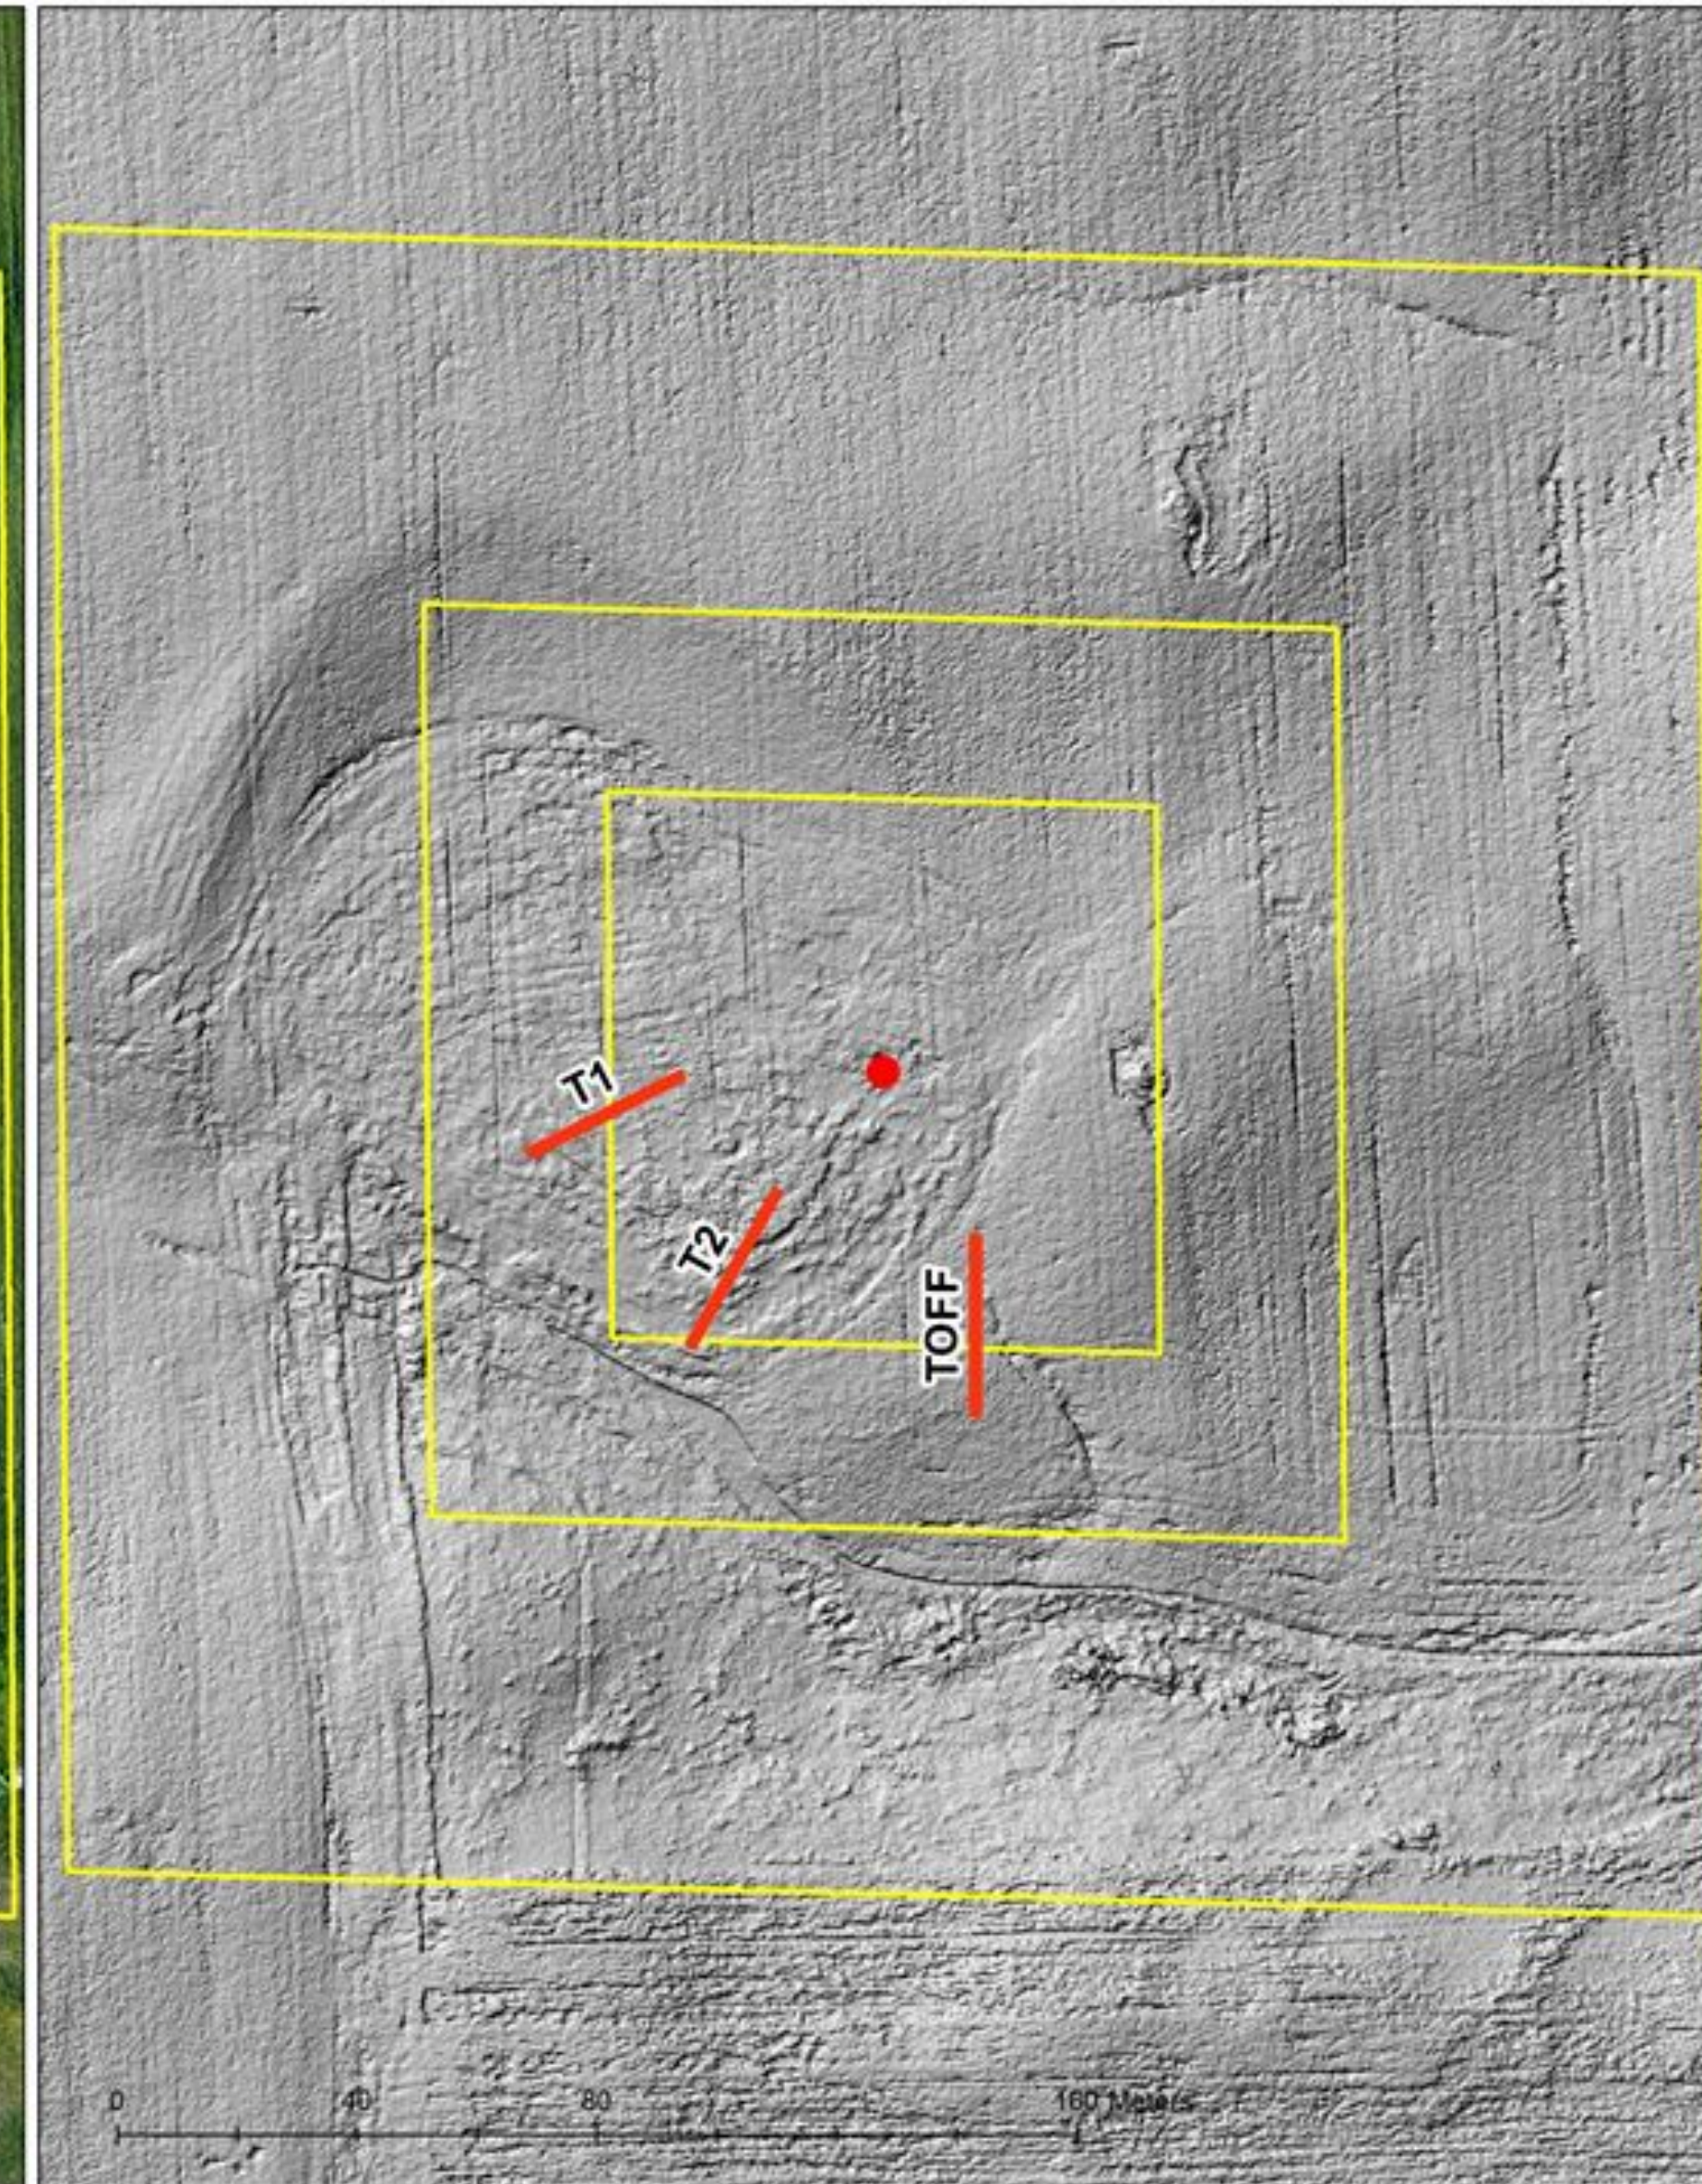
Duraroot surveyed 29 well pads for field validation.

- 19 in final reclamation
- 10 in partial reclamation

Two to three transects per well pad quantified soil cover, including vegetation, litter, rocks, and biotic crusts.

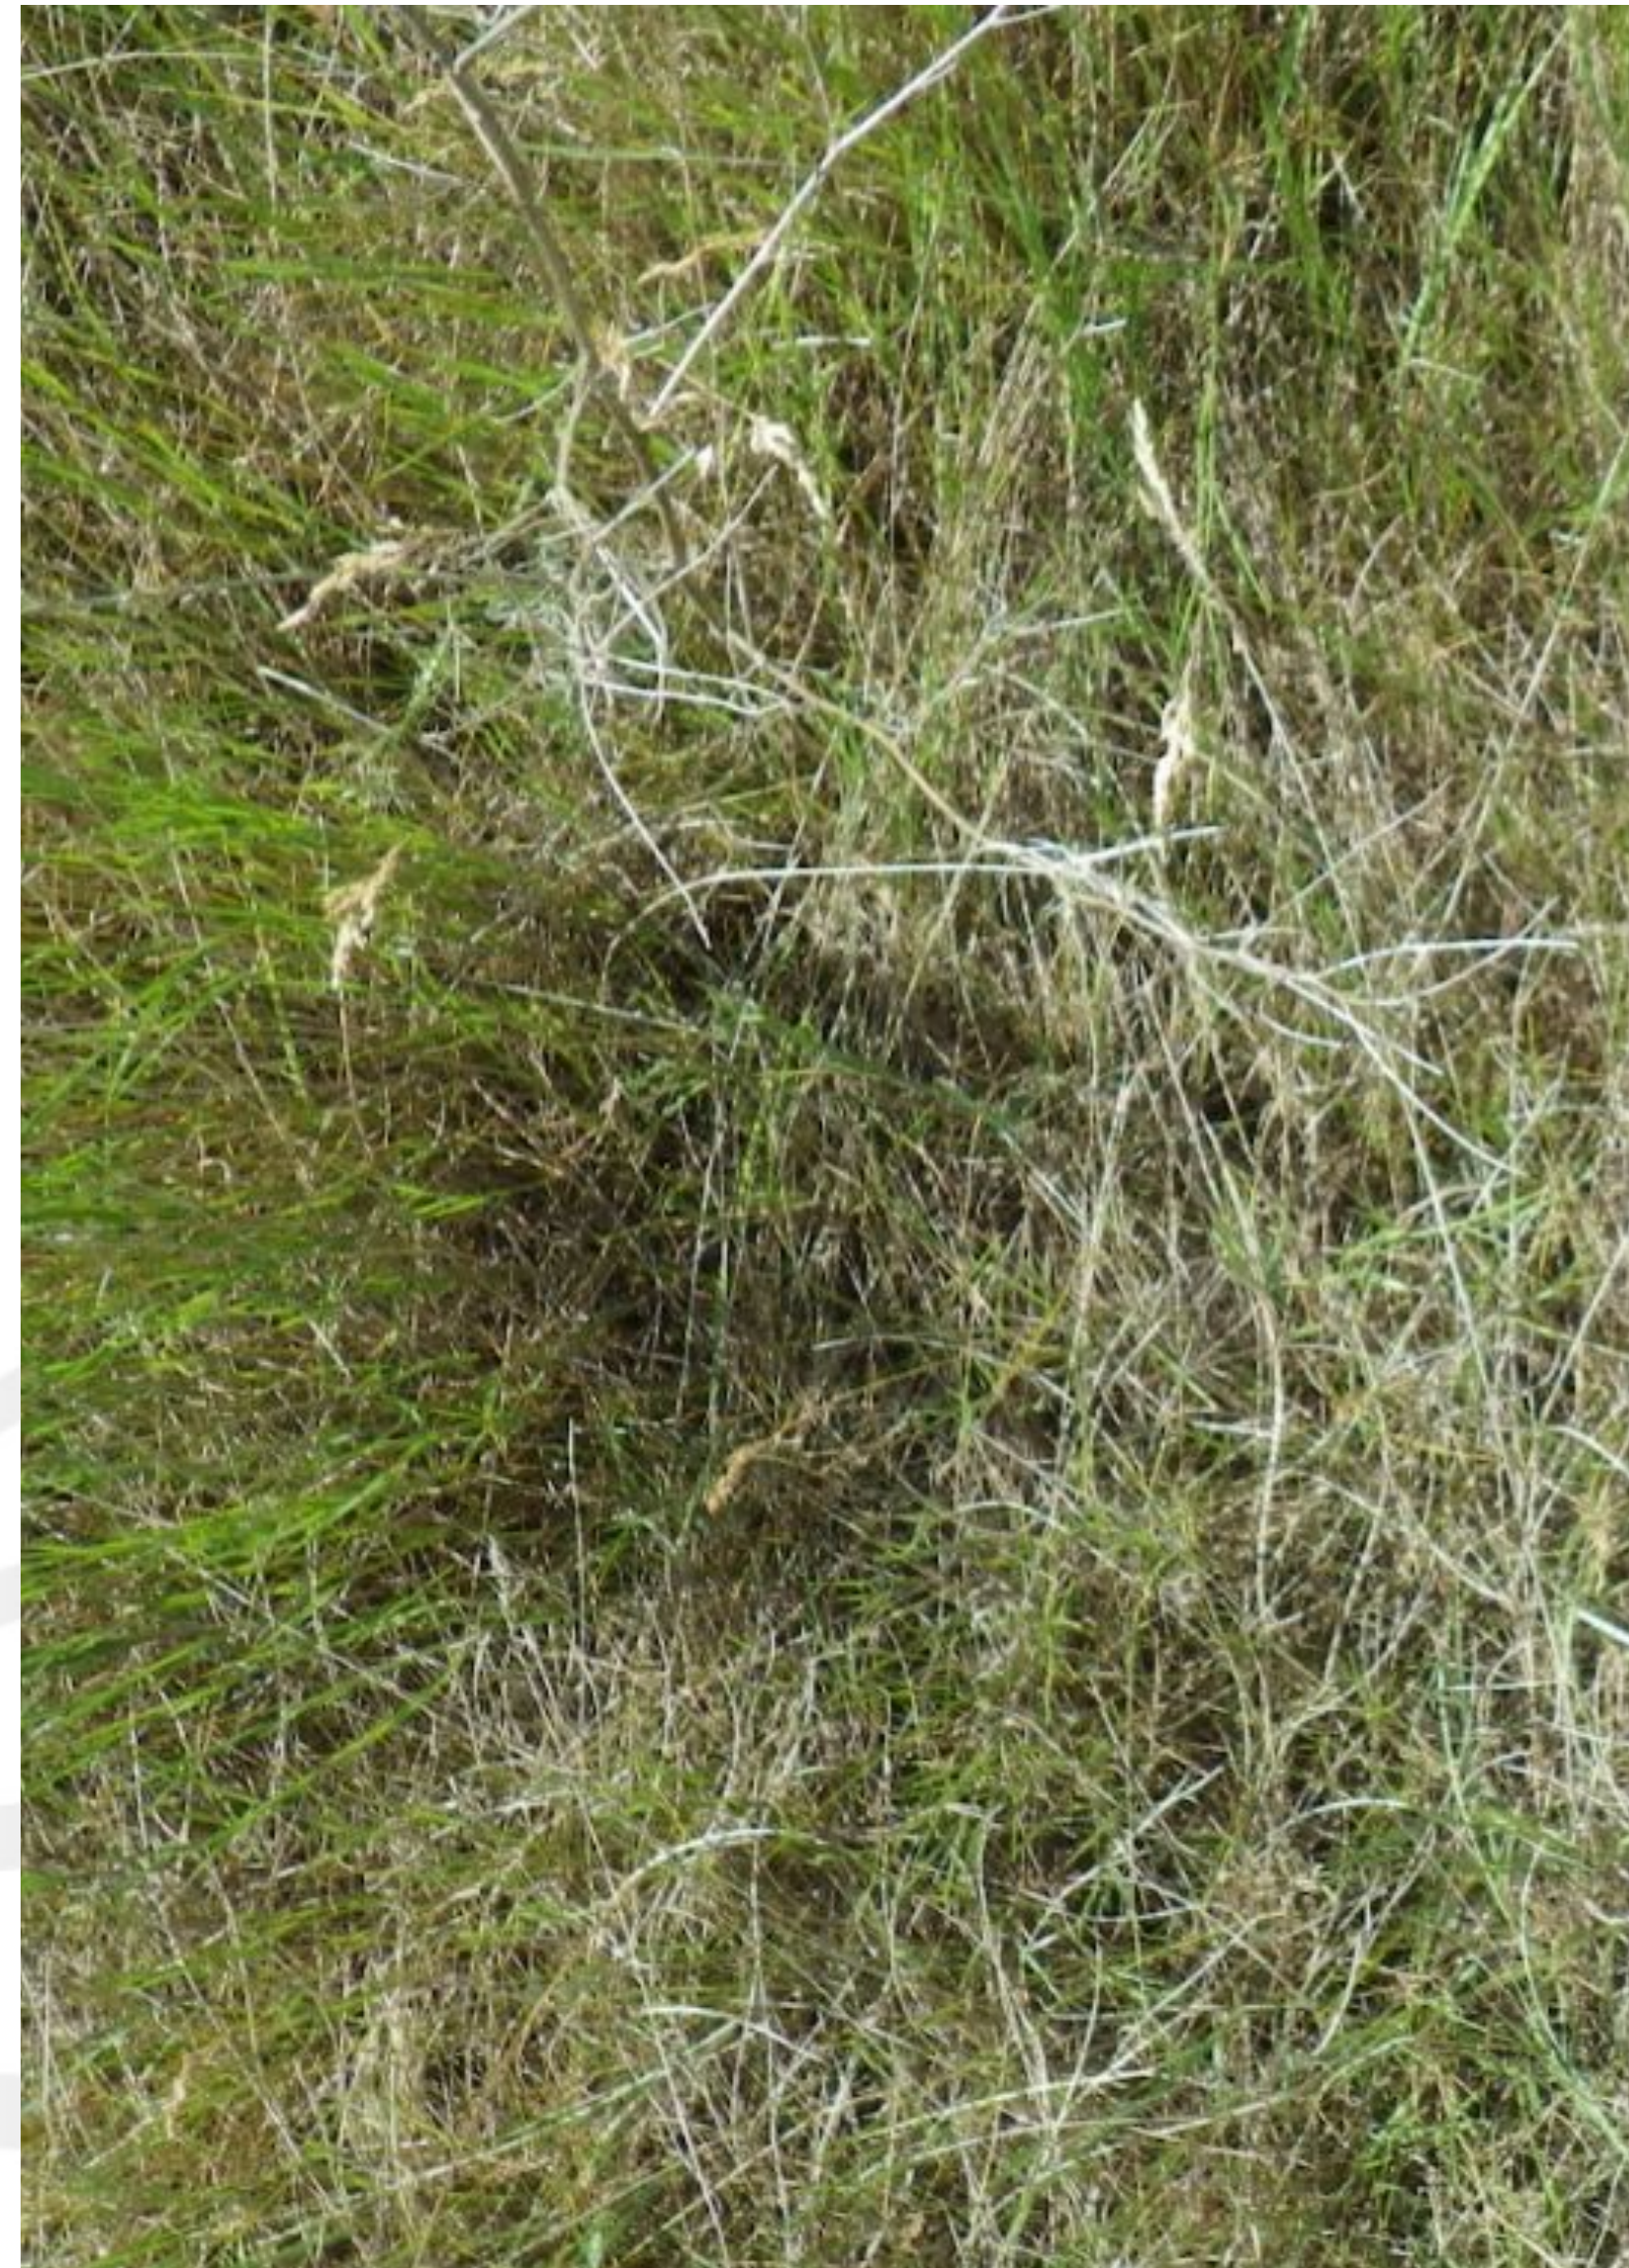
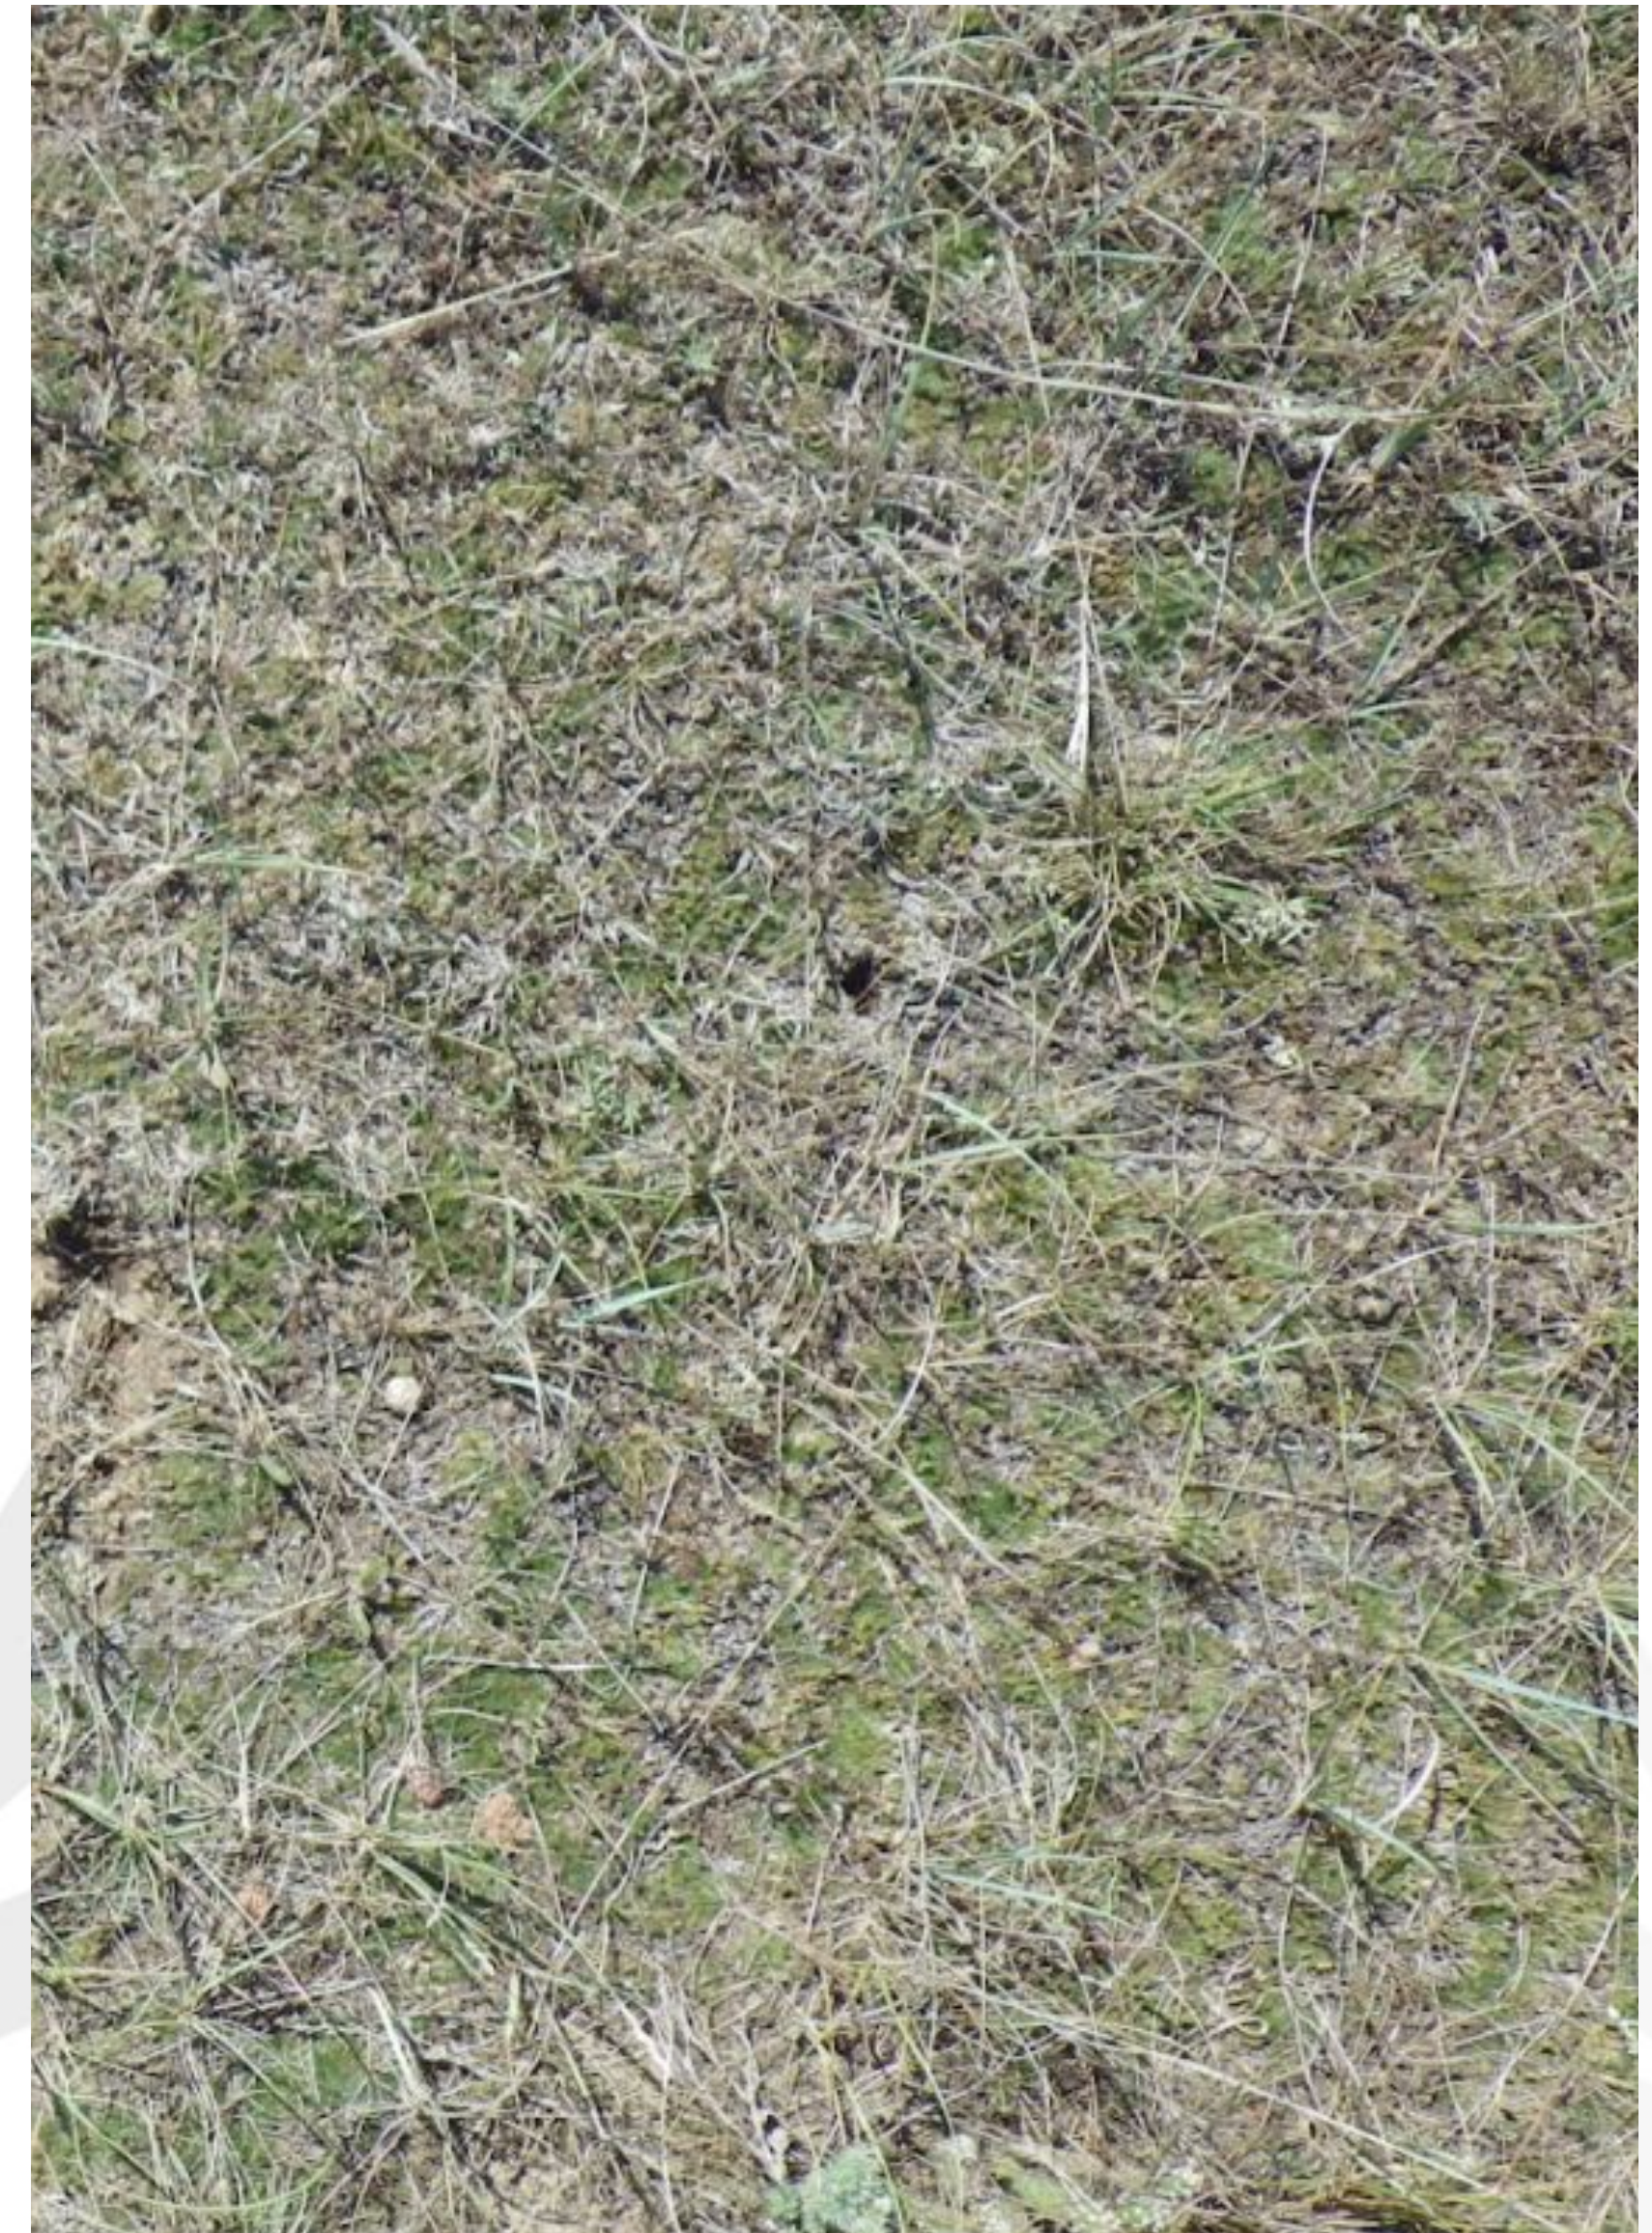
Three to five photographs per well pad captured ground cover for ocular verification.

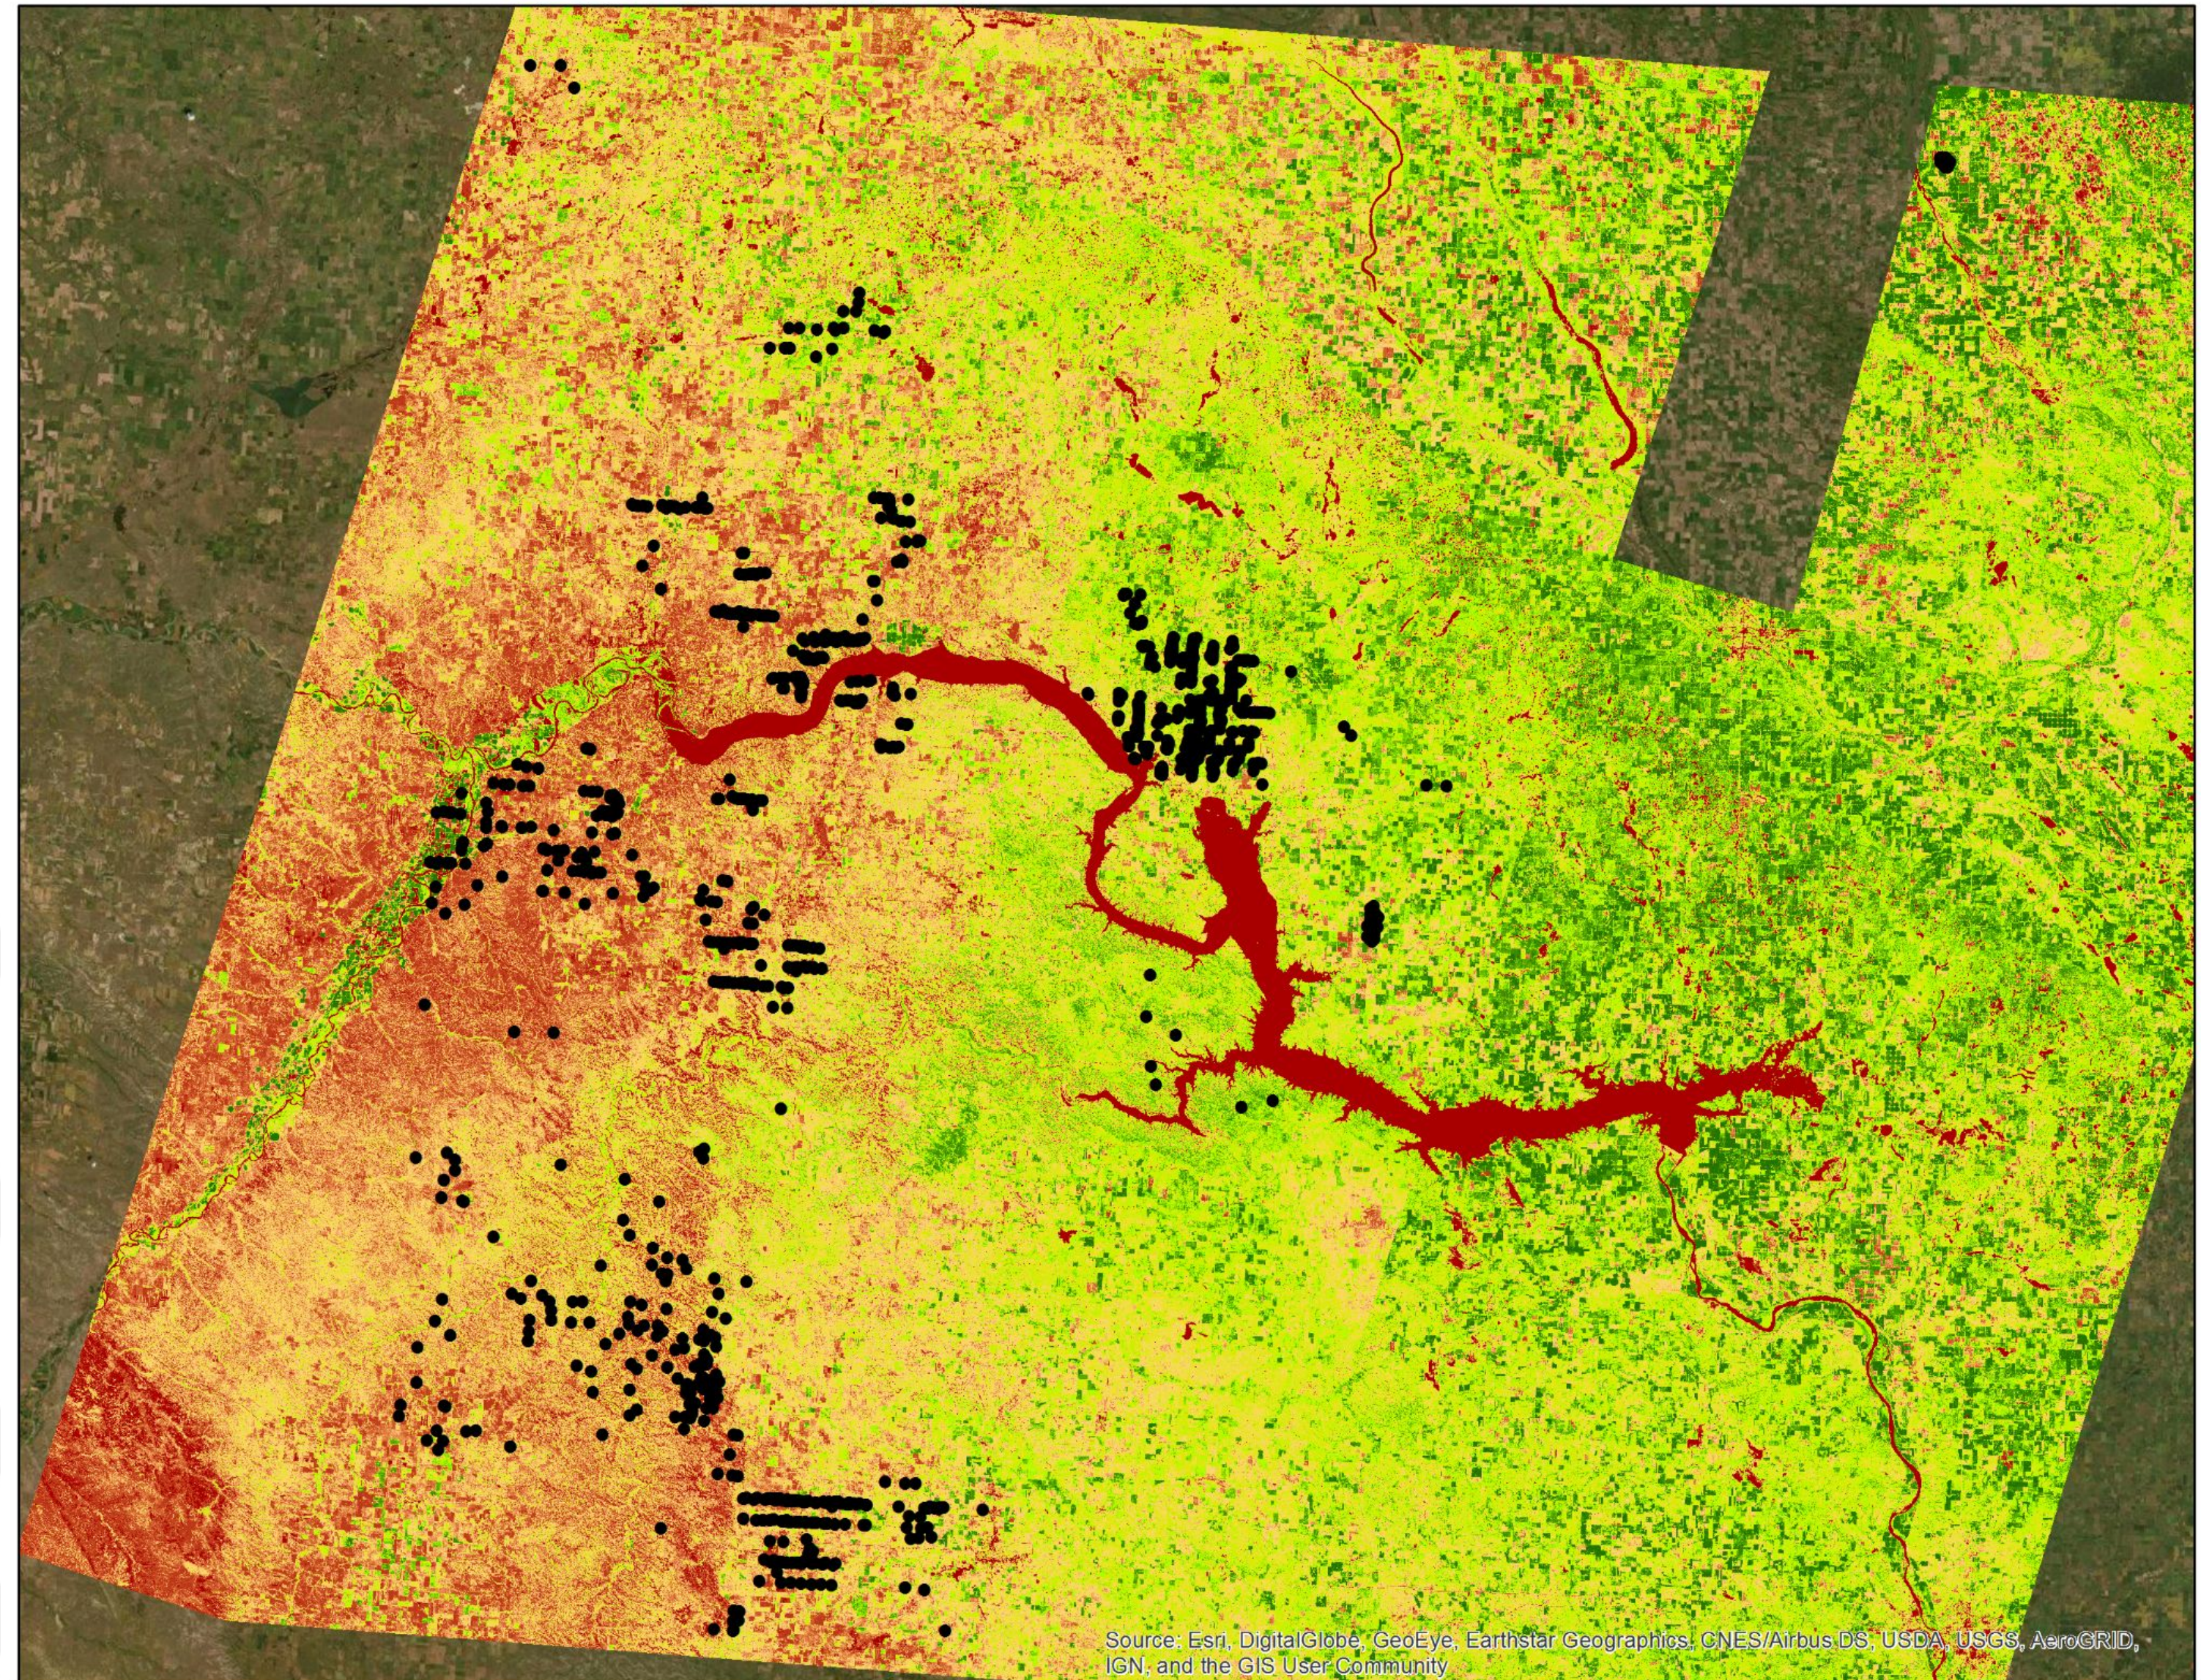
Teren performed a broad-scale assessment of vegetation vigor and classification on 2,313 well pads operated by Whiting using 0.6-meter NAIP data.
