G-051-099 Final Report: Remote Measurement of Reclamation Success

Development of Operational Aerial Analytics  
for Remotely Measuring Reclamation Success in North Dakota

**Final Report**

June 30, 2021

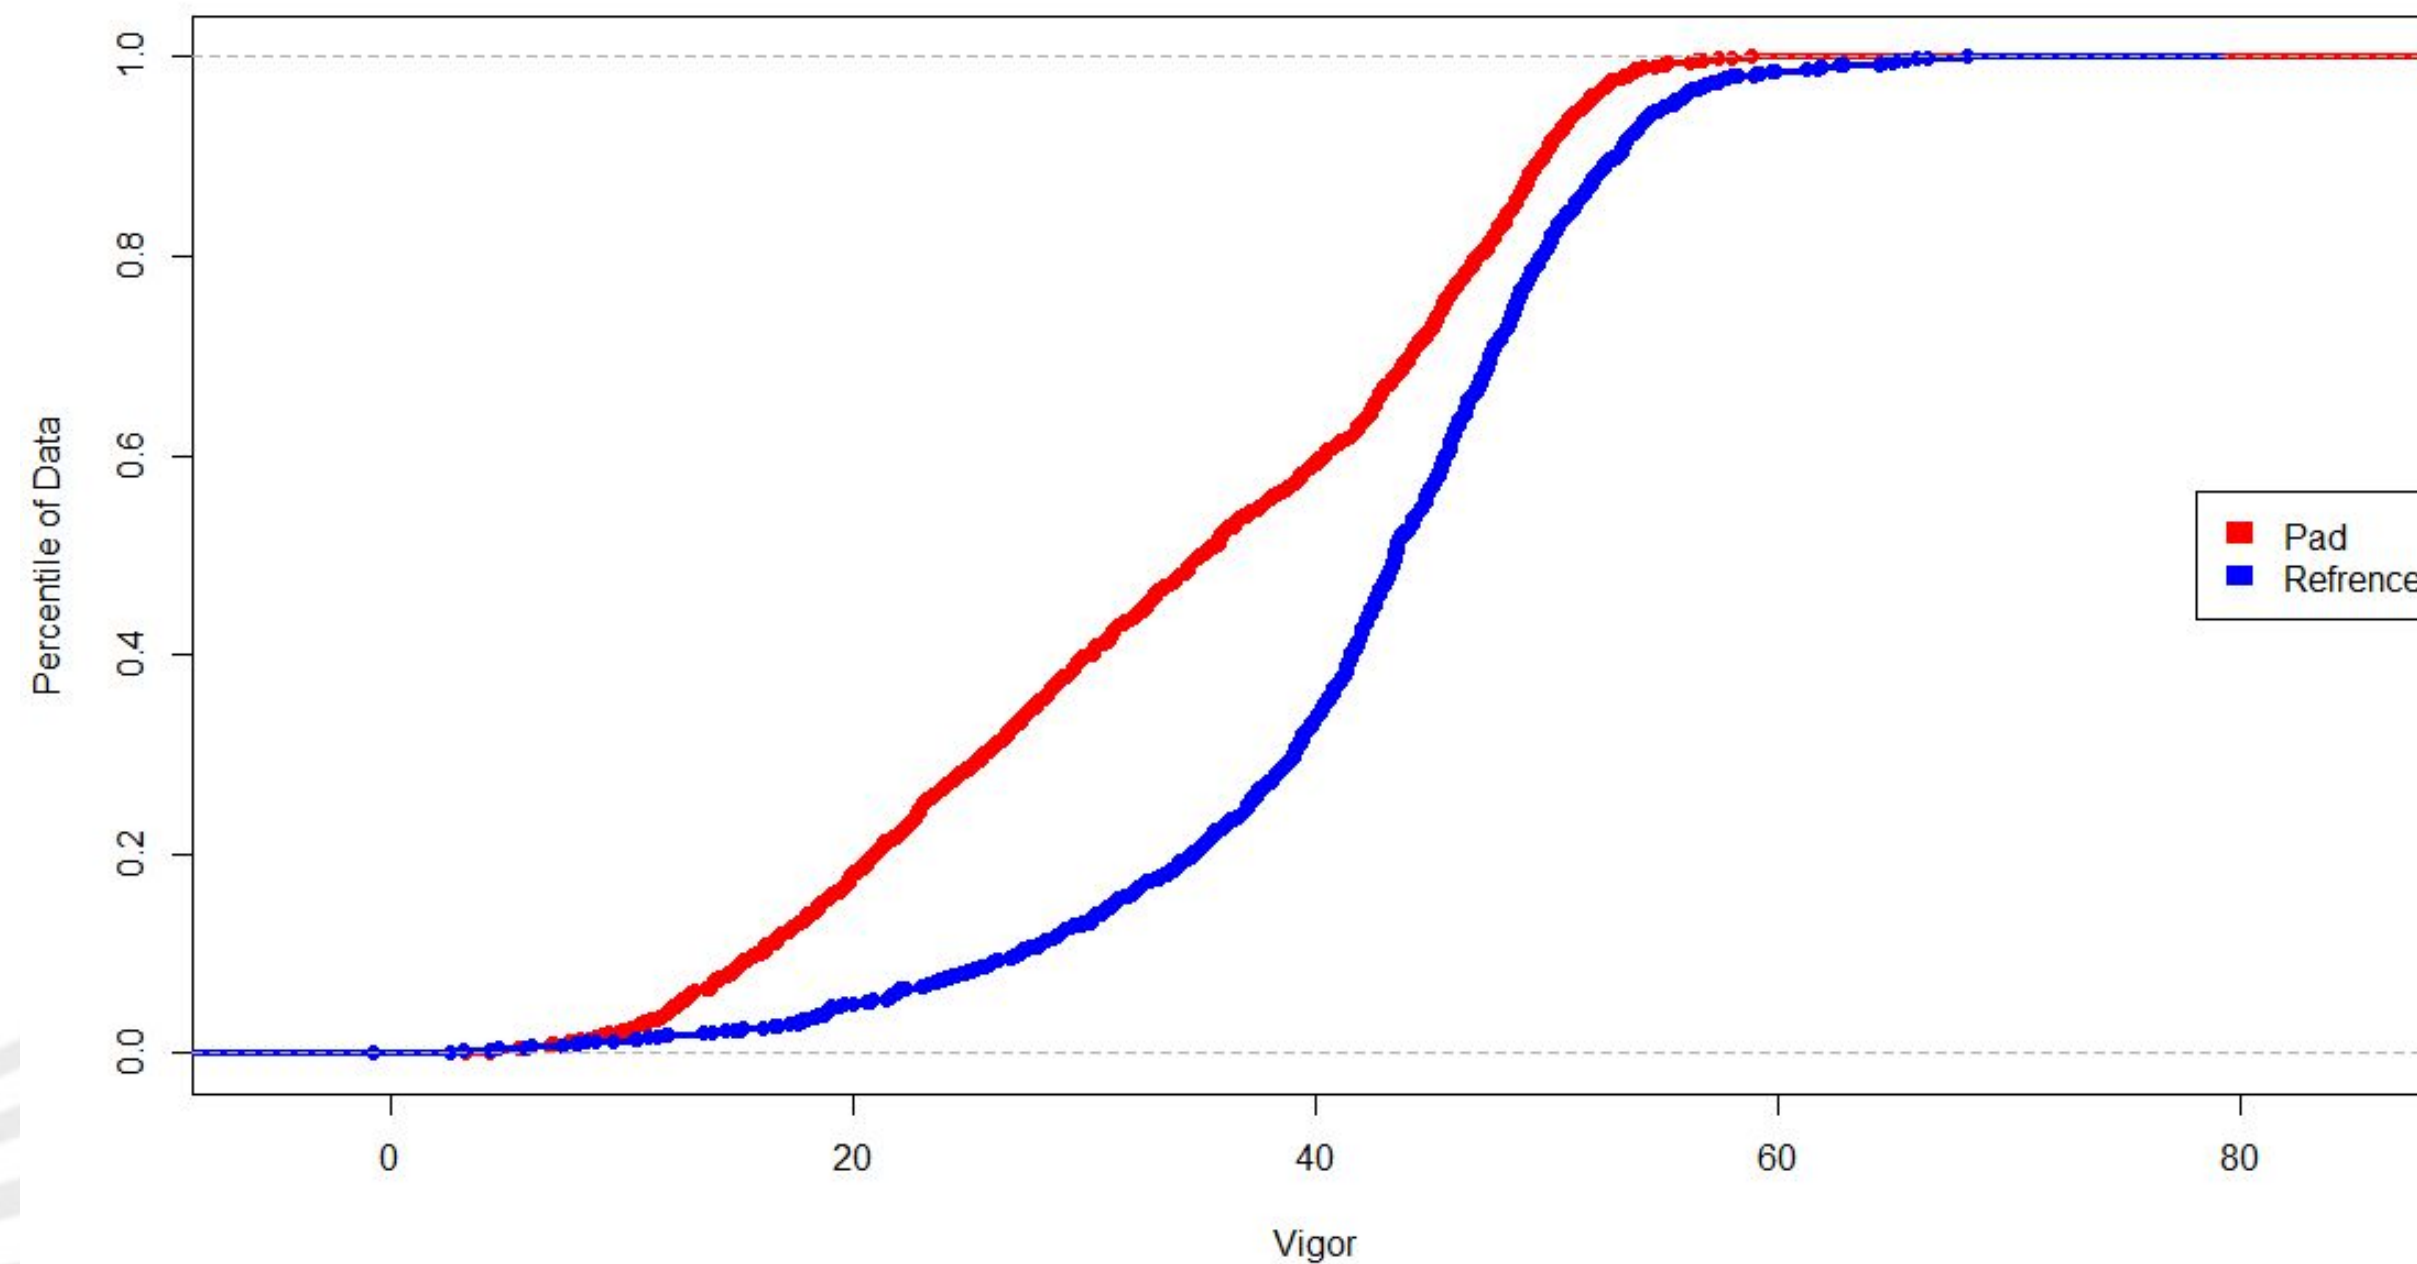
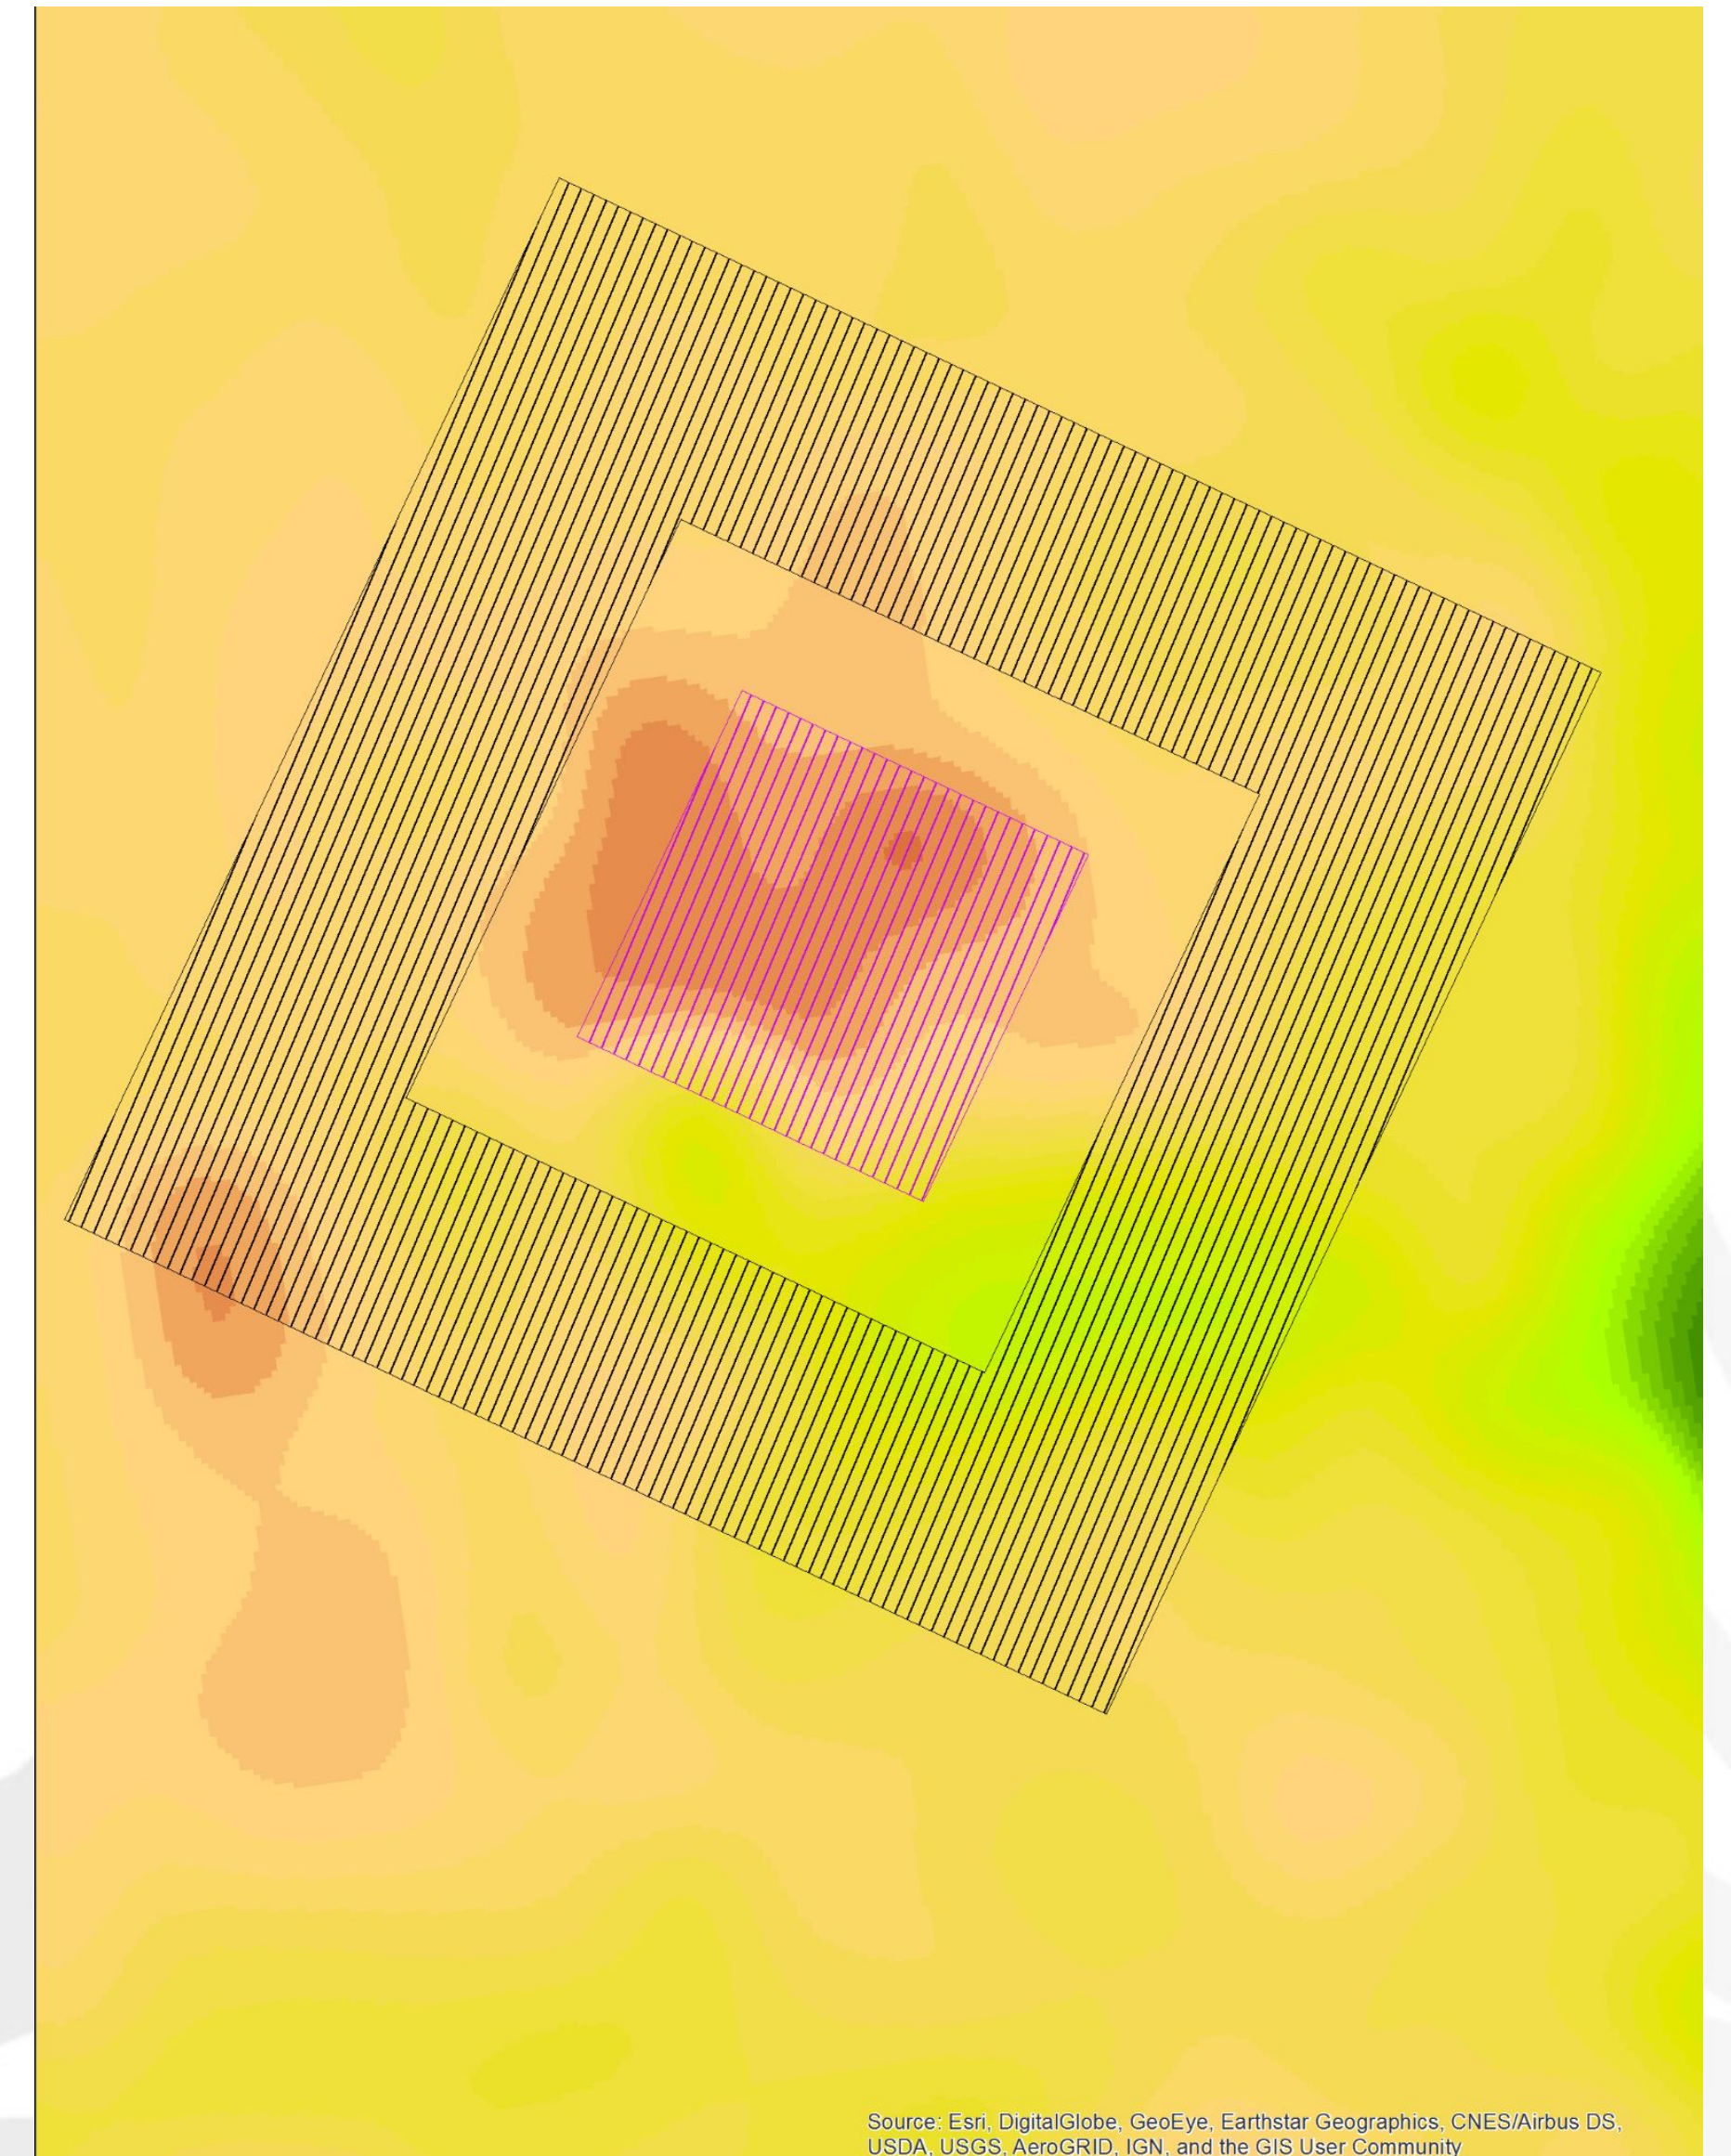
Teren statistically compared the pad and off-pad reference areas to produce a **Continuity Index** of vegetation vigor and classification for each well pad.

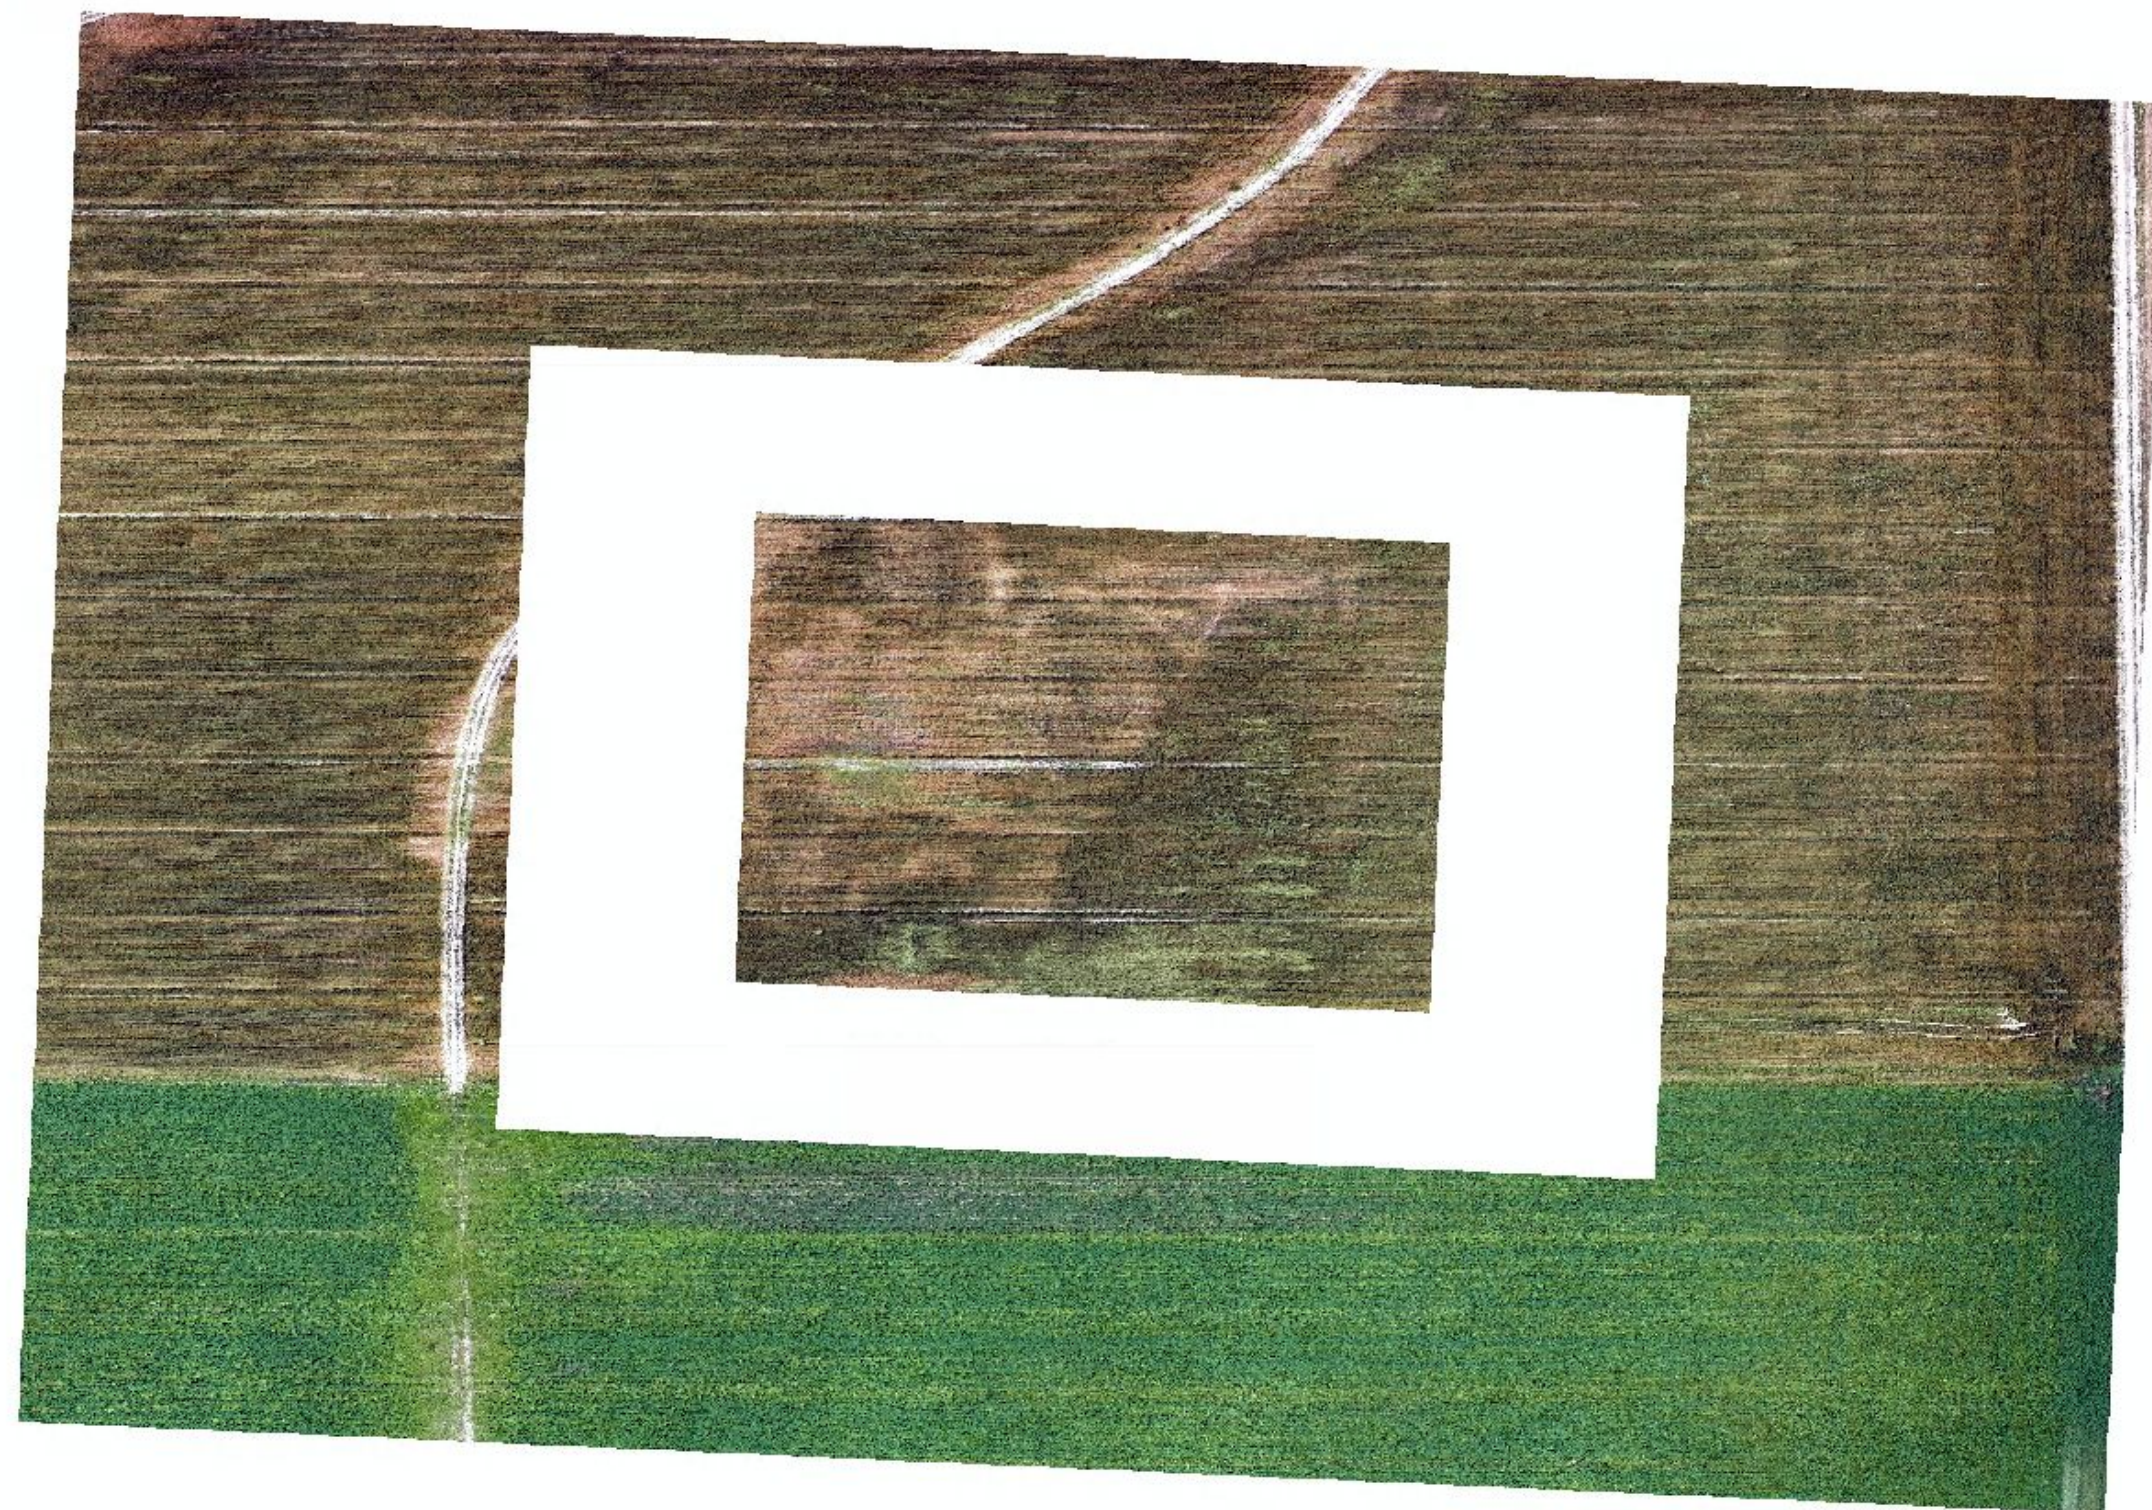
Unaltered orthomosaic

- Orthomosaic-based vegetation analytic assesses regrowth with high temporal relevance and accuracy.
- Automatically discerns ground cover type and determines total area and percentage of each type.

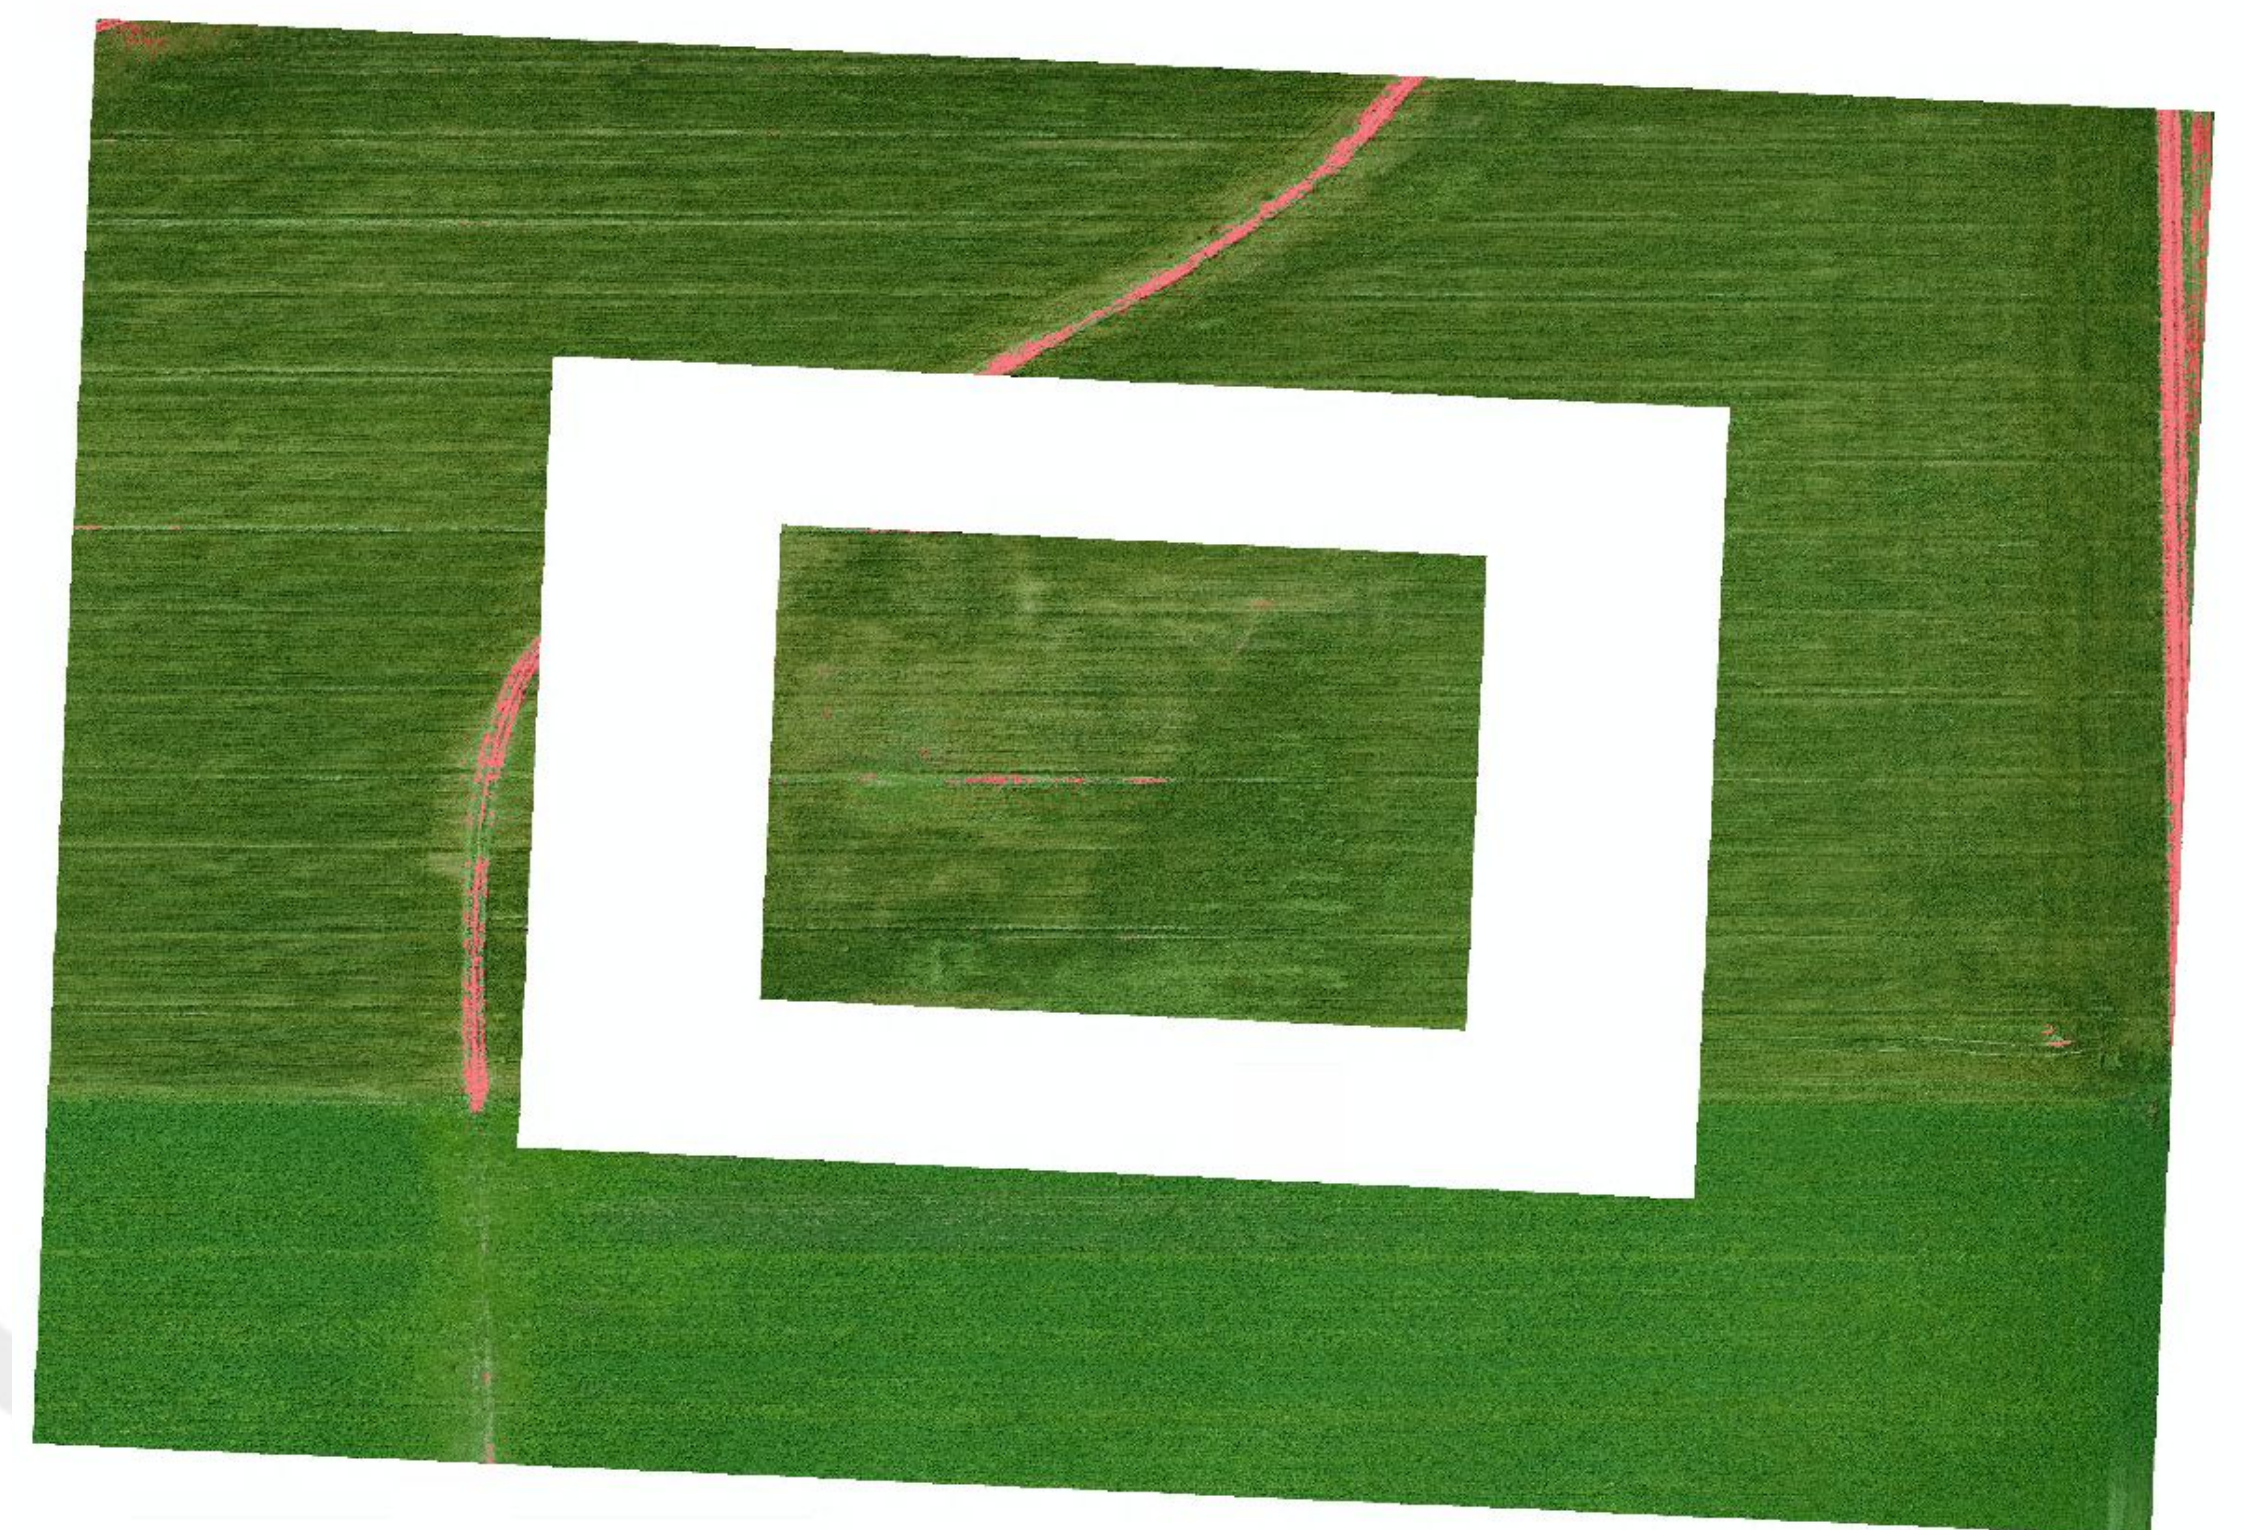
Model output with classified bare soil (red) and vegetation (green)

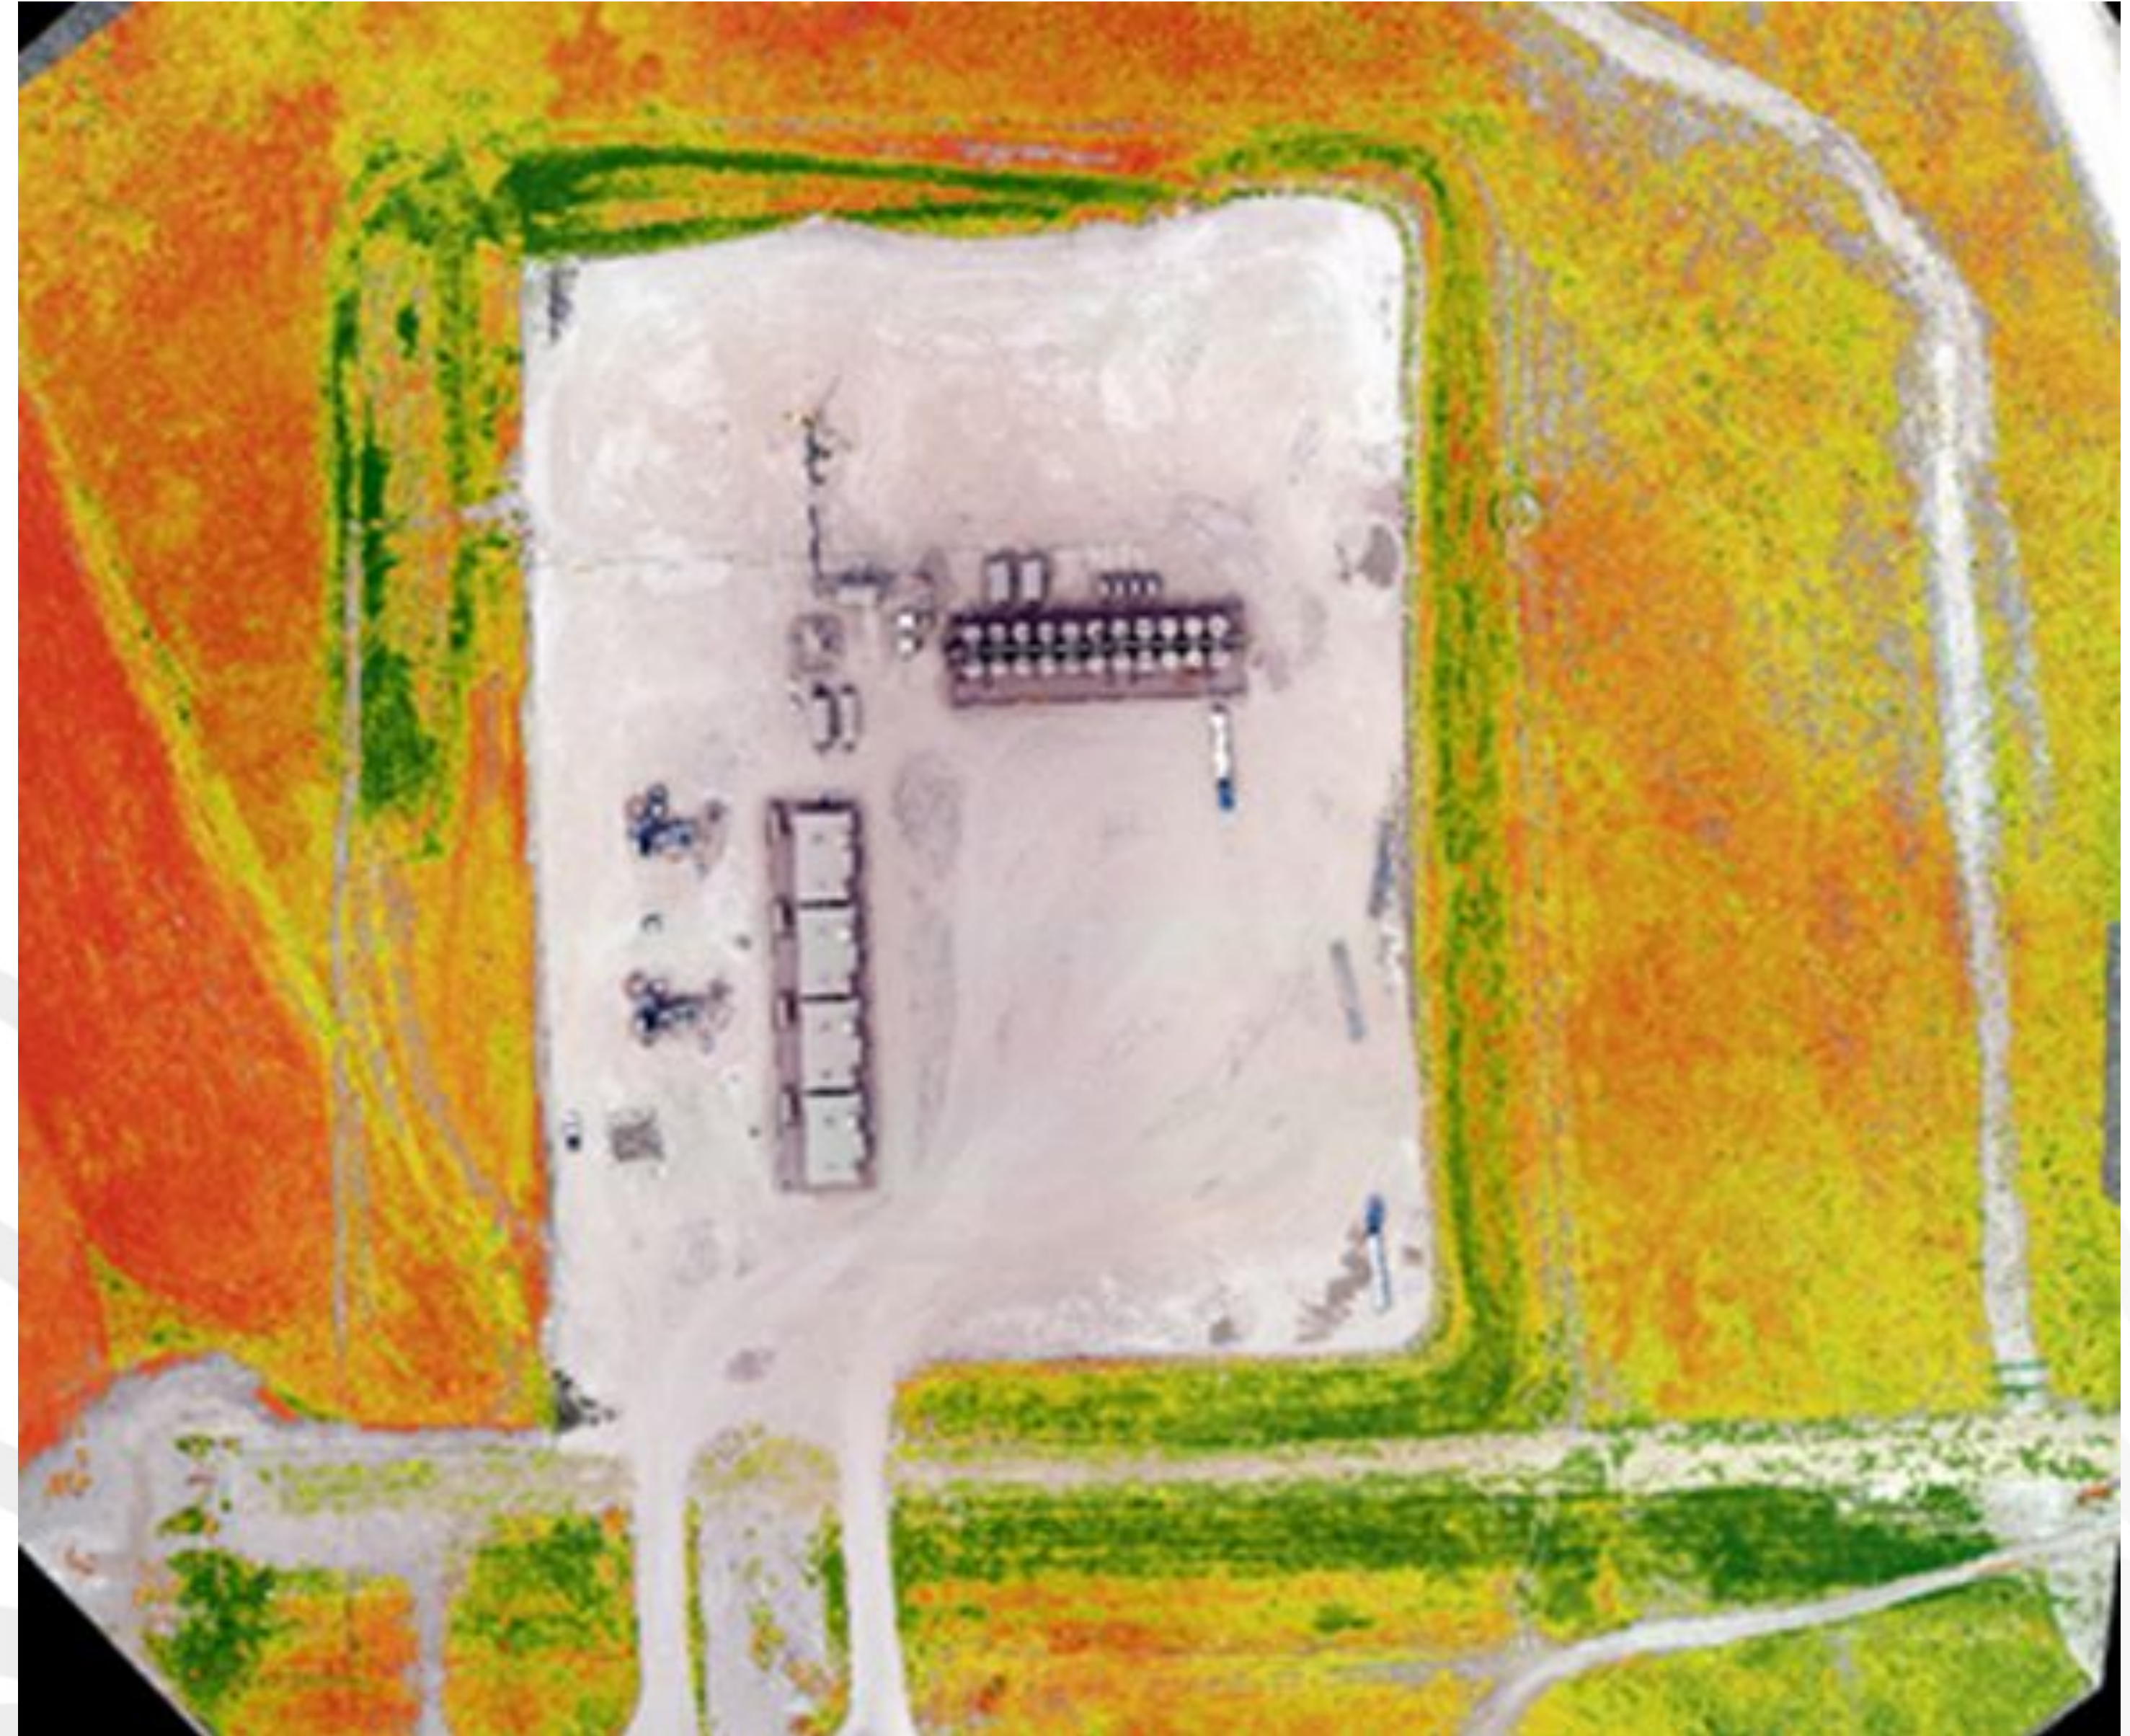
Vegetation vigor analysis on a well pad in interim reclamation.

Green indicates healthy vegetation with high levels of chlorophyll, and red indicates vegetation with low levels of chlorophyll.

- Average percent cover
- Standard deviation
- Continuity index

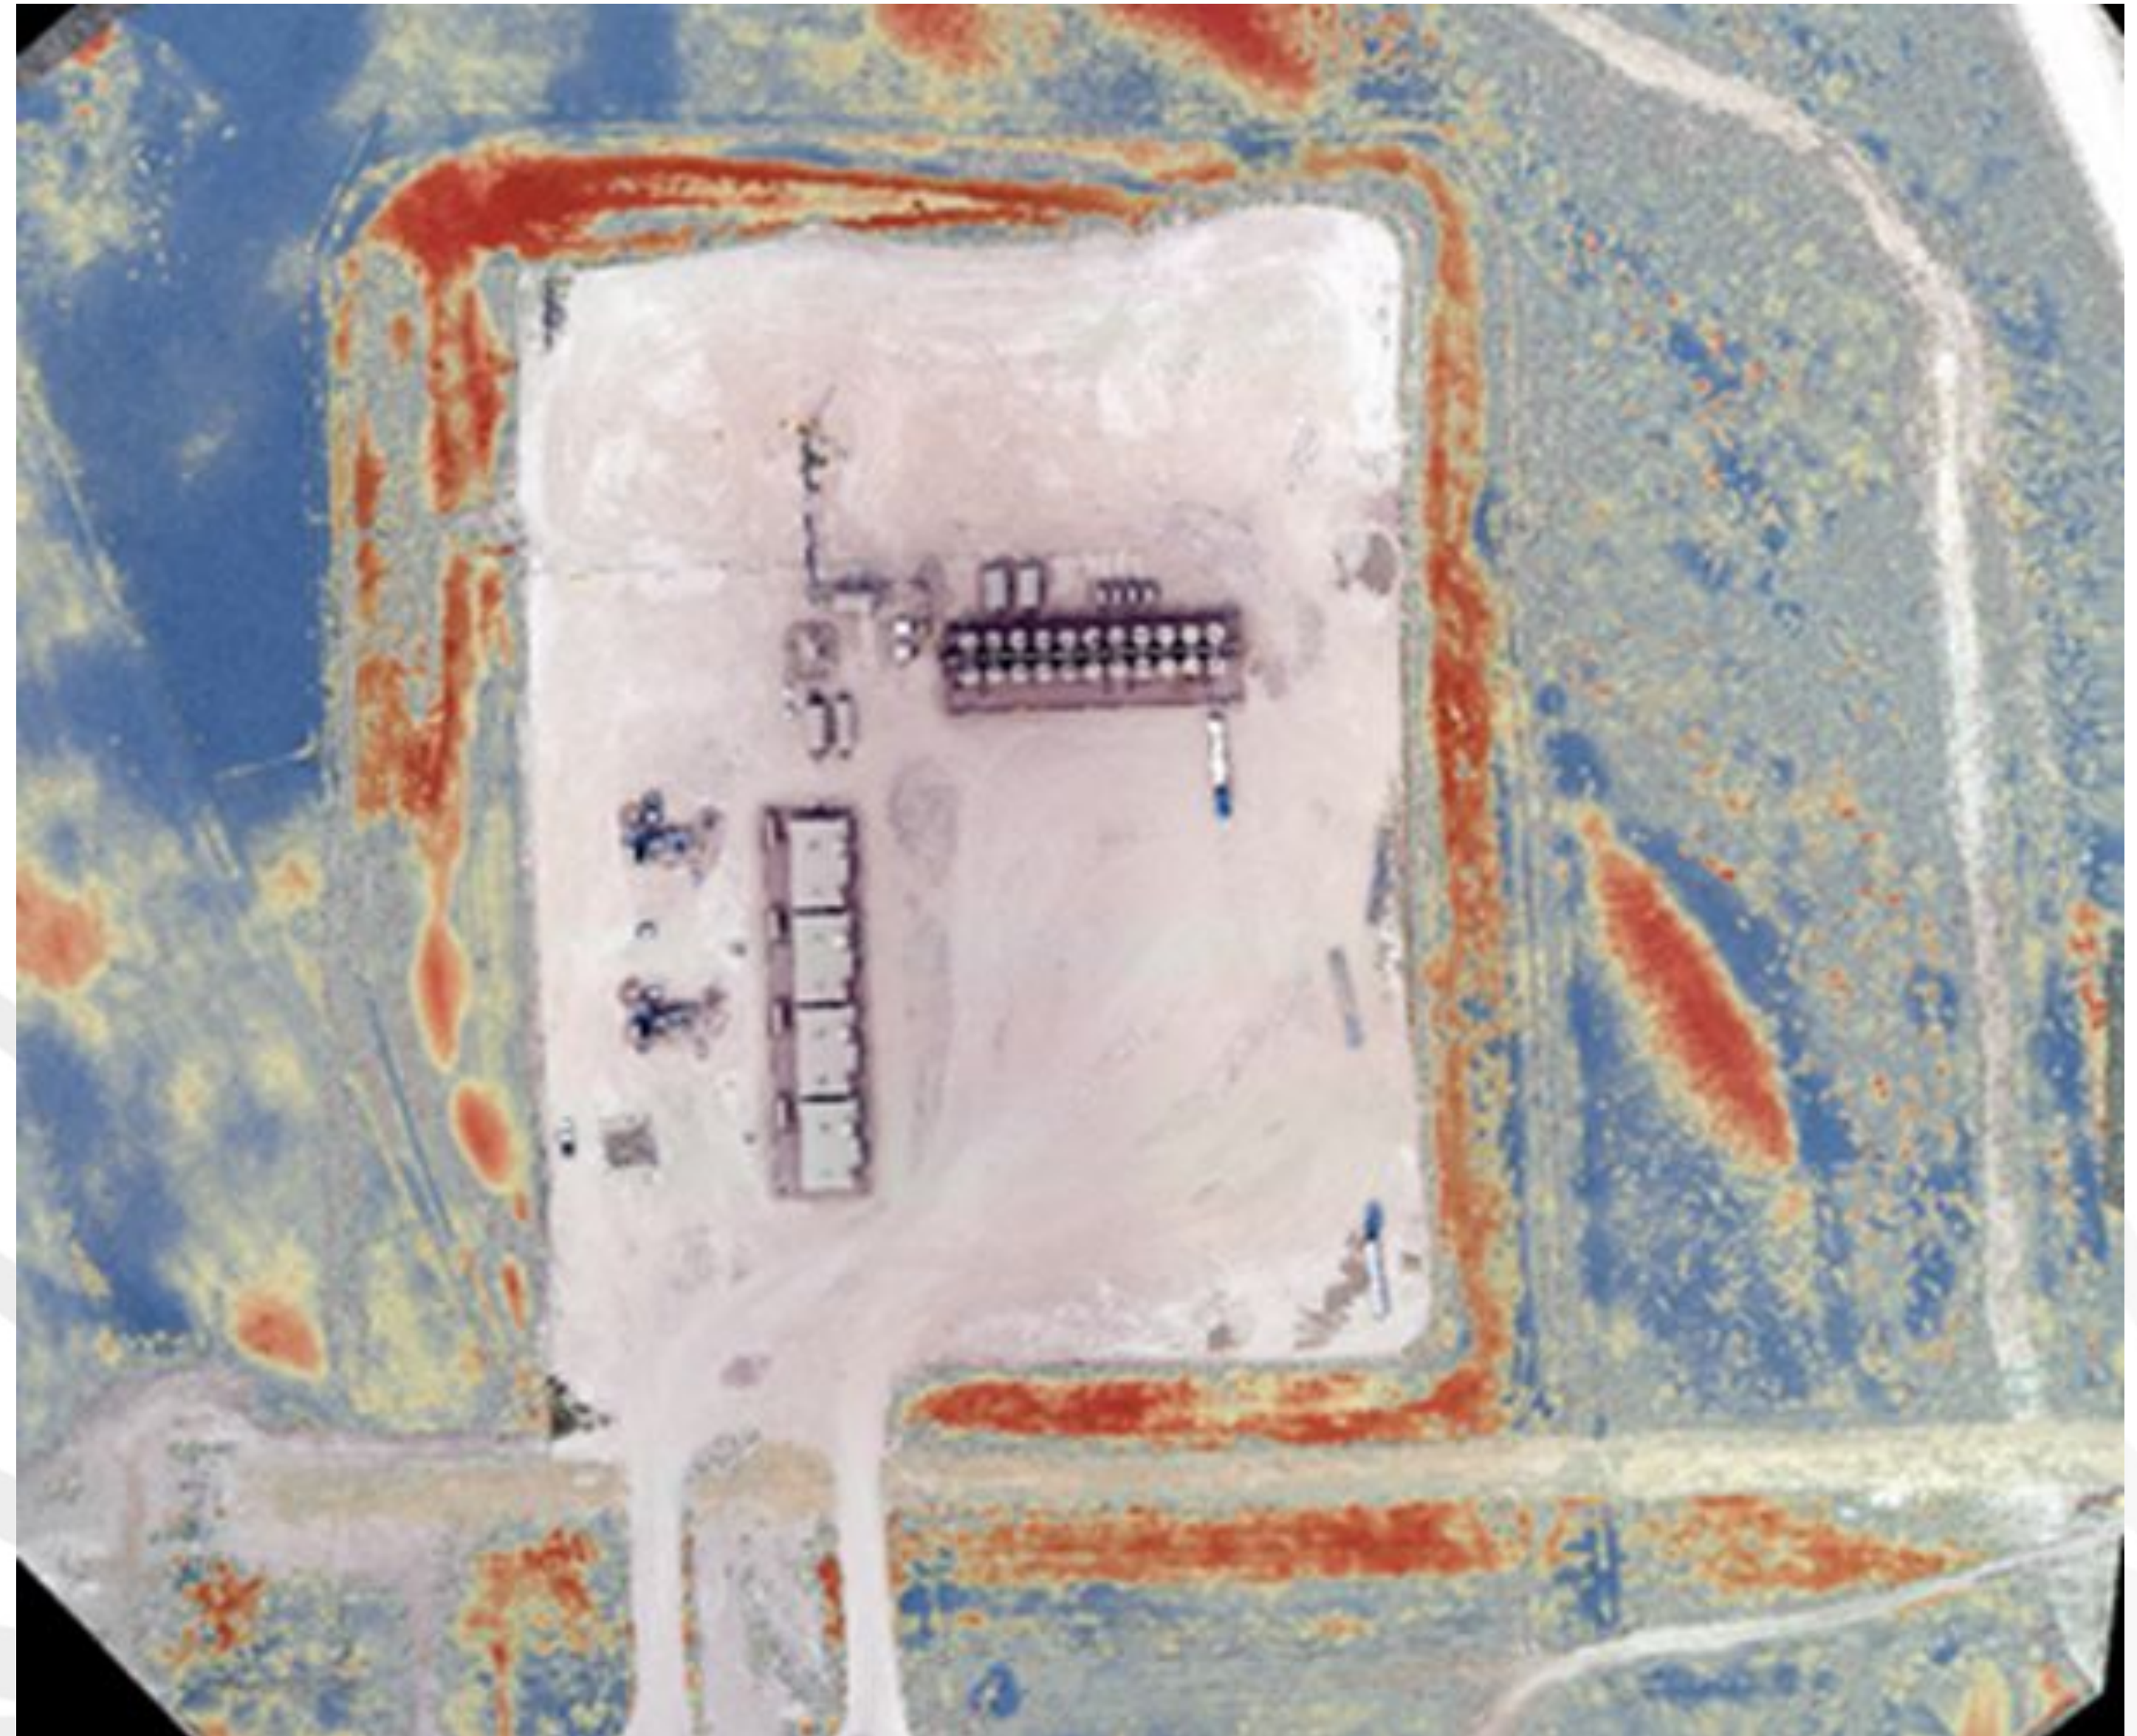
Vegetation structure analysis on a well pad in interim reclamation.

Red indicates taller woody vegetation, while blue indicates grass/forb vegetation.

- Average vegetation structure
- Standard deviation
- Continuity index
