G-051-099 Final Report: Remote Measurement of Reclamation Success

Development of Operational Aerial Analytics  
for Remotely Measuring Reclamation Success in North Dakota

**Final Report**

June 30, 2021

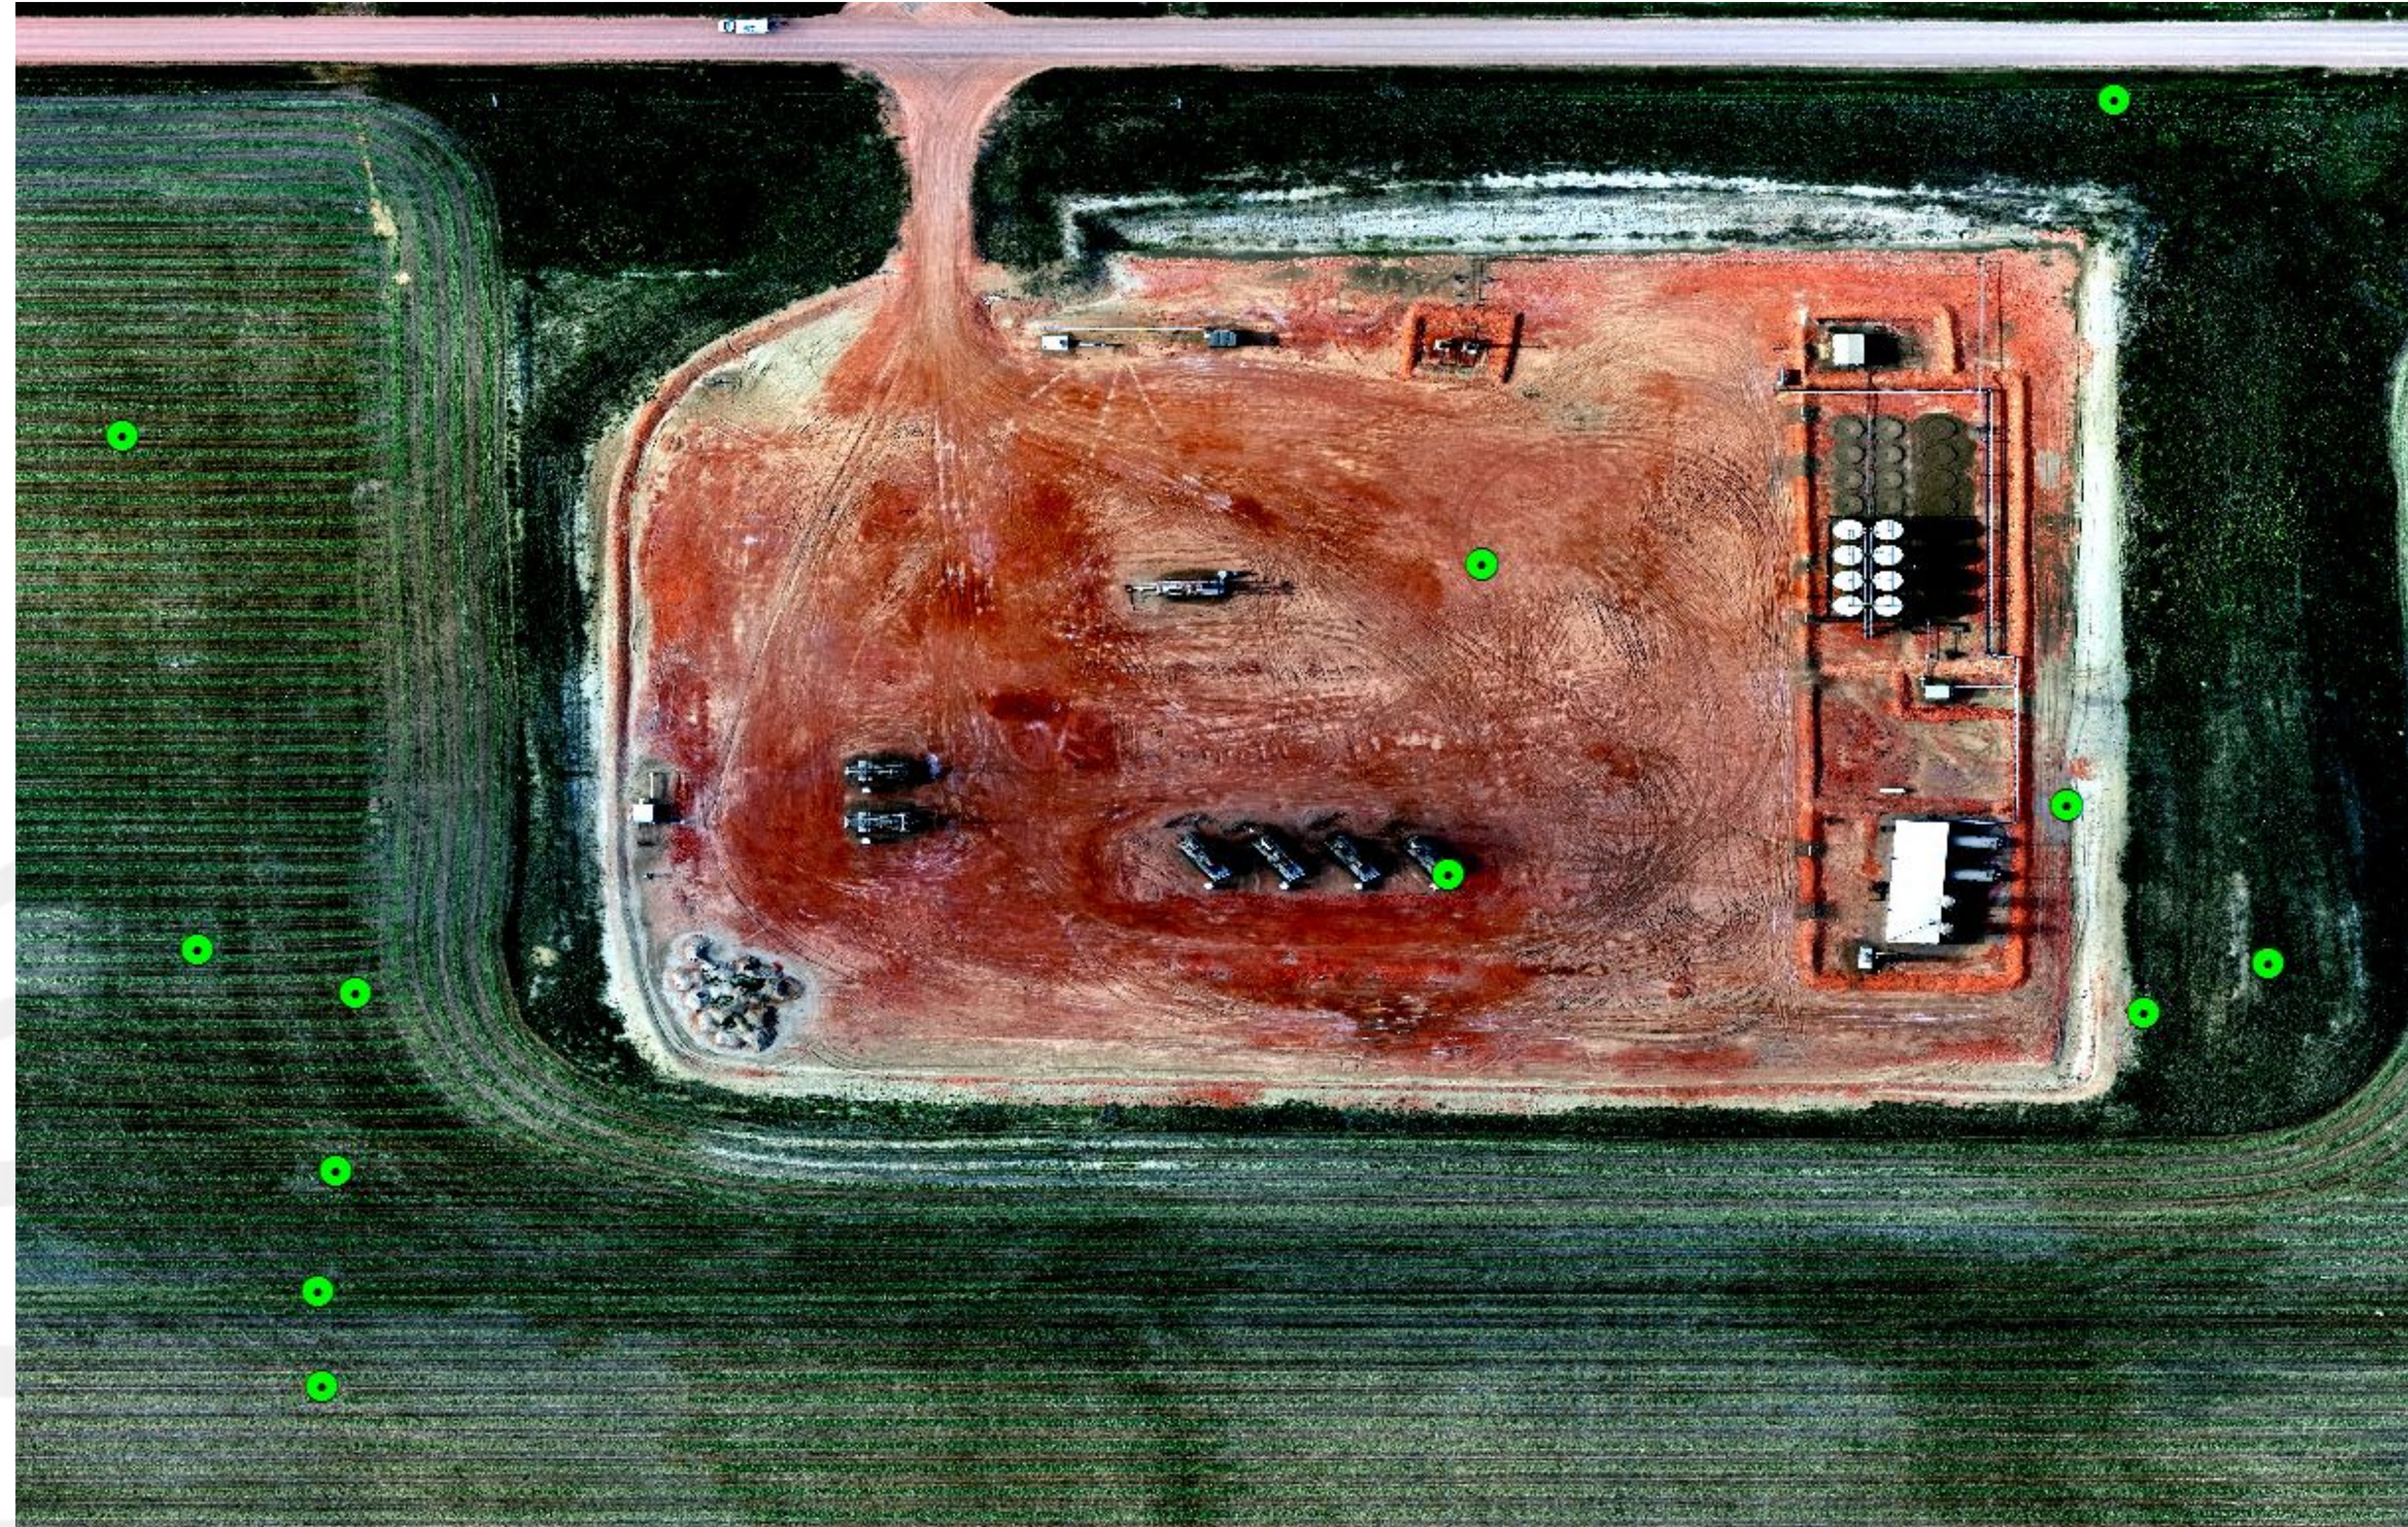
Model validation compared model outputs against 2,000 sample points and 20 1-meter plots distributed across all 100 Whiting well pad sites.

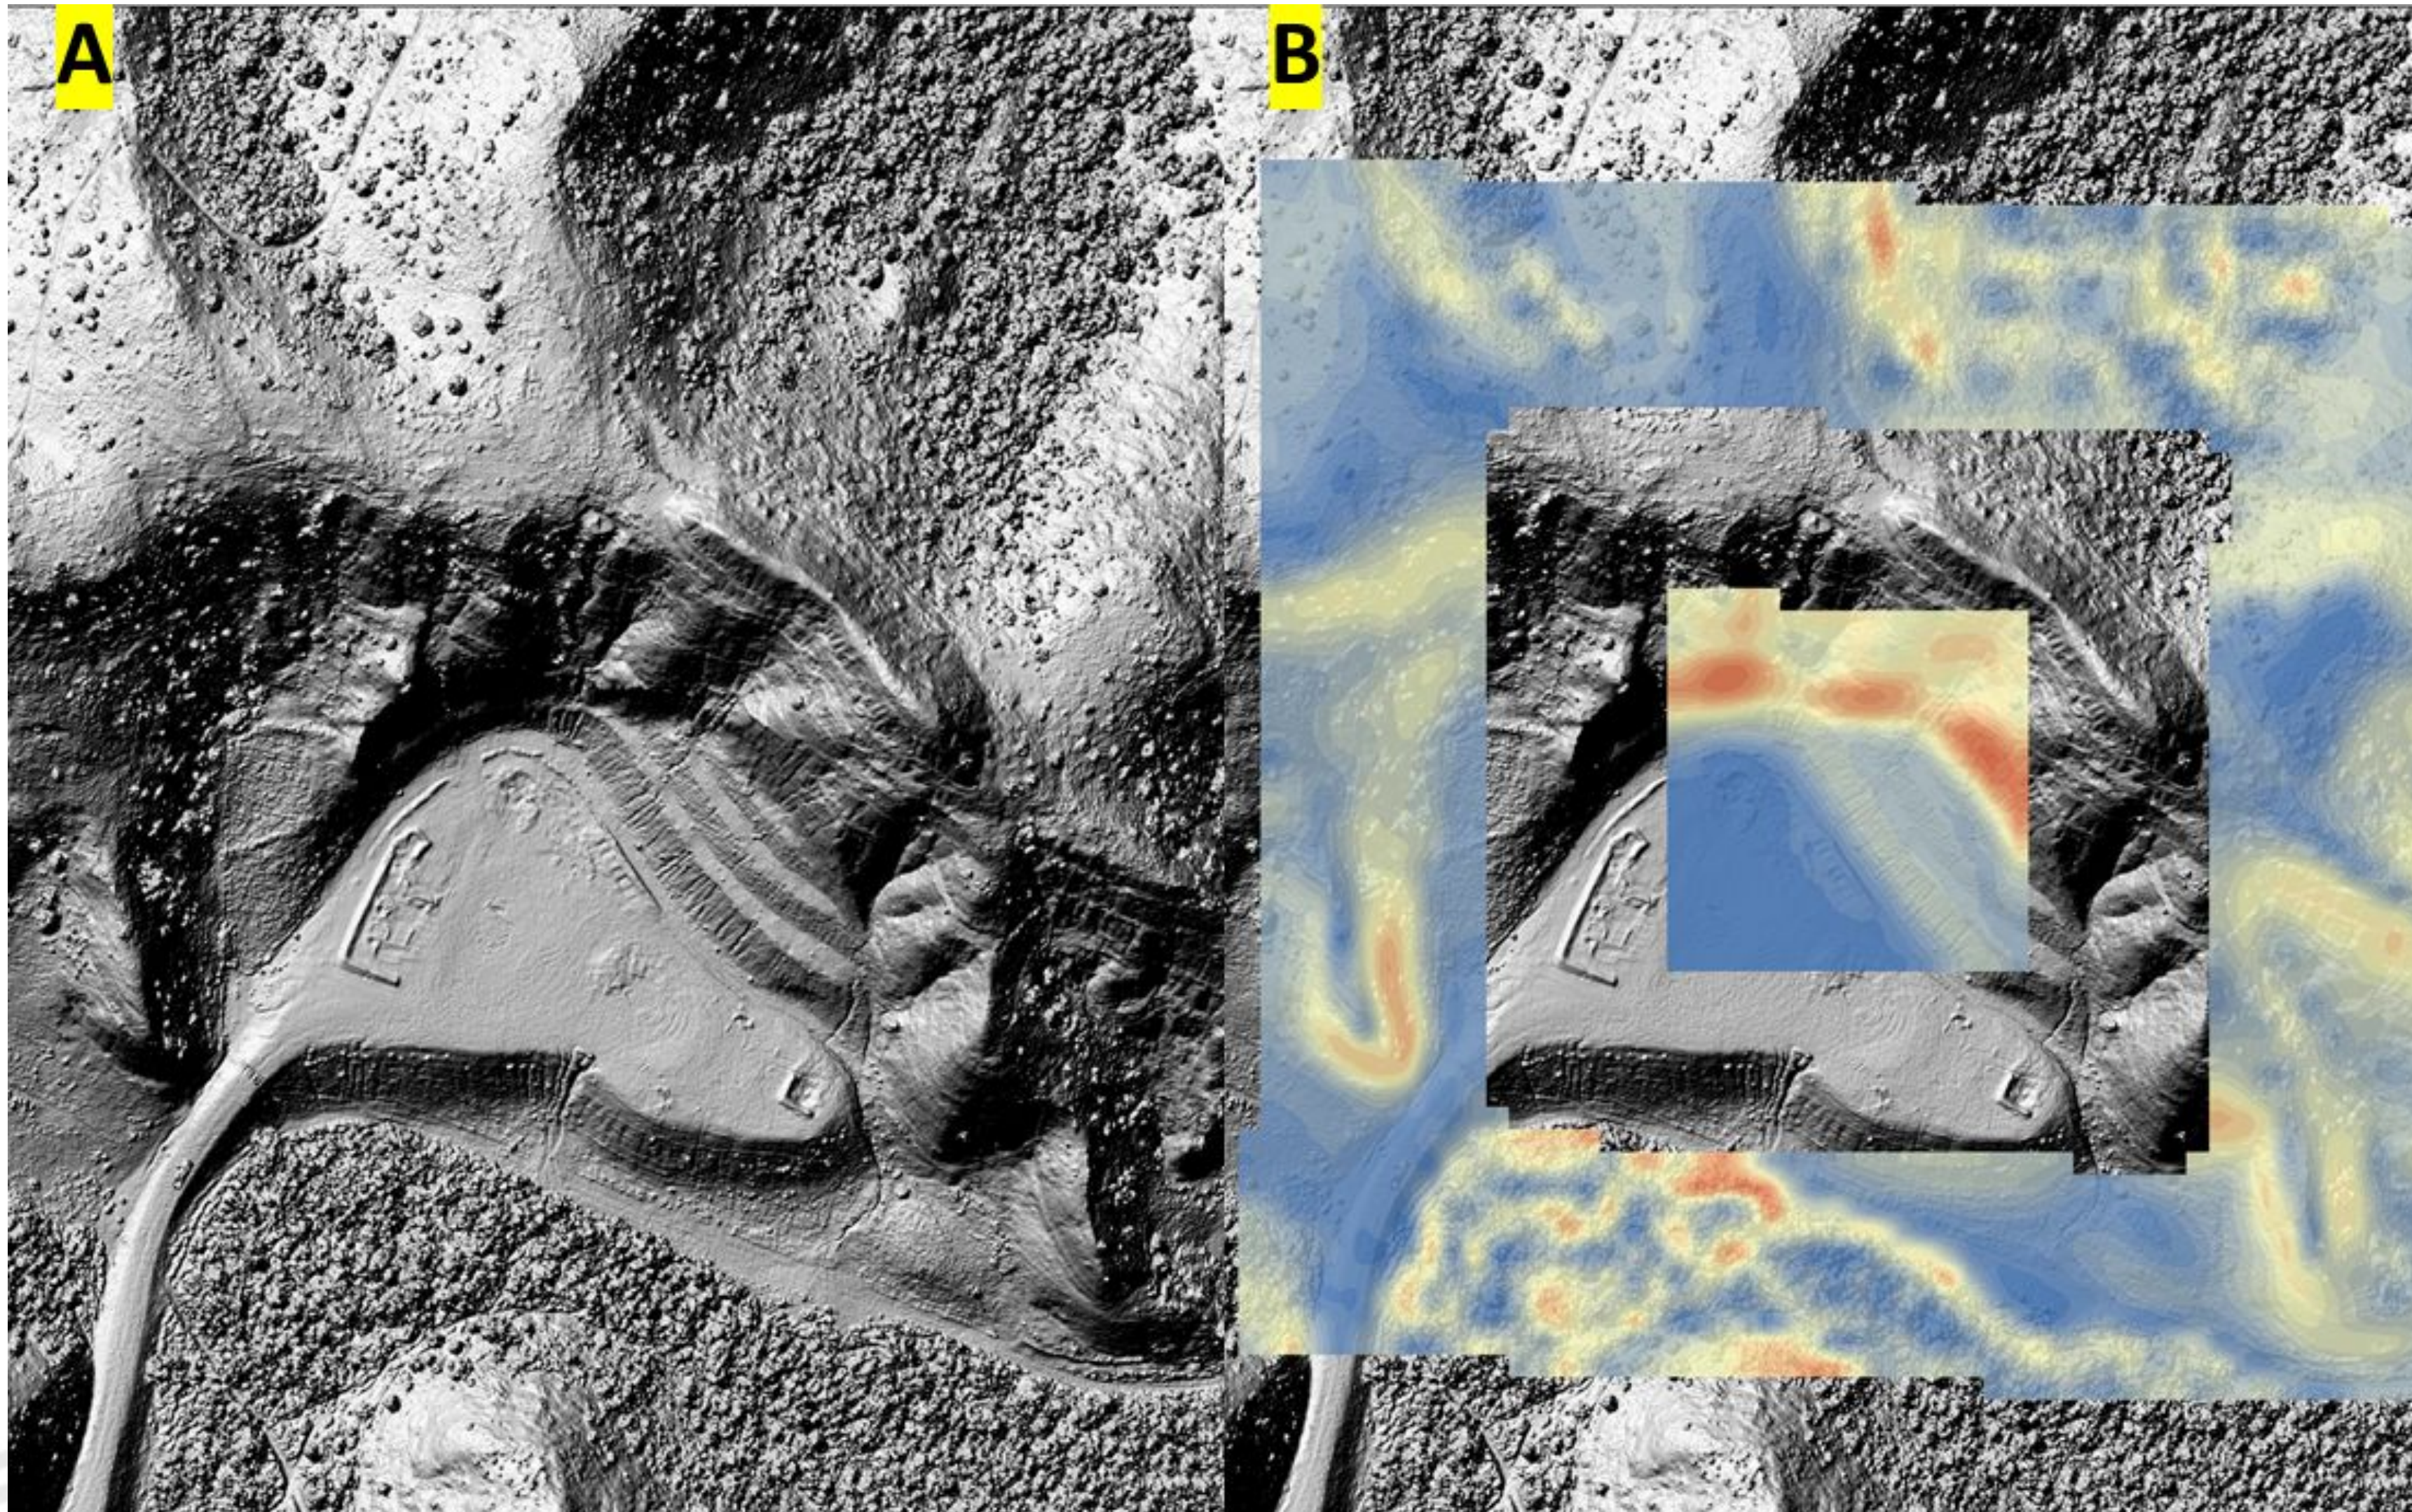
Digital surface model of well pad and reference area (A, left).

Contouring assessment where blue indicates shallow slopes and red indicates steeper slopes (B, right).

- Average slope
- Standard deviation
- Continuity index

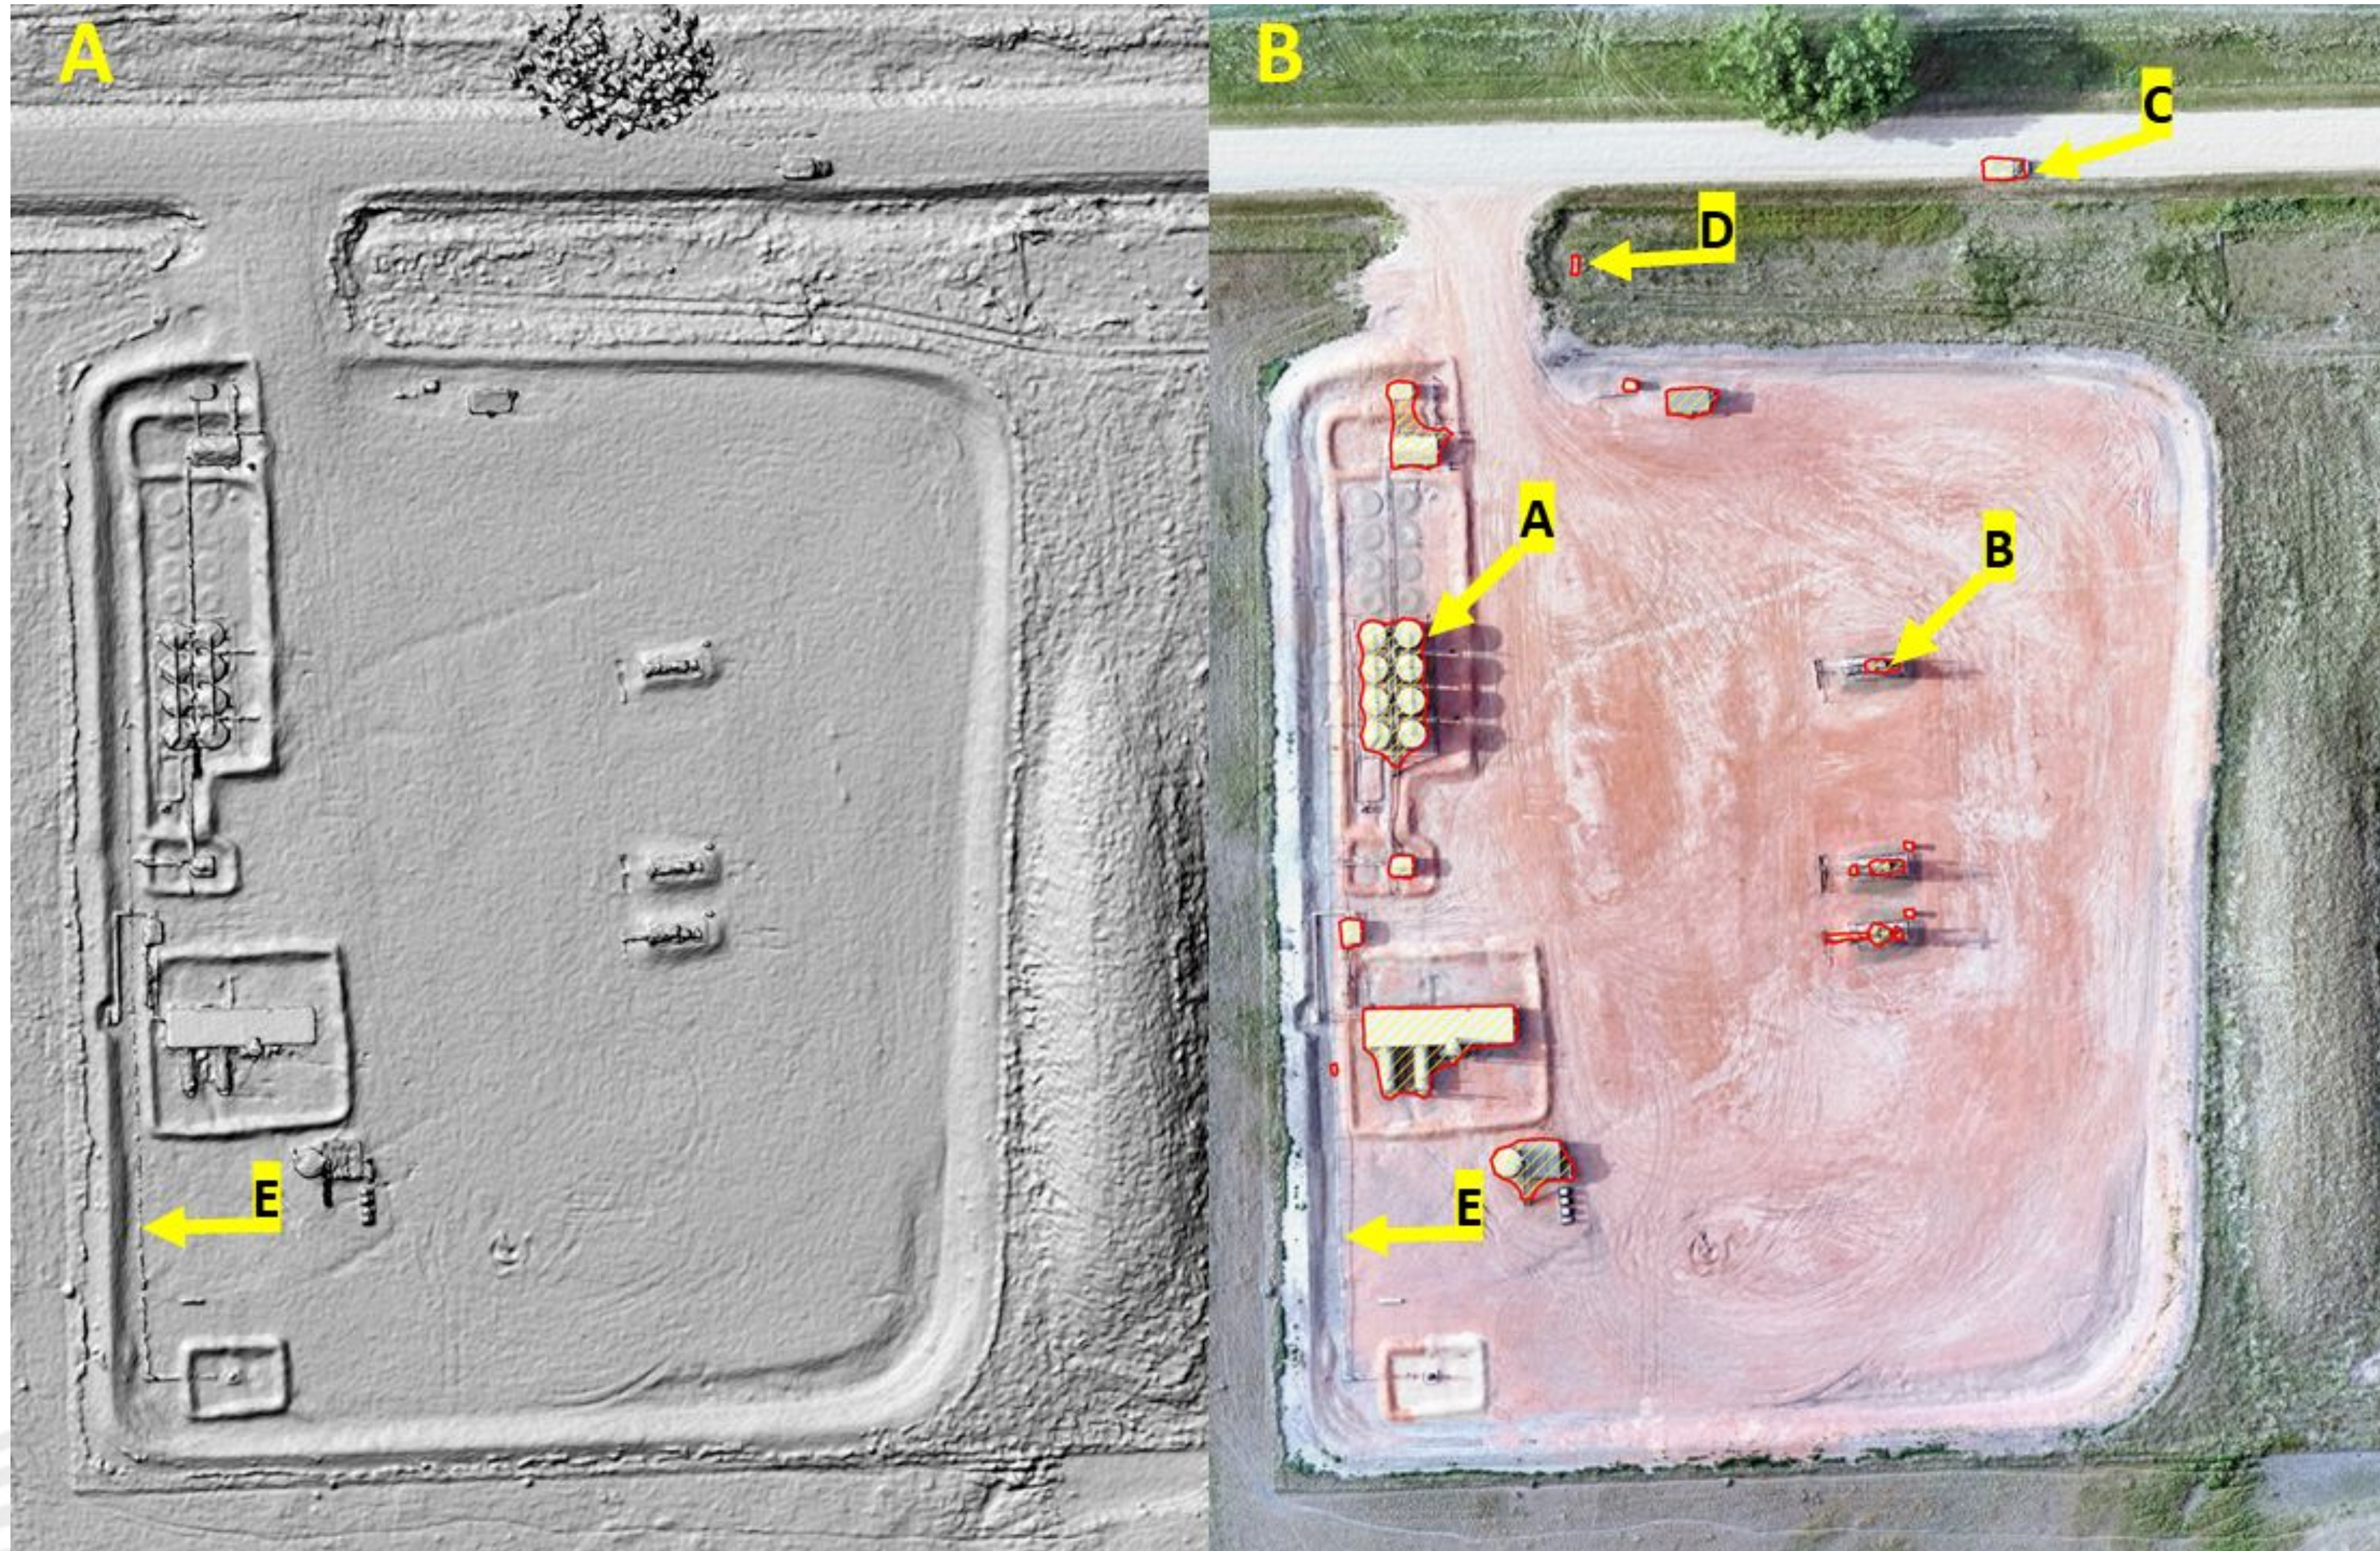
Infrastructure identification on an operating well pad's digital surface model (A, left) and orthomosaic (B, right).

- A. Stock tank
- B. Well head
- C. Truck
- D. Misclassification
- E. Pipe

- Number of structures

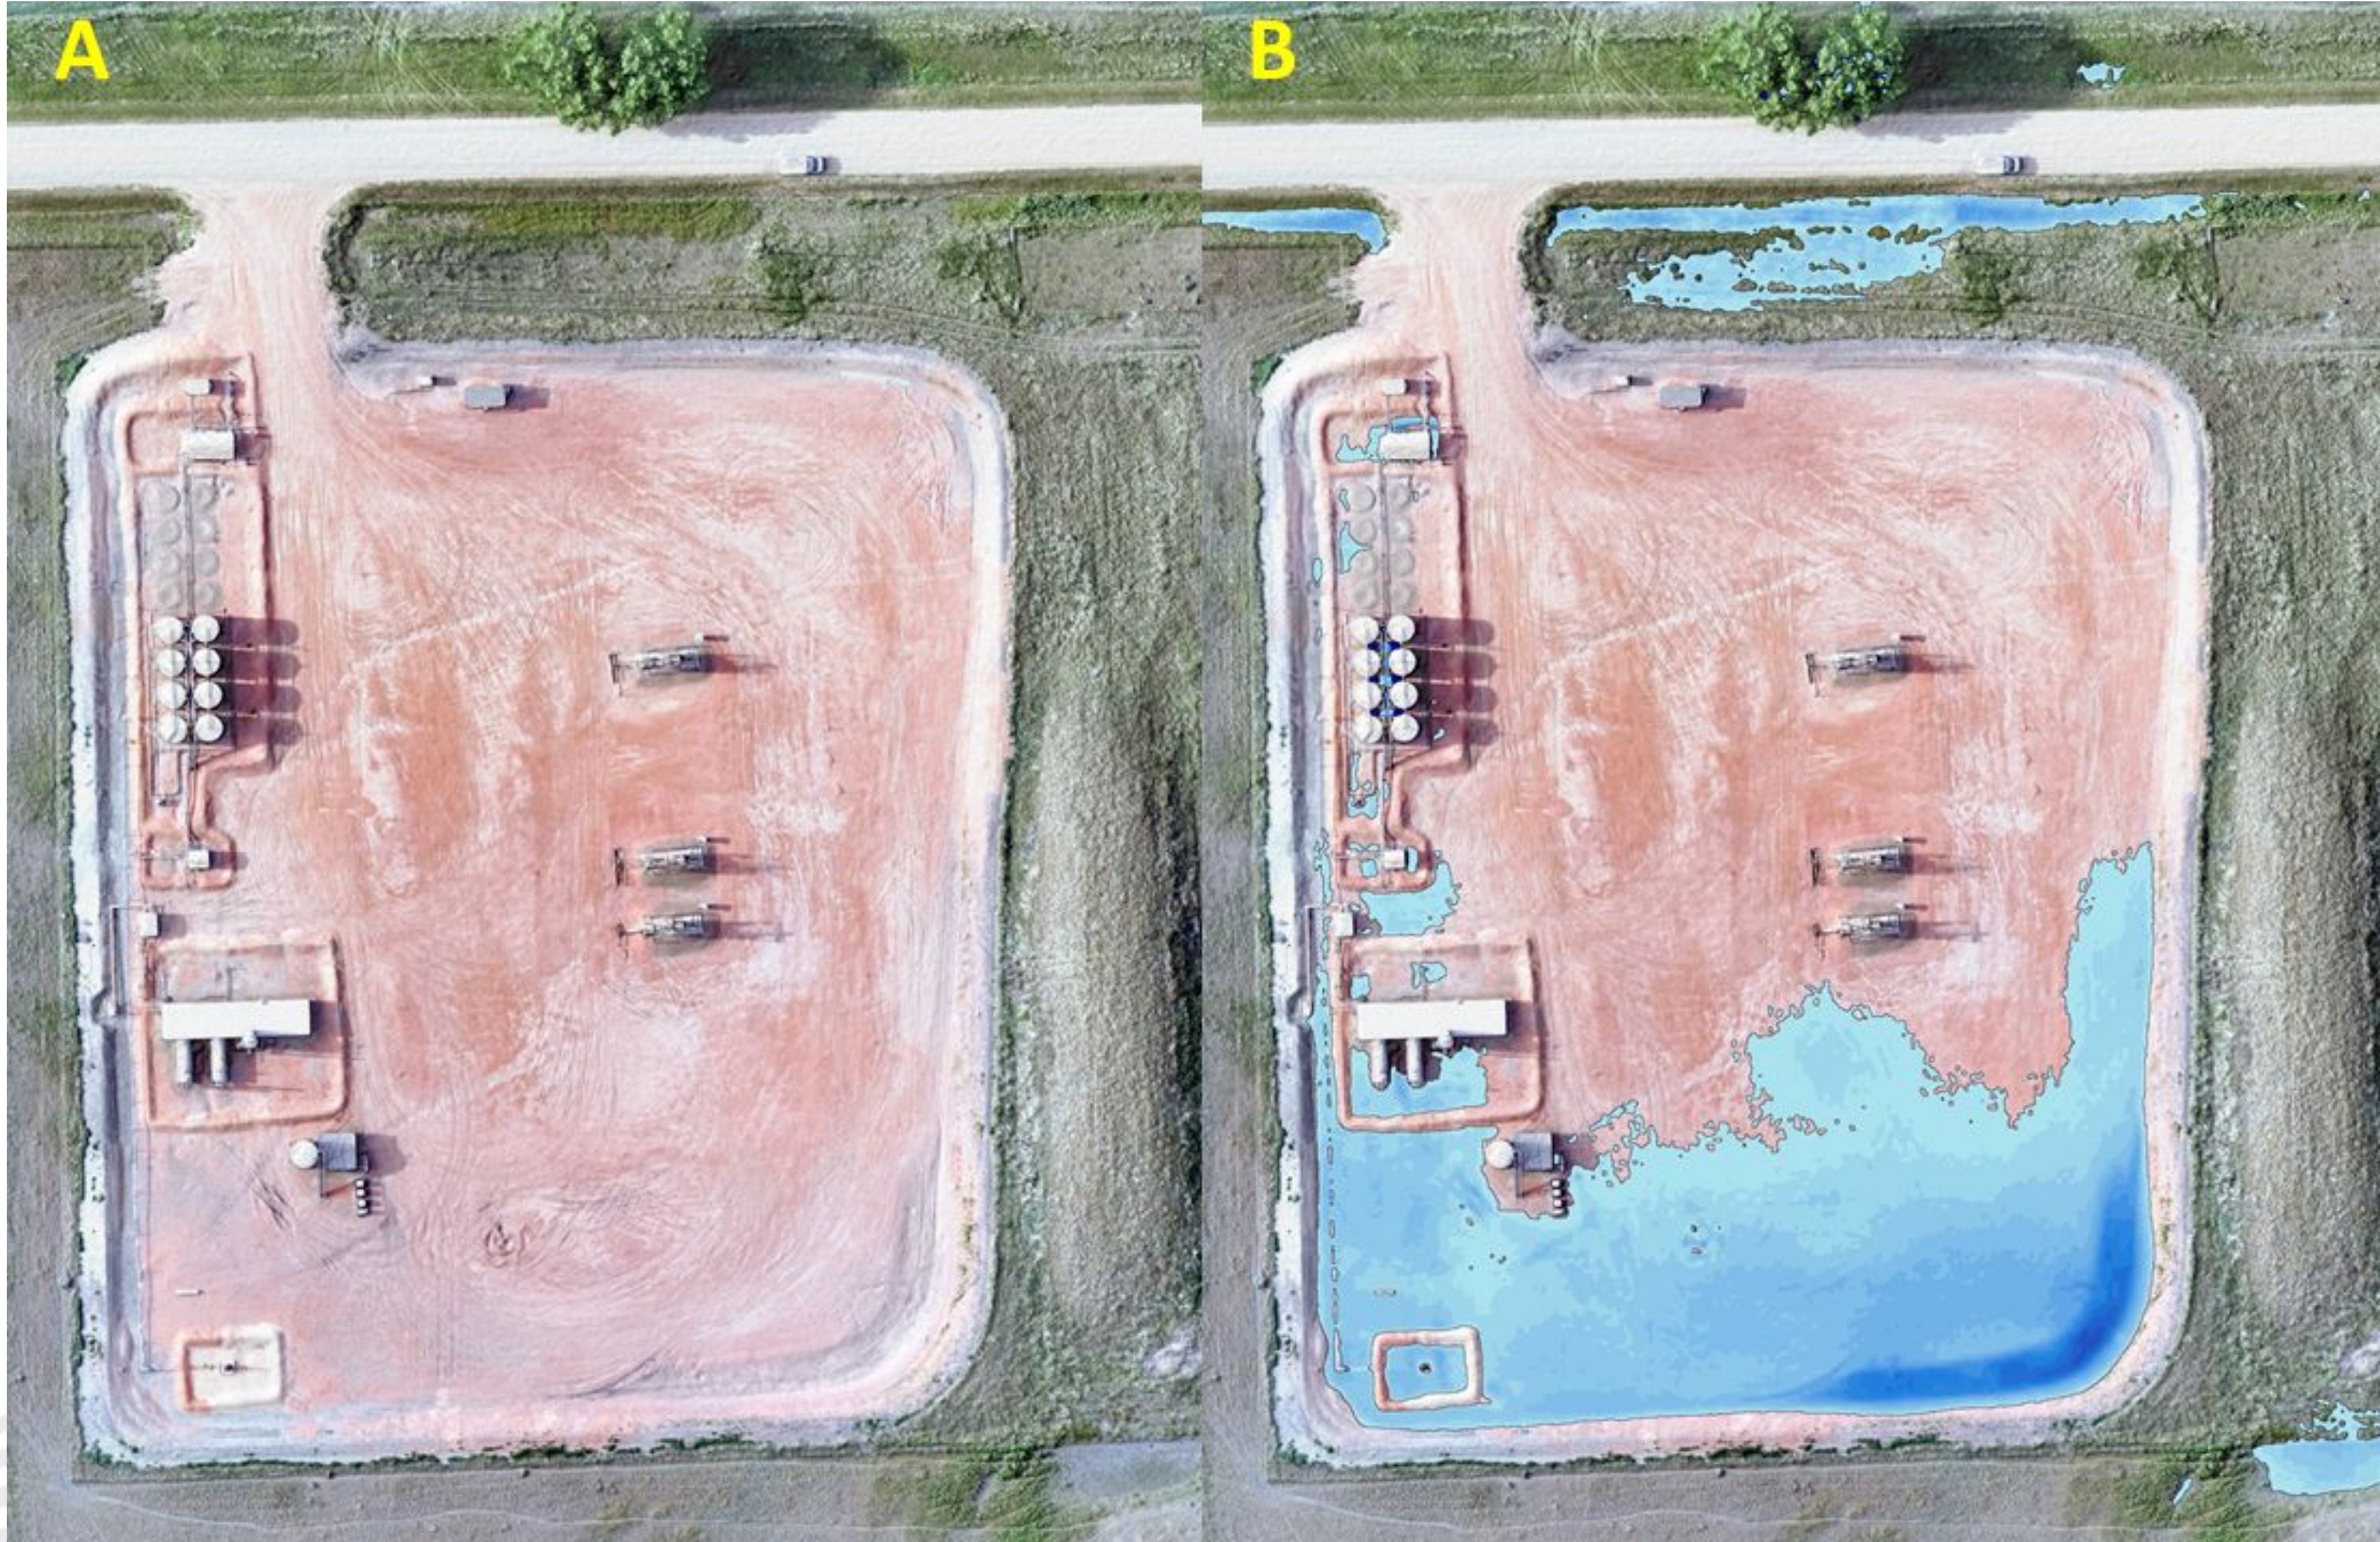
Orthomosaic (A, left) and surface hydrology assessment (B, right) of an active well pad.

The surface hydrology assessment models ponding and stormwater hazards, with darker blue indicating deeper inundation.

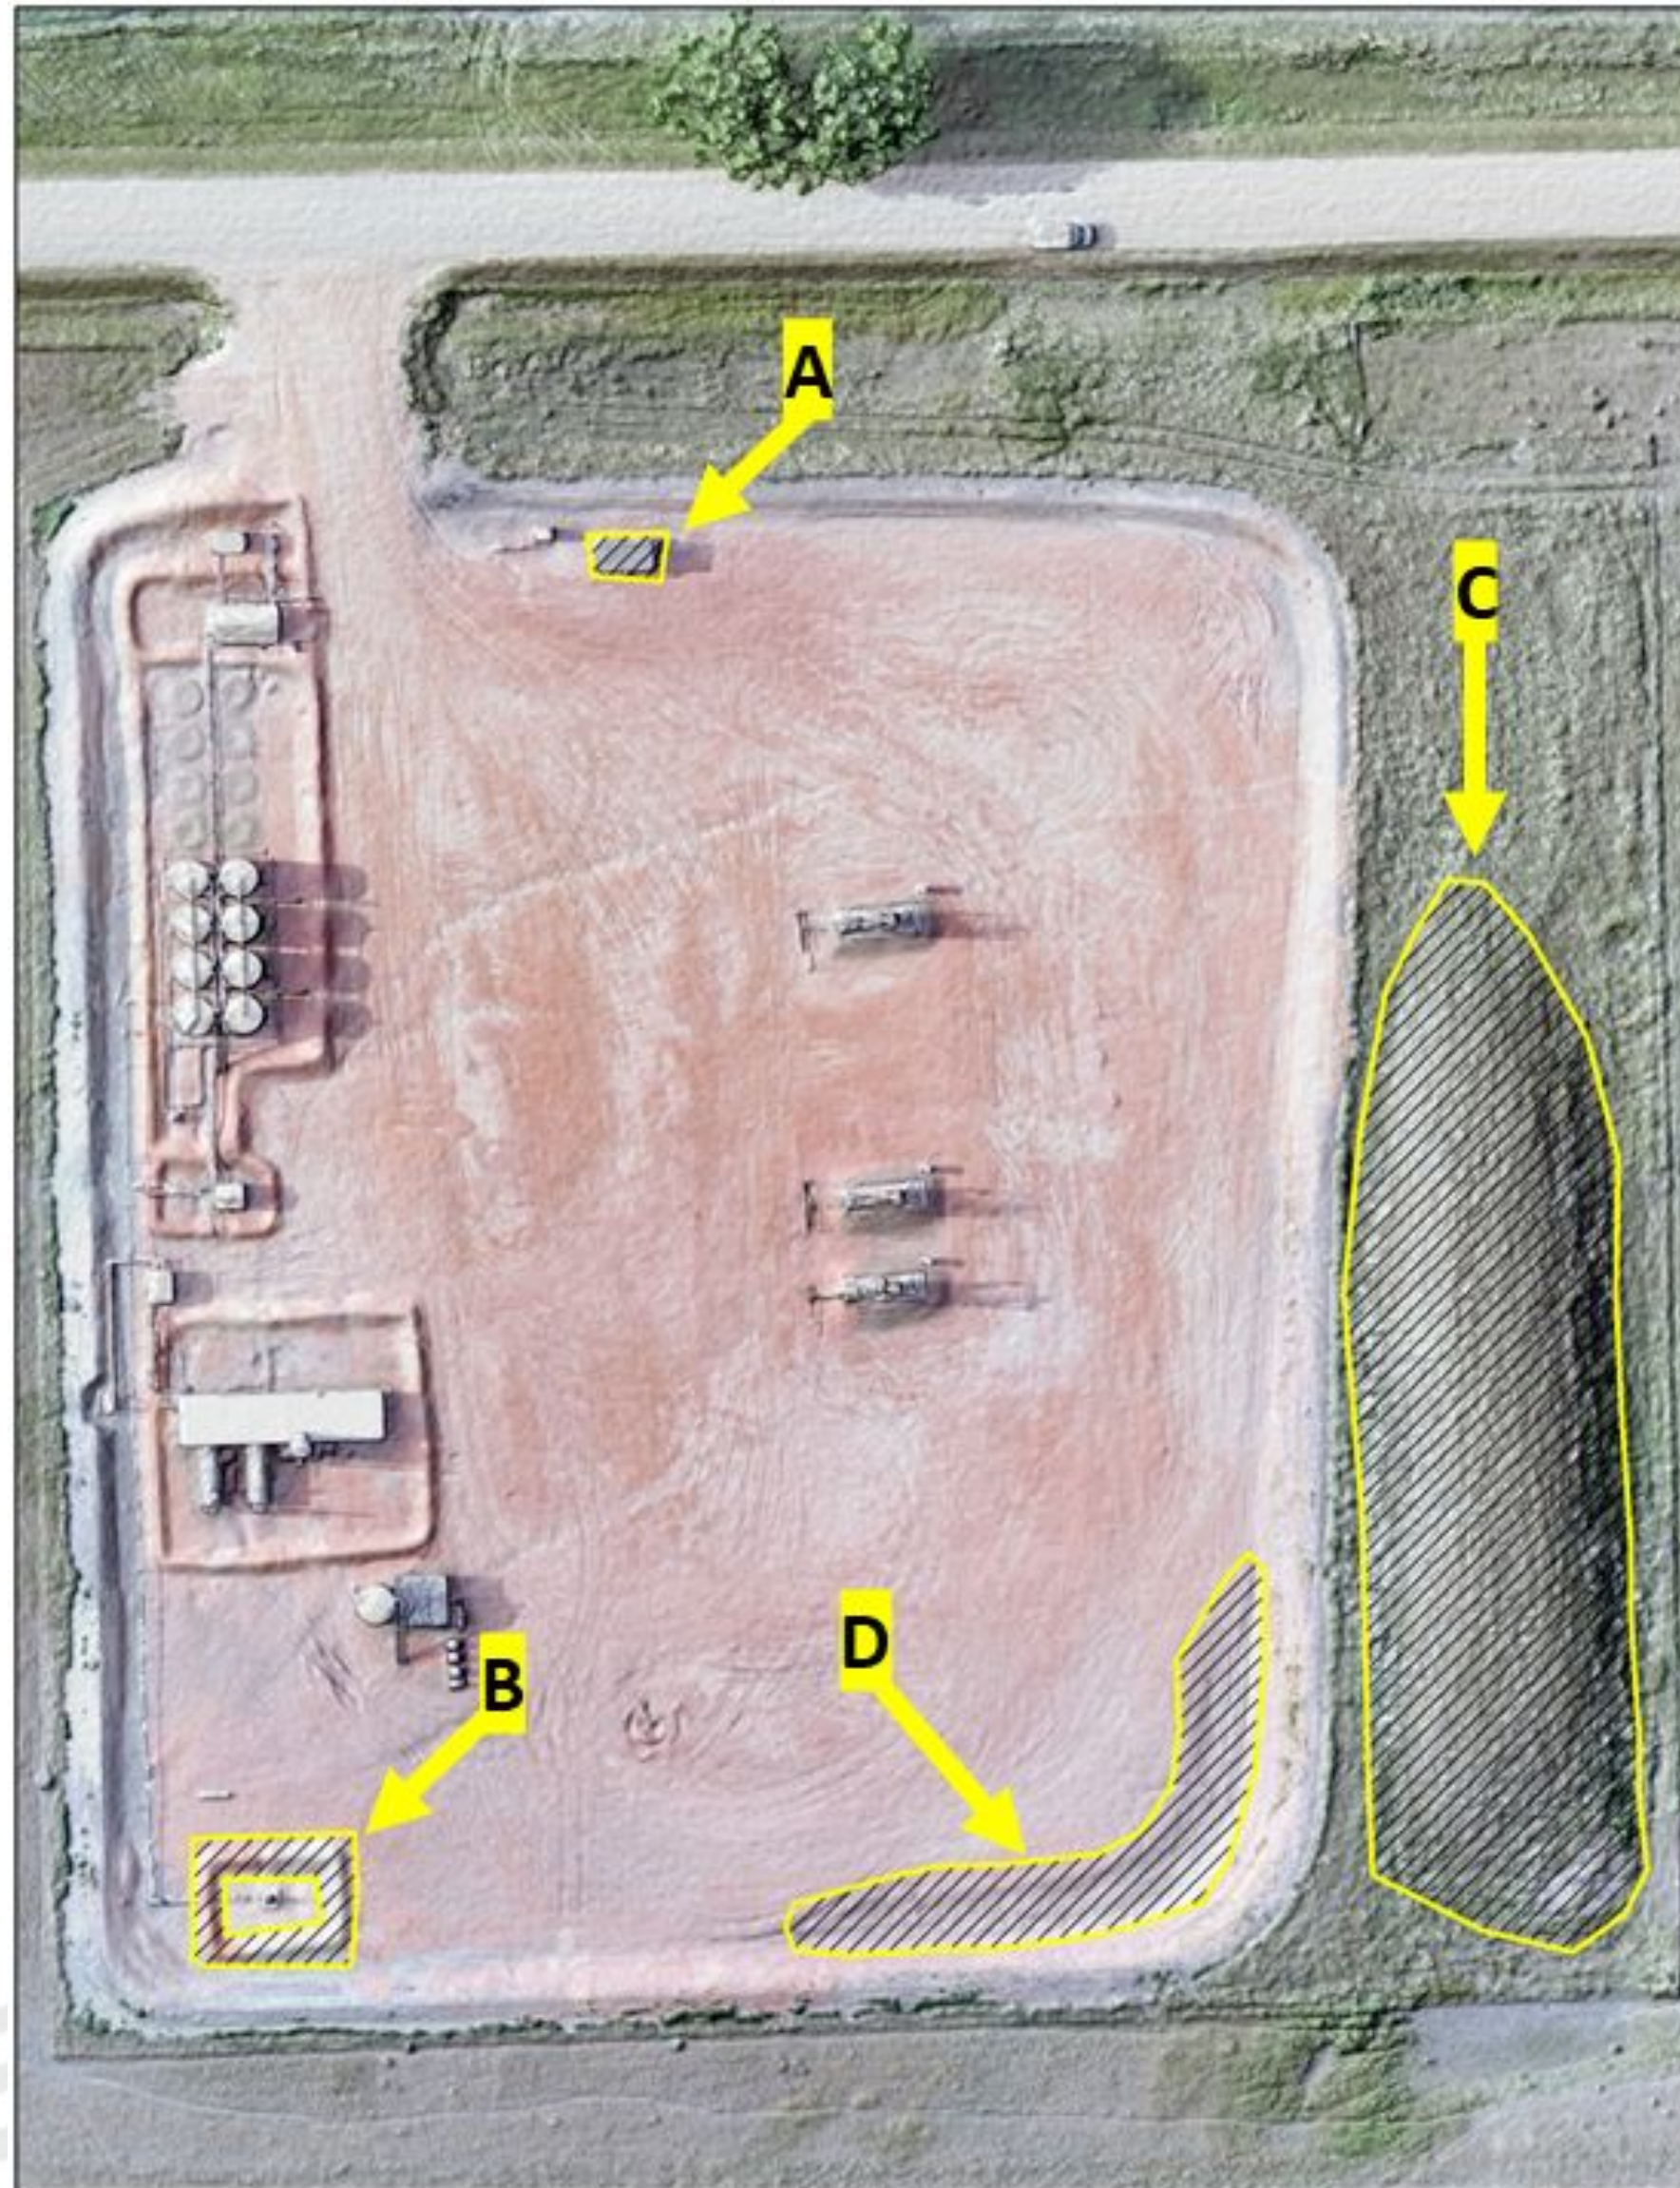
The volumetrics tool enables the user to delineate the features of interest and calculates the volume in cubic yards for all of the delineated features.

- A. Small building at 89.4 cubic yards
- B. Bermed area at 56.3 cubic yards
- C. Topsoil stockpile at 5,116 cubic yards
- D. Concave area that accumulates water at -175 cubic yards

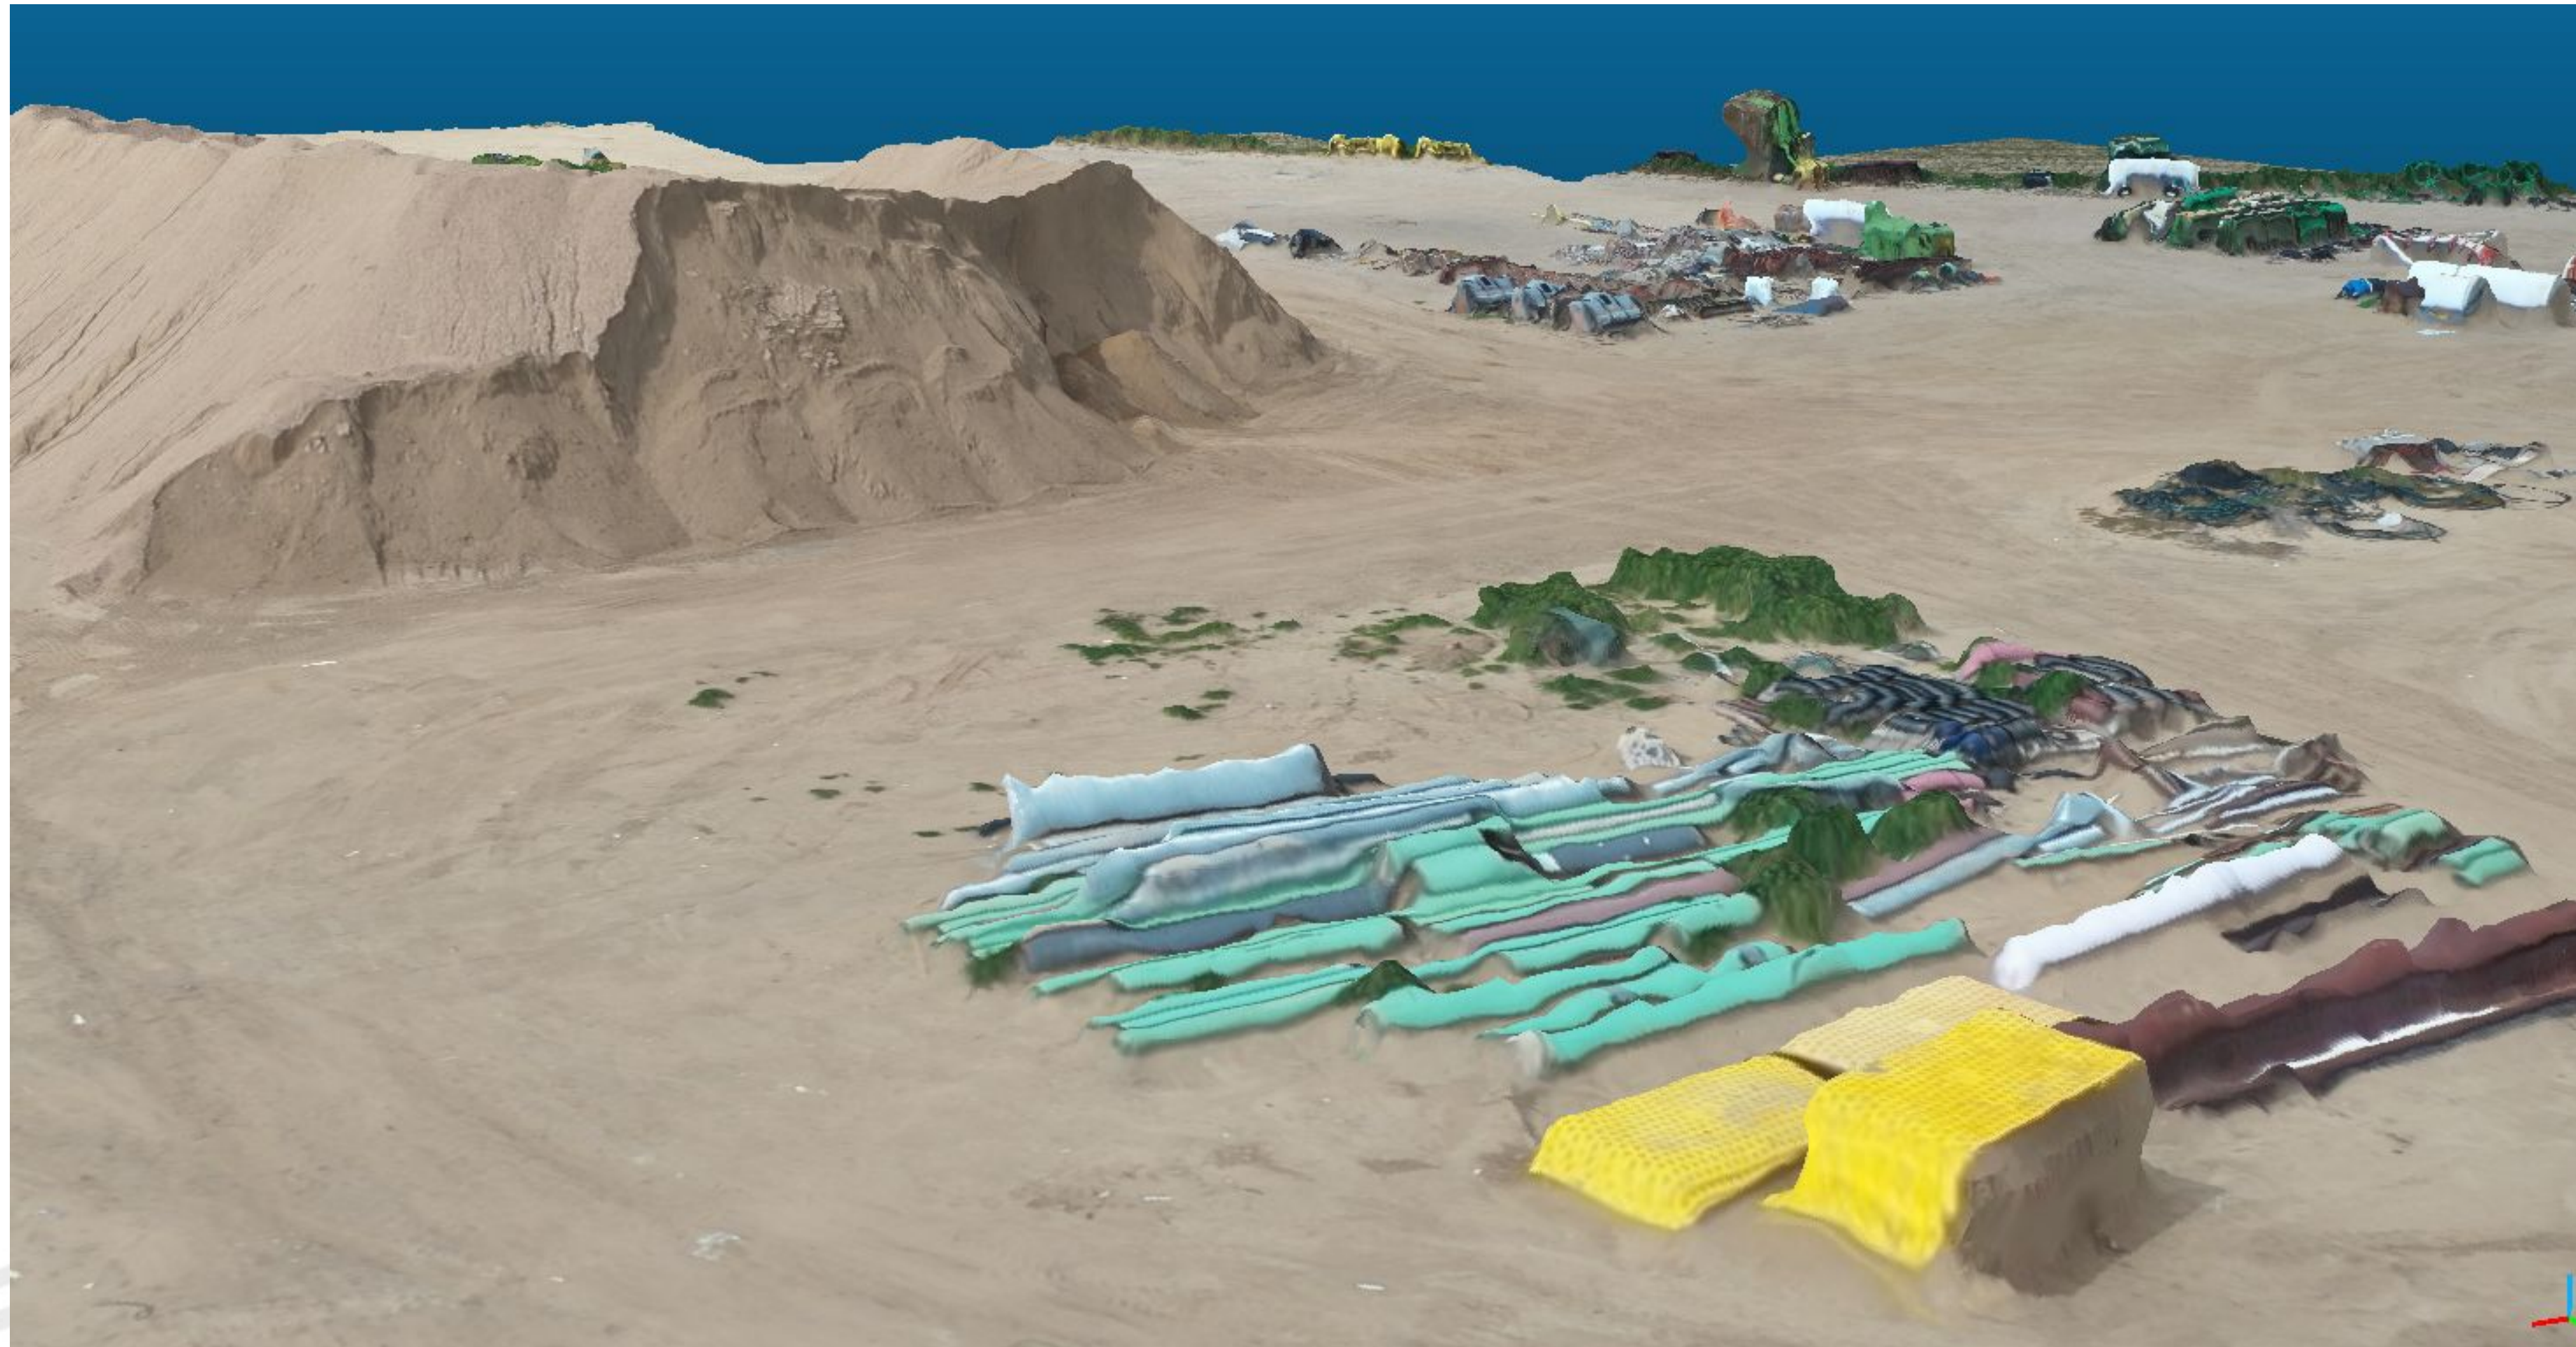
3D perspective of an orthomosaic of a stockyard
