G-051-099 Final Report: Remote Measurement of Reclamation Success

Development of Operational Aerial Analytics  
for Remotely Measuring Reclamation Success in North Dakota

**Final Report**

June 30, 2021

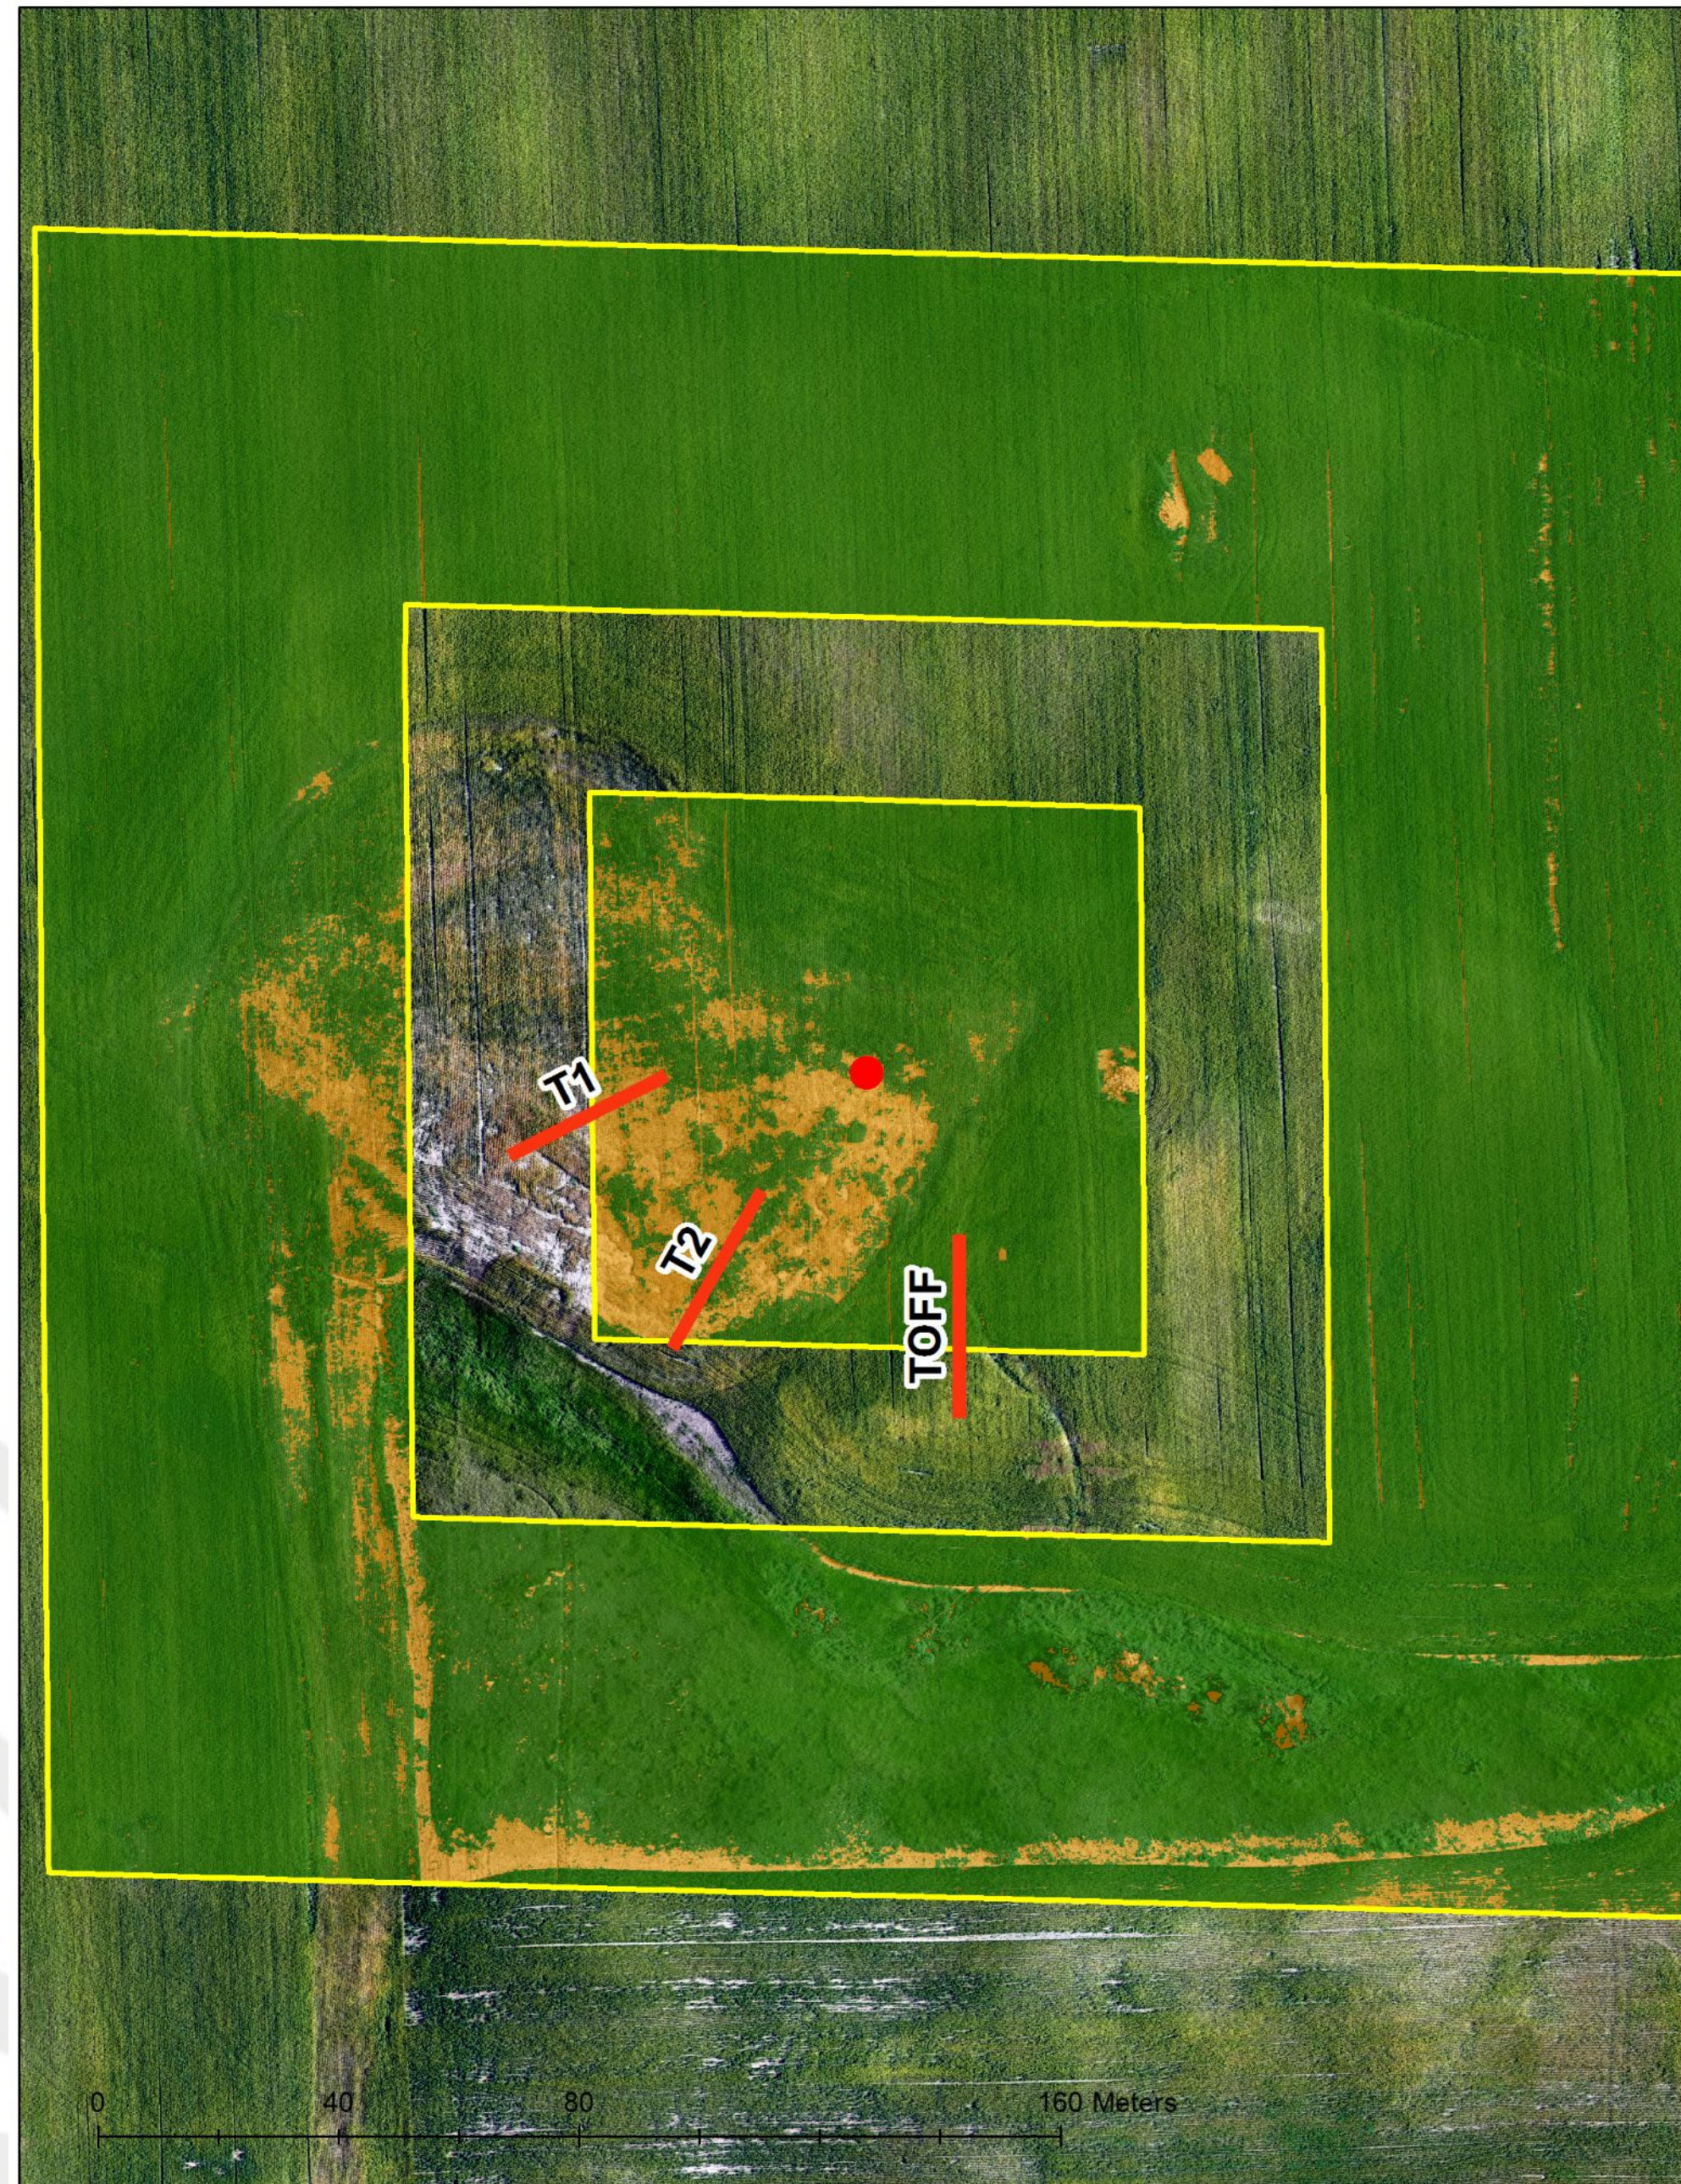
Vegetation analytic output, with green indicating vegetation cover greater than 15% and brown indicating bare ground.

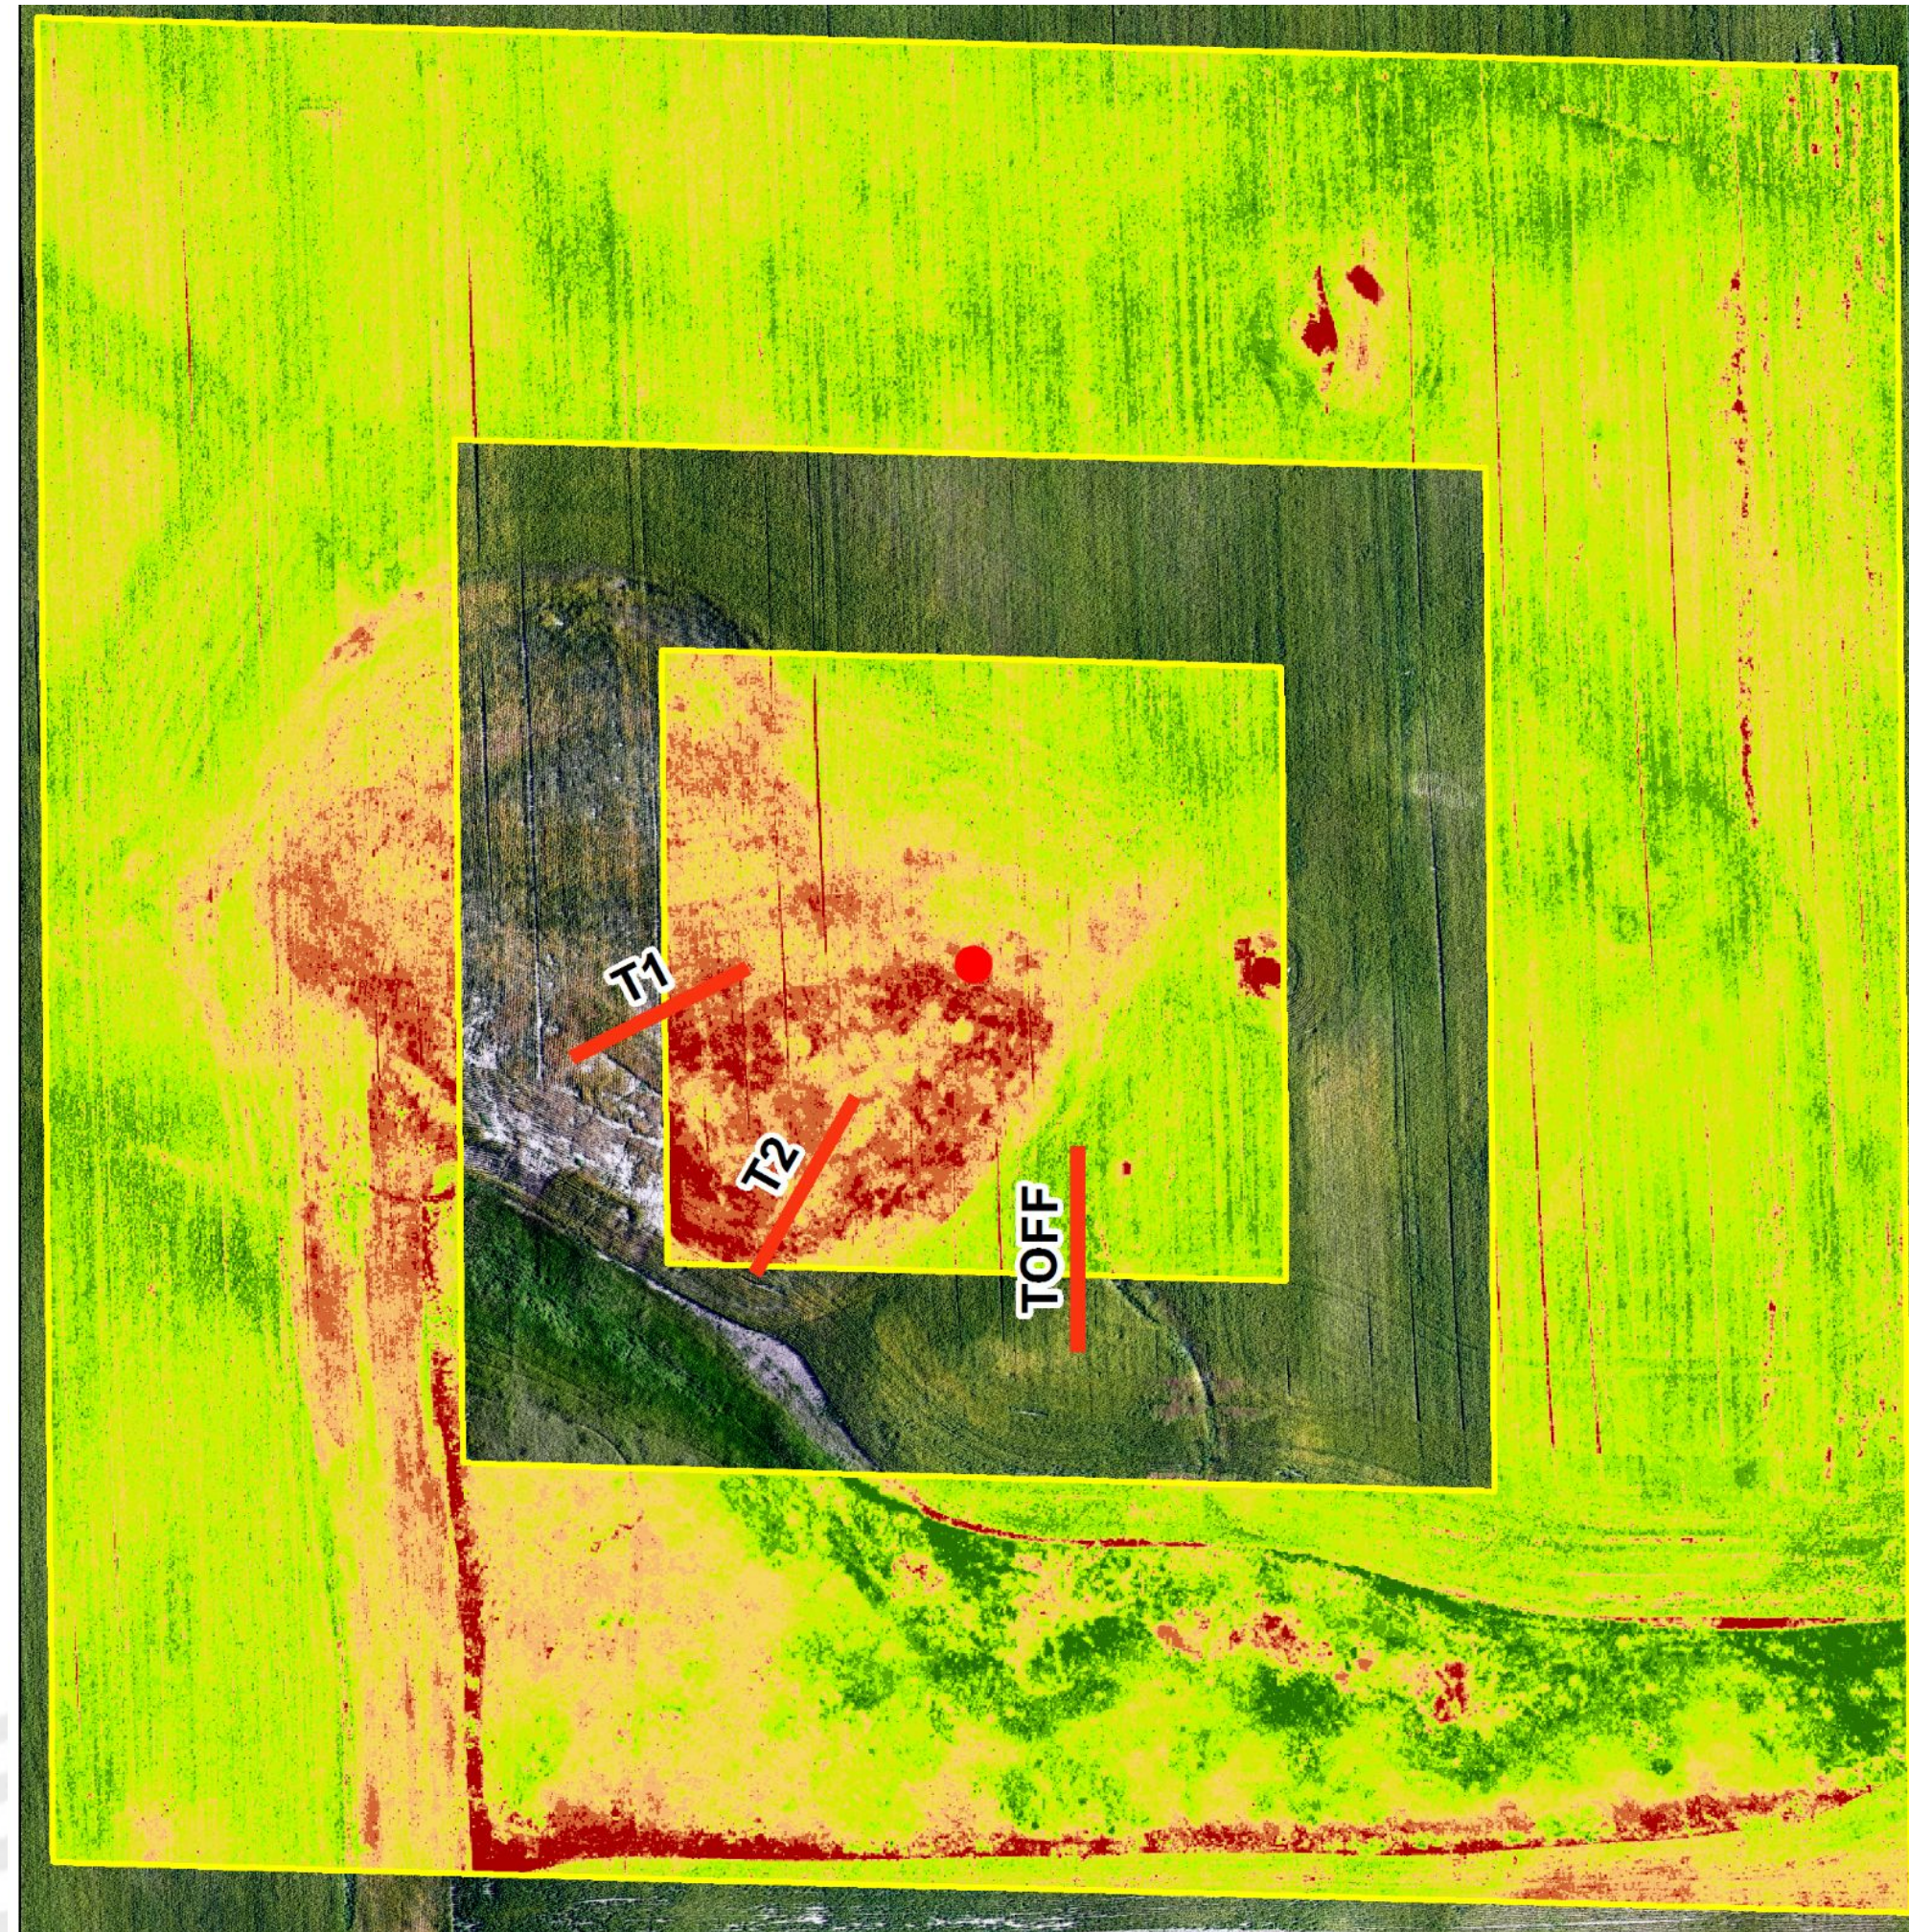
Vegetation vigor analytic for the Christen 24-10 well pad and reference area with greener areas indicating high vegetation vigor and dark brown colors being bare soil or senescent vegetation.

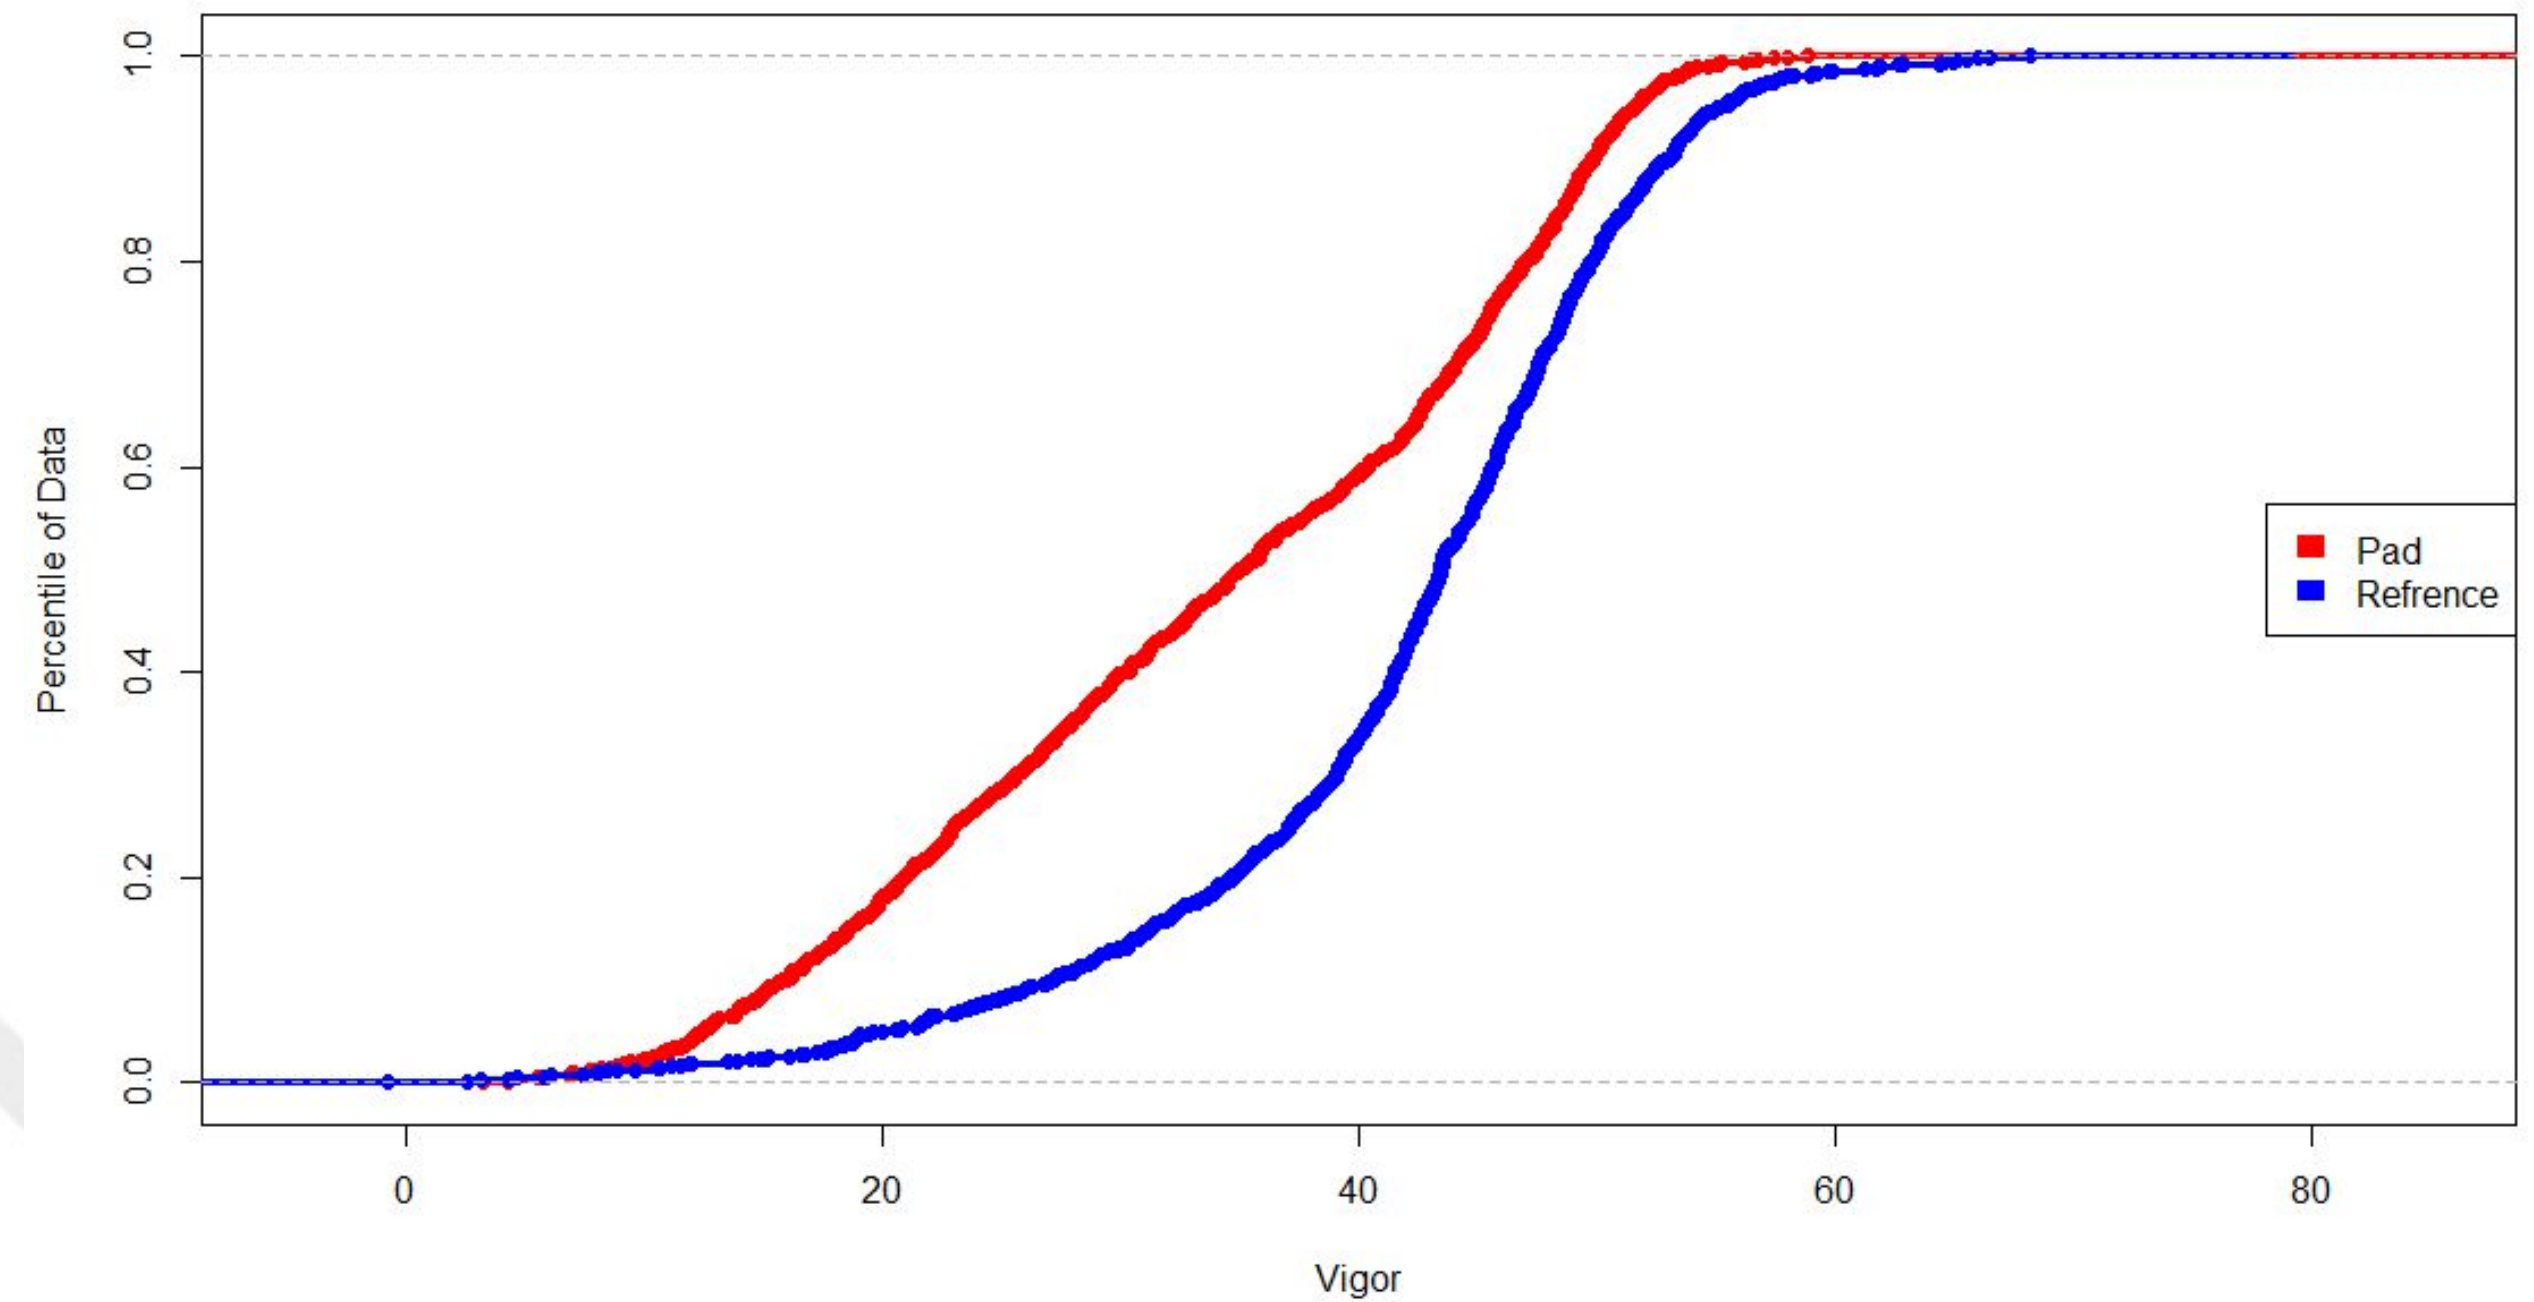
Cumulative distribution function (CDF) comparing vegetation vigor between the well pad (red line) and the reference area (blue line).

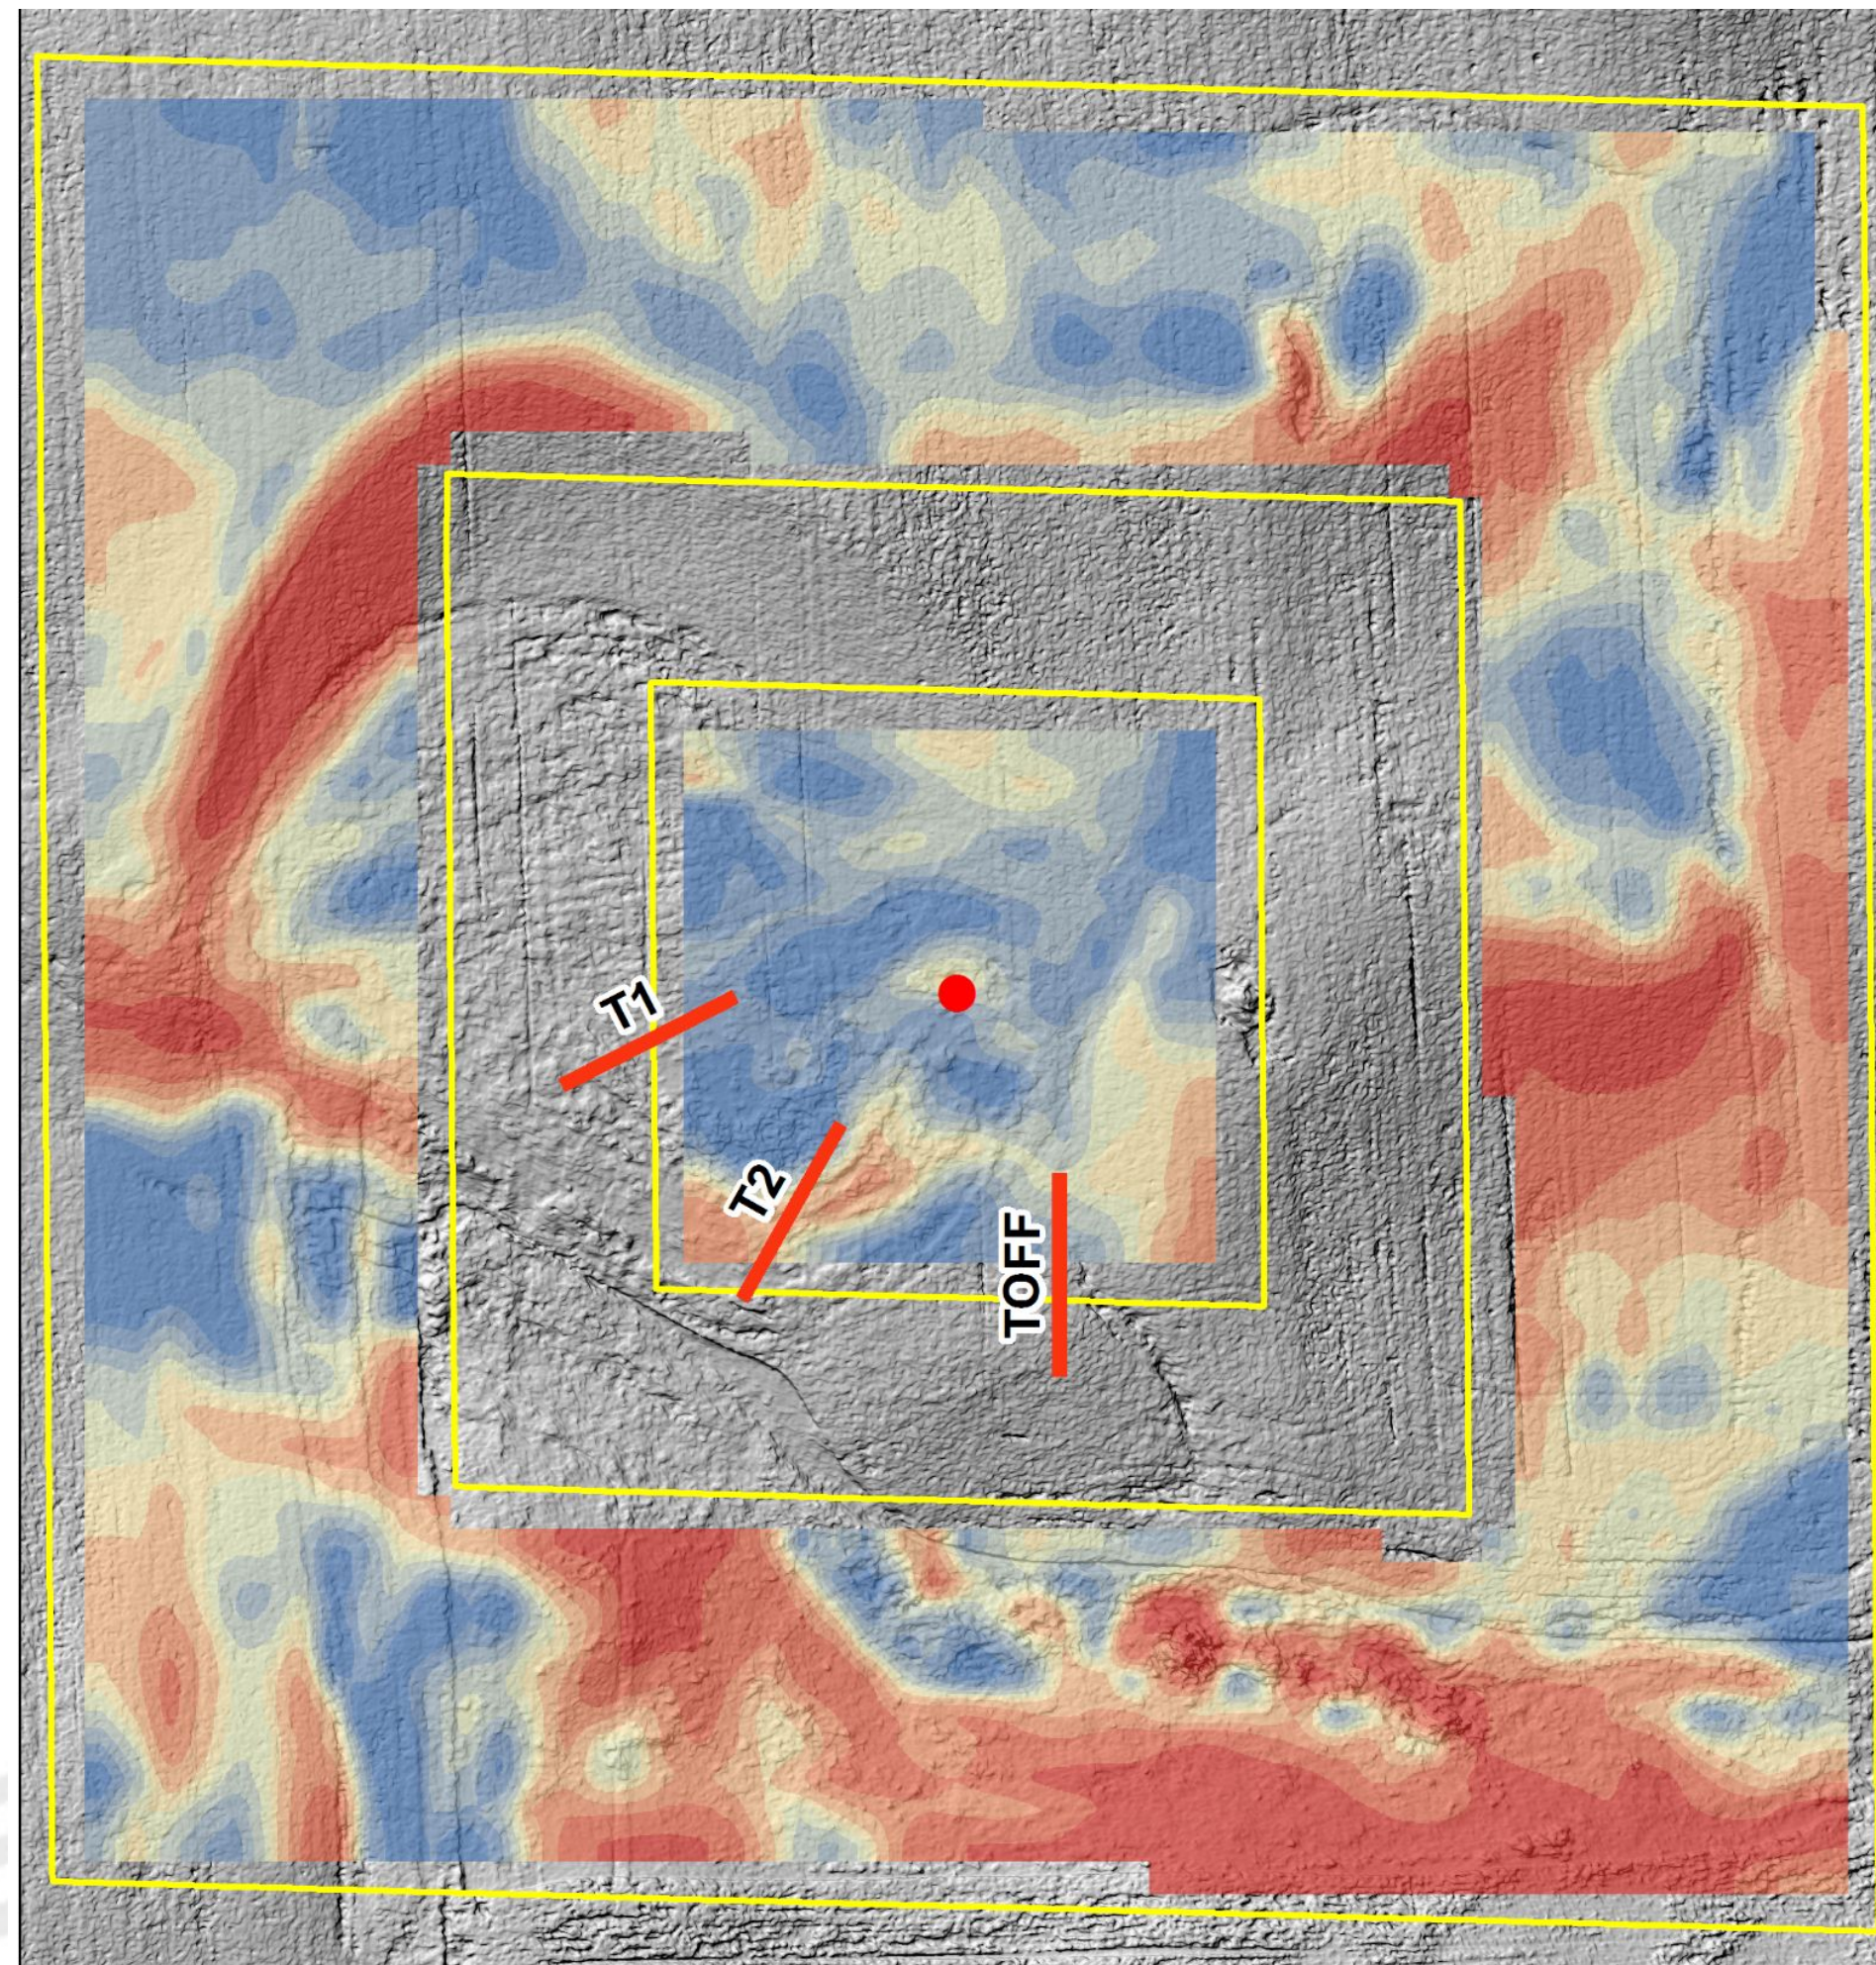
Contouring analytic for the Christen 24-10 well pad and reference area with blue indicating low-gradient slope and red indicating high-gradient slope.

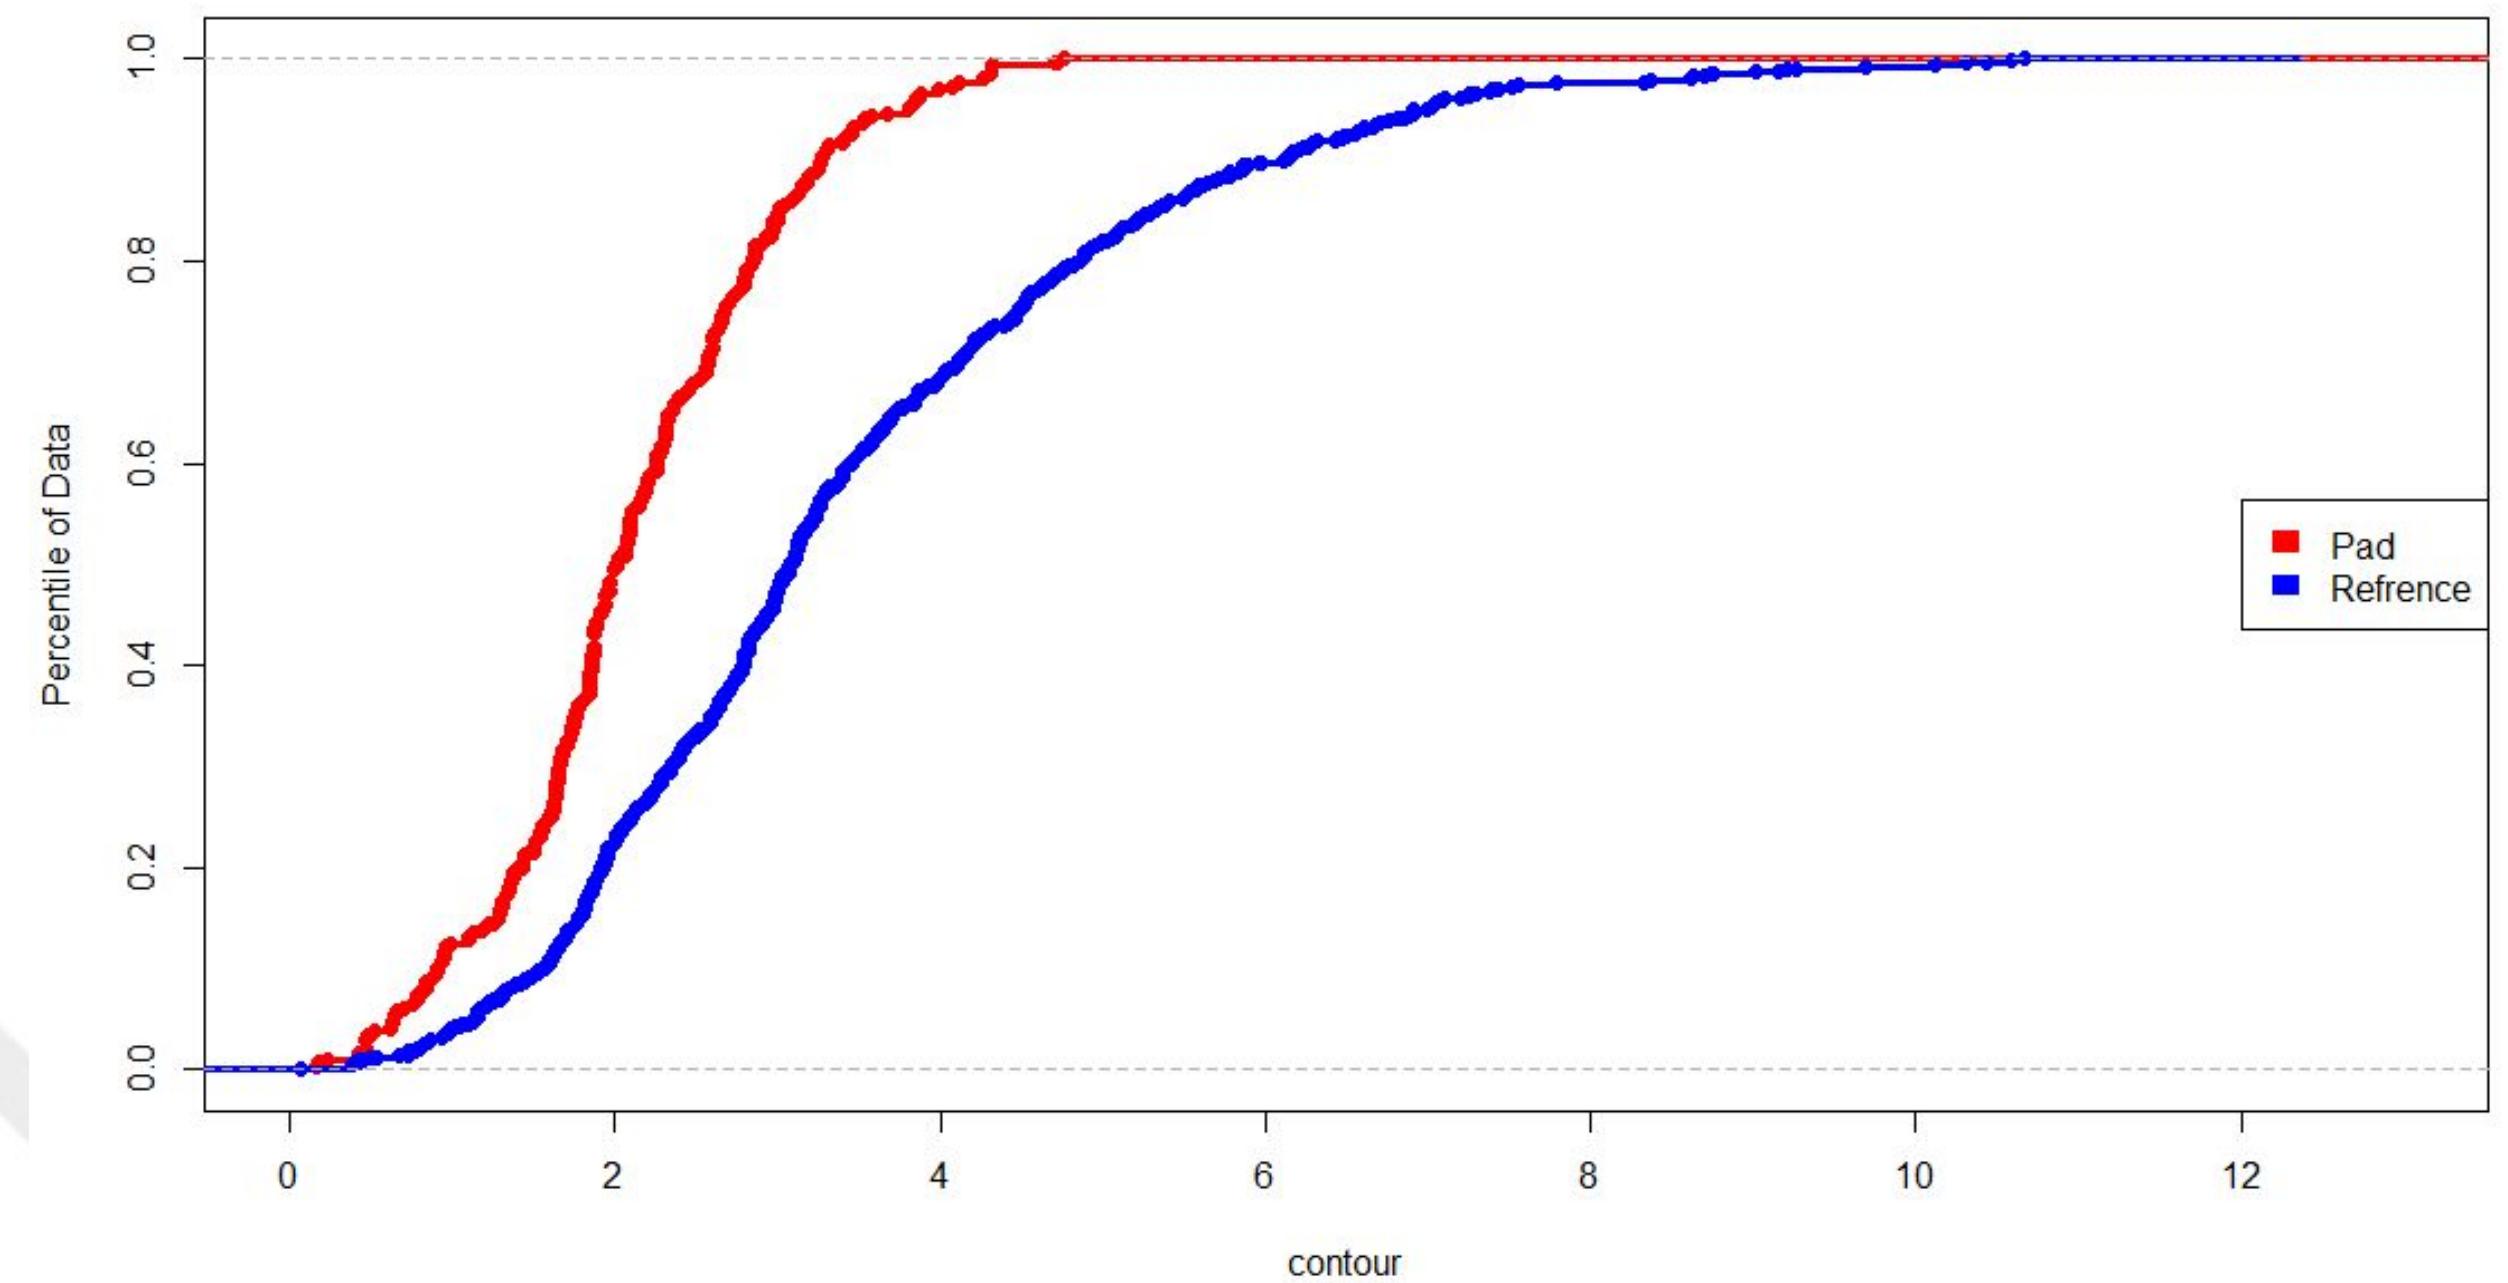
Cumulative Distribution Function (CDF) comparing contouring metrics between the Christen 24-10 pad (red line) and reference area (blue line).
